# AGENDA

## Historic District Commission Meeting

7:00 PM - Tuesday, January 10, 2023

206 – 210 N. Washington Street  
Ypsilanti, MI 48197

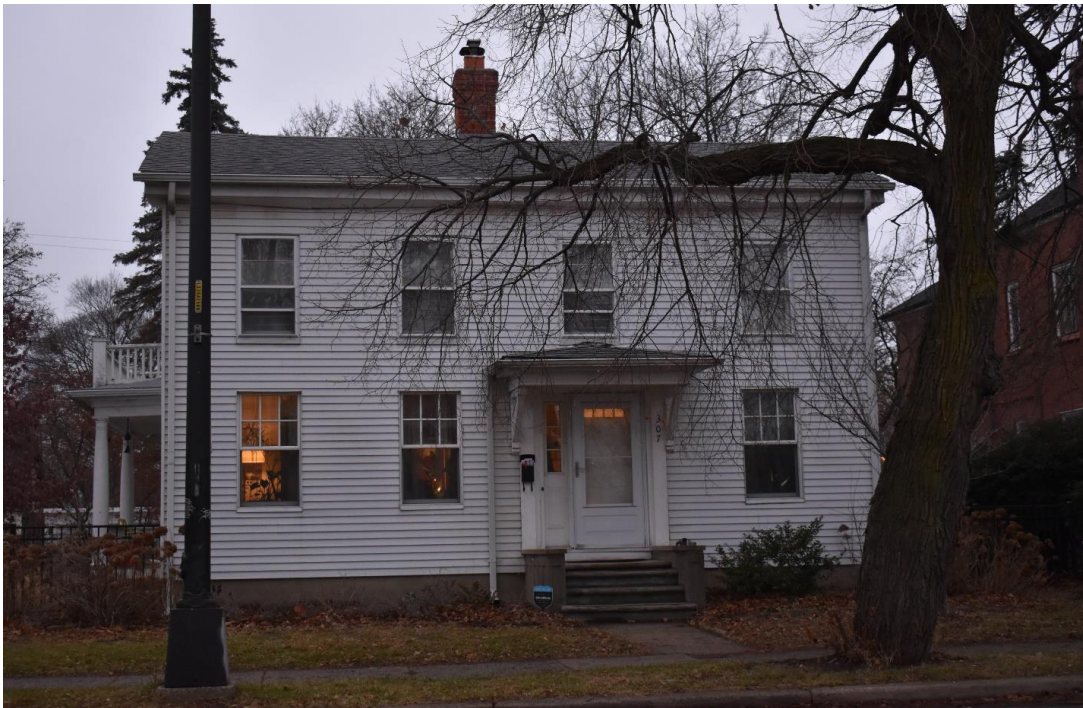
- b. In this case, the proposed work would not obscure or damage any historic features, but it would be conspicuous from the sidewalk.
  7. The City's historic district design guidelines are comprised of the District Fact Sheets and are based in the Standards and Guidelines mentioned. Upon review of the City's Fact Sheet on Alternative Energy (attached), staff finds, as would be expected, that the local guidelines also state that the solar panels "should not be visible on the primary façade (or façades if located on a corner lot) of the historic structure." However, the proposed:

*Figure 1.* Primary (east) façade of 307 N Washington. Proposed on this roof slope are five solar panels installed horizontally along the lowest edge and seven solar panels installed vertically behind/above those, with none immediately in front of the chimney. (Staff picture, January 6, 2023.)

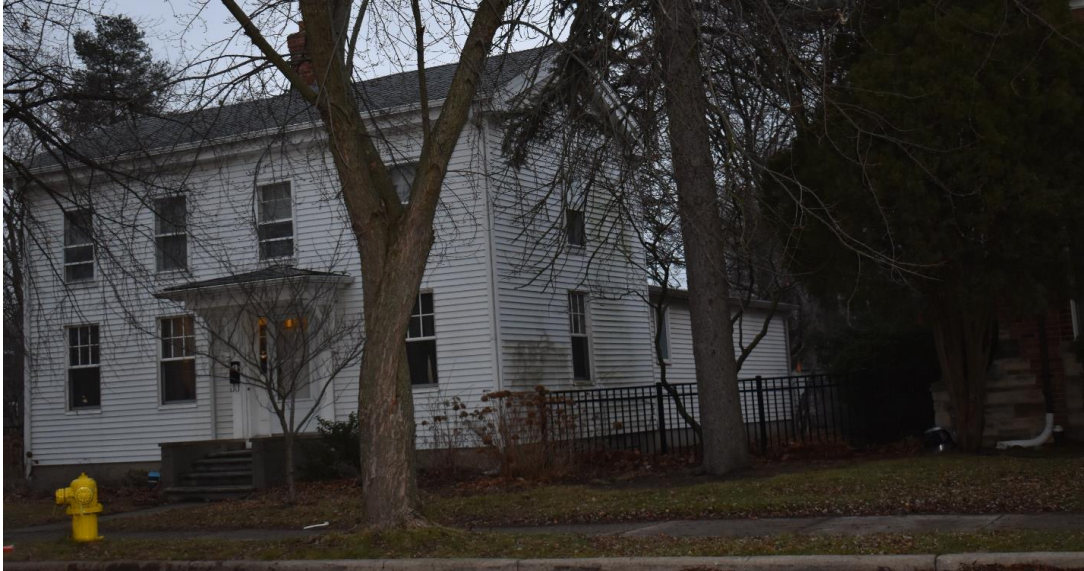
*Figure 2.* 307 N Washington. The front elevation is the house's east side. Here, the north end (side) of the house with the gable and Greek Revival detailing is also visible, as is the rear addition. Solar panels are proposed on the roof visible at the front of the house, and also on the roof of the addition, on the southern slope.

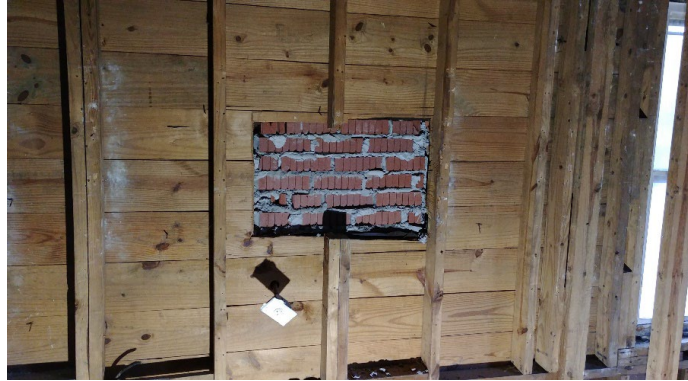
Figure 2: Example of Wall Framing Discontinuity

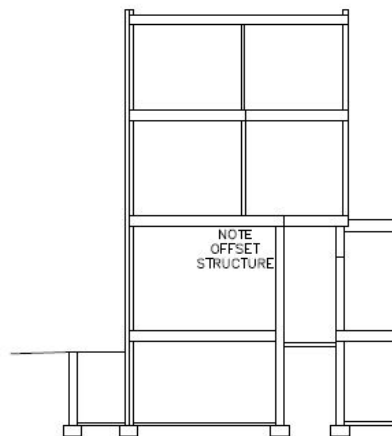
The interior bearing wall on the second and third floors is offset from the foundation by nearly two feet. This creates a situation where the second floor joists are carrying the full loading from the bearing walls above as shown in Figure 3. At the current span, the 2<sup>nd</sup> floor joists would be overloaded and not meet the minimum deflection requirements.

Figure 3: Eastern Zone Building Cross Section (Courtesy CDI Architects)

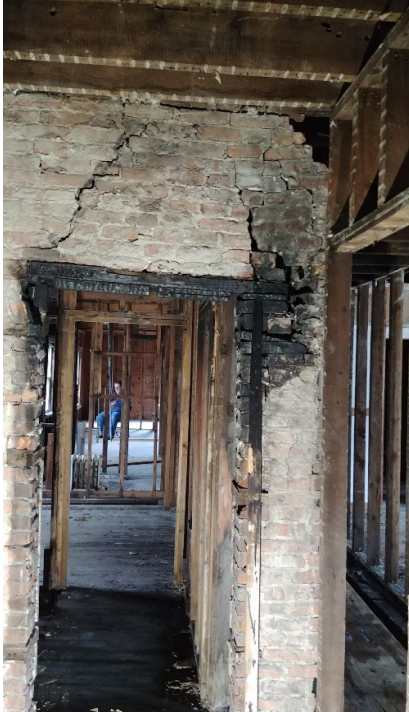
Figure 4: Failing Bearing Wall

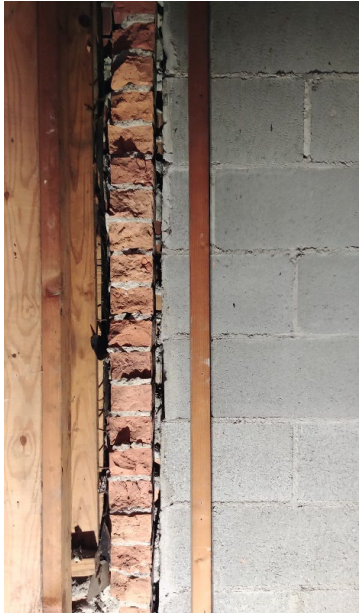
The Western Zone has numerous significant structural issues. First, the framing around the central stairway is fire damaged and must be replaced. In addition, the floor system around the stairway was not properly supported with appropriately sized headers in the floor framing. Or, the posts that supported the floor framing have been removed.

Figure 5: Masonry Connection

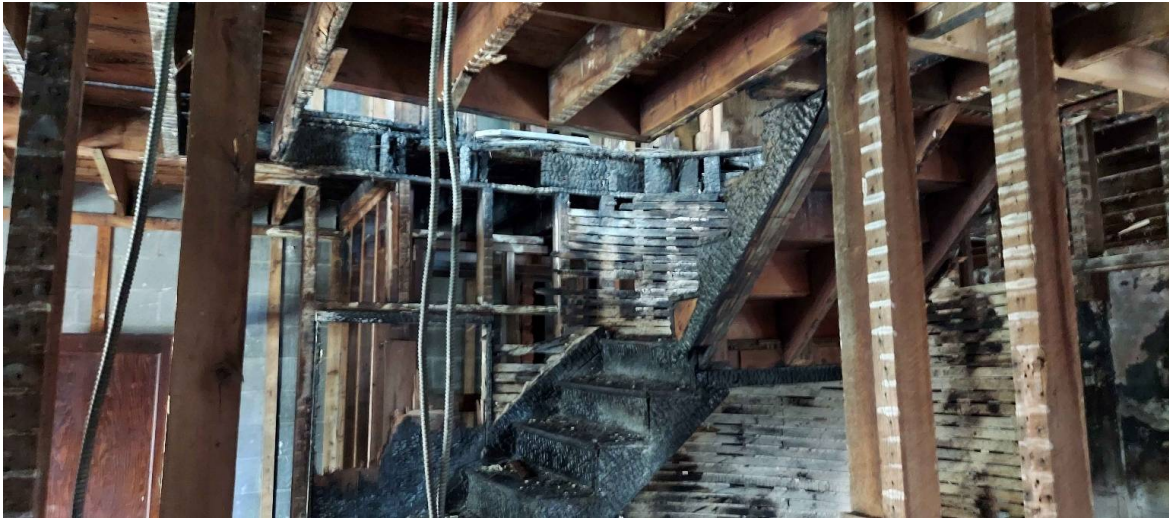
The fire appears to have been worst in the area of the front stair in the tower, and particularly at the upper levels. The stair and surrounding framing is badly burned and will obviously need removal, as will much of the roof framing at least in the front half of the tower.

Fortunately most of the exterior wall behind the stair appears to be multi-wythe brick, so not much obvious loss of load-bearing capacity there. Floor sheathing is mostly missing at the first floor, presumably due to fire or water damage, and heavily damaged or deteriorated elsewhere in the front of the tower, and is recommended for replacement.

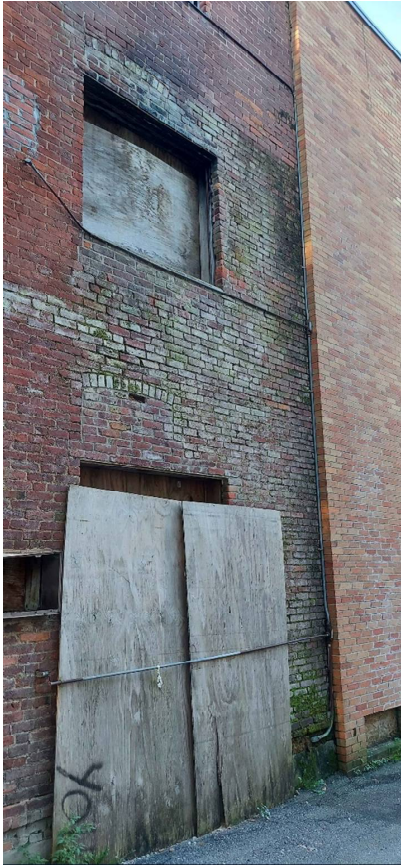
The building was no prize prior to the fire – small apartments, oddly configured, with mostly narrow halls and narrower stairs. Windows are old and in poor condition, and it appears there was minimal insulation. Heat was provided by old radiators from a central boiler, with some apartments having thru-wall air conditioner units (several of the radiators tested positive for lead-based paint). The newer parts of the basement foundation, as well as the many window well walls, appear to be single wythe CMU probably with minimal reinforcing, with some worrisome cracking particularly on the west end of the south basement wall. The one good aspect is the exterior brick, which despite its age, appears mostly in good shape except the area north of the worst part of the fire where mortar is badly worn probably from heat and water penetration.

The fire caused a lot of damage, but the time since the fire has also not been good to the building, with no heat provided (so potential of frost heave damage) and minimal maintenance. The previous owner did apparently put a new roof over part of the tower after the fire, so it was not open to the elements, but there are some signs of water penetration possibly through broken windows and elsewhere, not to mention the water used to fight the fire. Much of the water, of course, eventually flowed to the basement, which would likely be damp anyways without conditioning. As a result, the basement surfaces are pretty well covered with mildew or worse. We should also note that the timelines for these projects are long; to get public approvals, get funding approved, do drawings, get permits, and close on funding could easily result in three or more years of deterioration before construction starts.

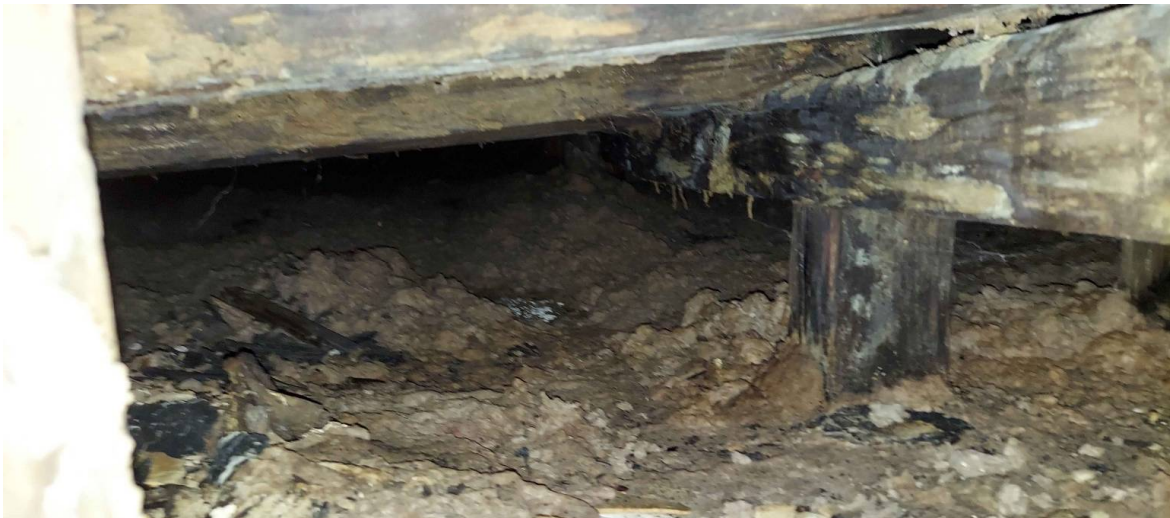
and sheathing was left in place as ceiling framing, with new structure added above, mostly invisible from below although there are finished recesses up into that area hinting at the situation (the stepped up roof is also visible from the tower windows). But the fire at the rear stair in the tower exposed an area of this roof structure, which is somewhat scary – random timber stubs over the earlier framing with timber beams connecting them, and filled in between with loose fill insulation that appears likely to be wet from the fire fighting and/or general humidity. We can't evaluate anything about the structural capacity, bearing locations, current condition of members, etc. without exposing it much more than it is now. Our recommendation would be to remove the entire raised roof and start over.

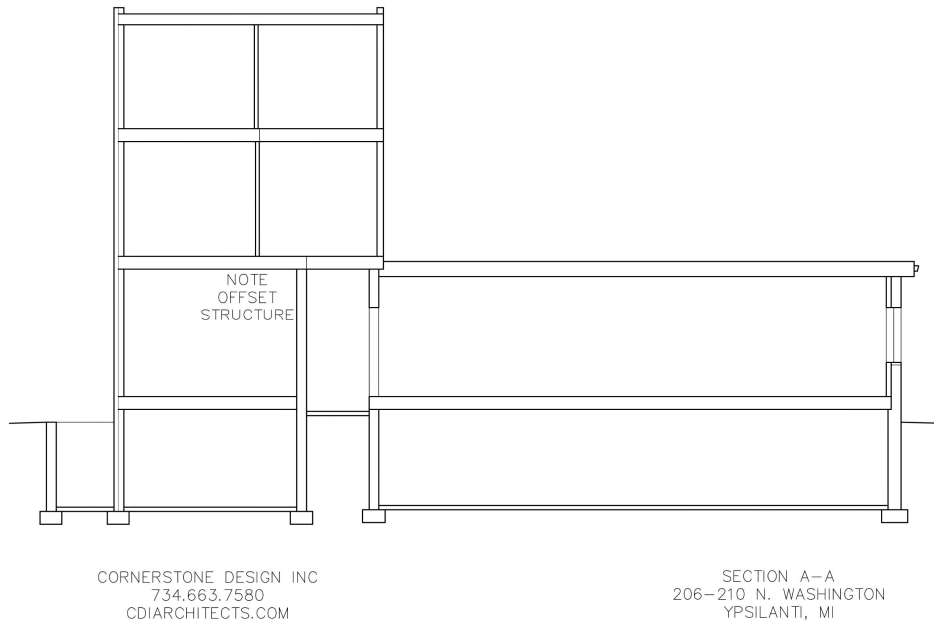
The existing tower framing is also challenging, with 2x8s at 16" on center at the 3<sup>rd</sup> floor and the roof, and 2x10s at 16" on center at the 2<sup>nd</sup> floor; we think the first floor was also 2x10s but didn't have good access to measure it due to dangerous conditions. Modern 2x8s could span about 11' with apartment loads (not higher loads in common areas); these are in places spanning as much as 16'. They are older wood, and often closer to the actual 2"x8" size than modern lumber, but it is difficult if not impossible to know what qualities to give it for calculation.

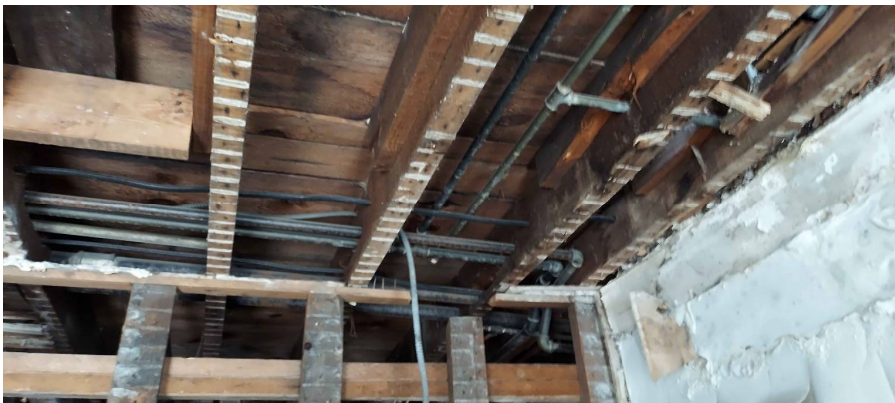
Many of the joists are also frequently cored for pipe penetrations, etc., probably more than should be allowed.
