# AGENDA

## Historic District Commission Meeting

7:00 PM - Tuesday, June 14, 2022

## HDC Work Permit Staff Review

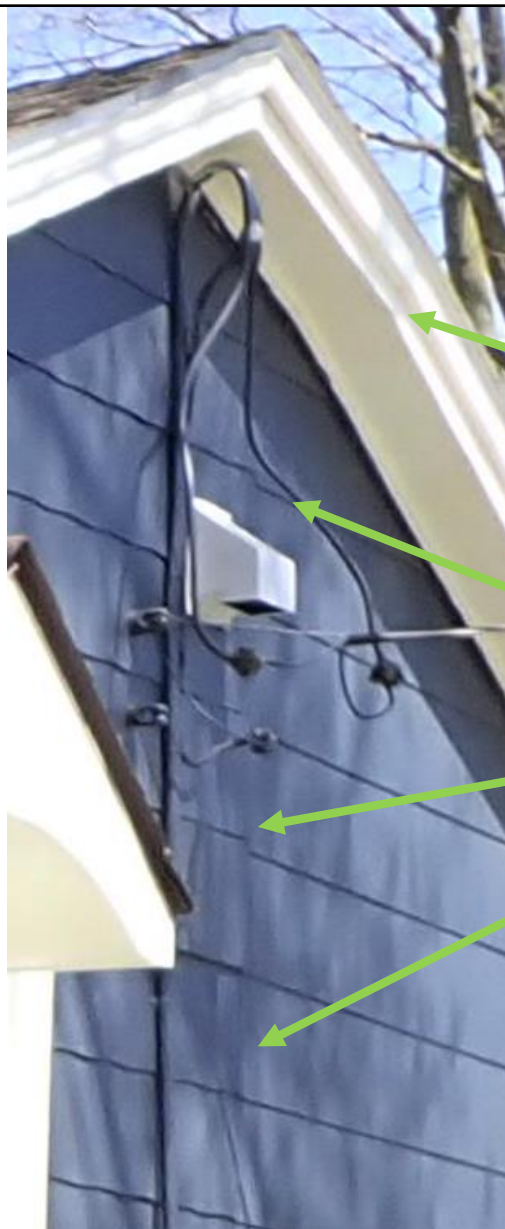
FOUNDATION TYPE CHANGES  
HERE AND THERE IS A STRAIGHT  
CUT GOING UP THE WALL WHERE  
NEW (MATCHING) SIDING IS STARTED –  
ALSO THE ROOF PITCH DOES  
“CHANGE” OFF CENTER OF ROOF  
SLIGHTLY (it’s not the photo)

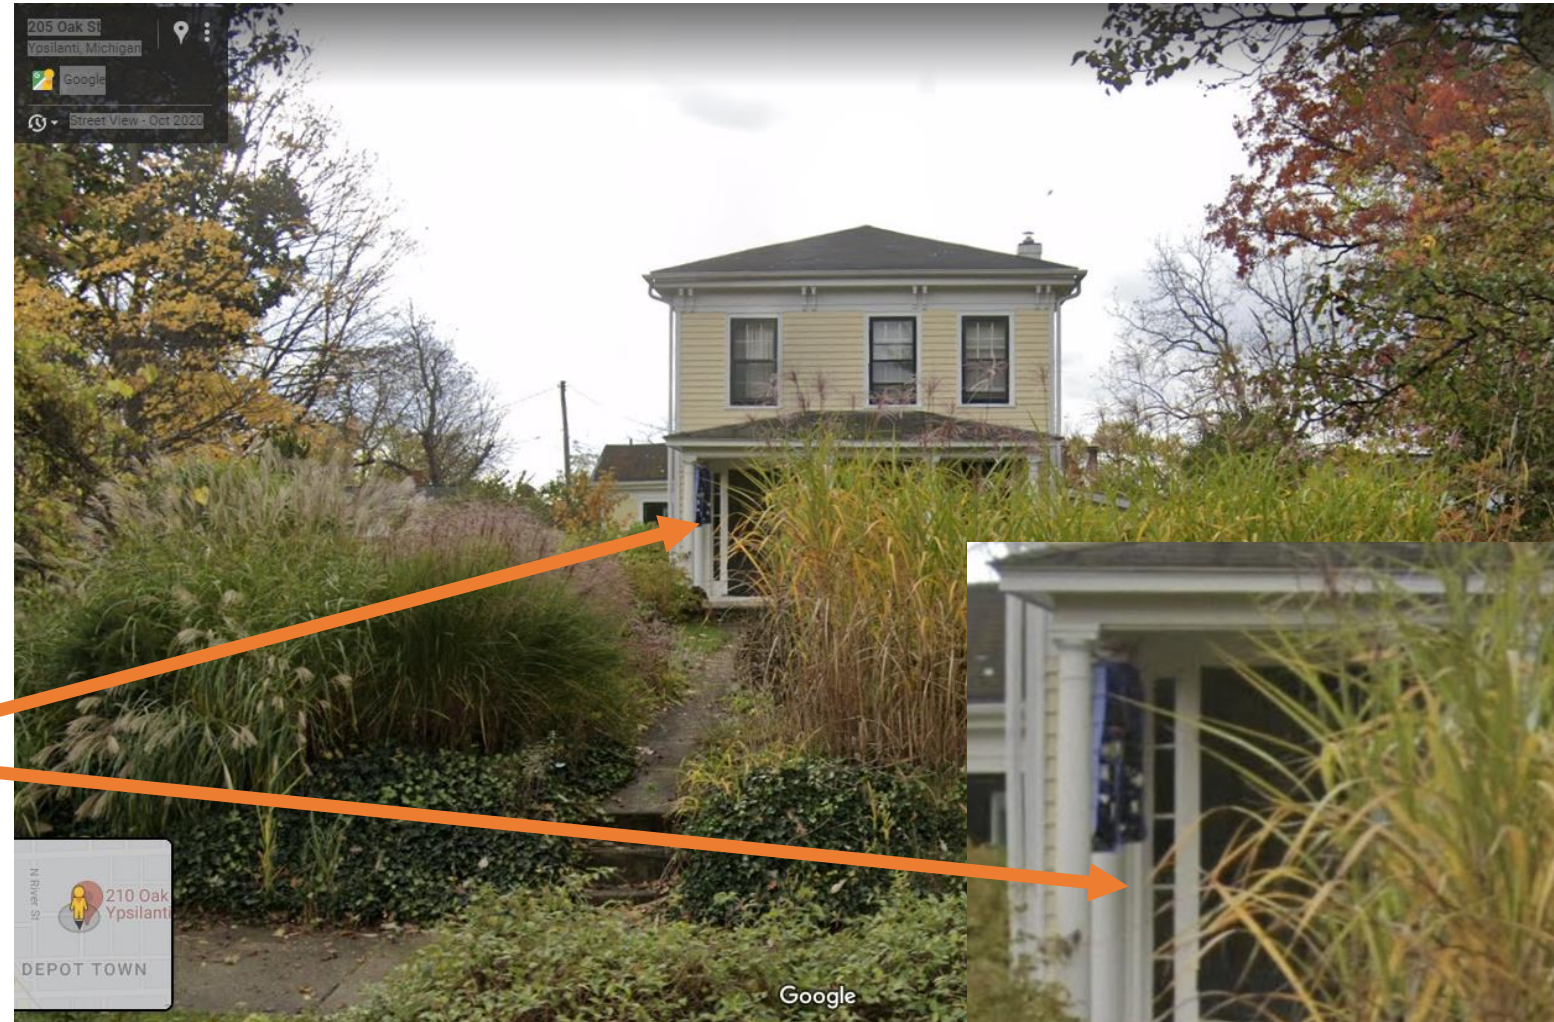
Glass in transom  
isn't original and  
is two pieces of  
glass butted  
together – it  
looks like the “1”  
is the only thing  
covering the gap  
between the  
glass panes

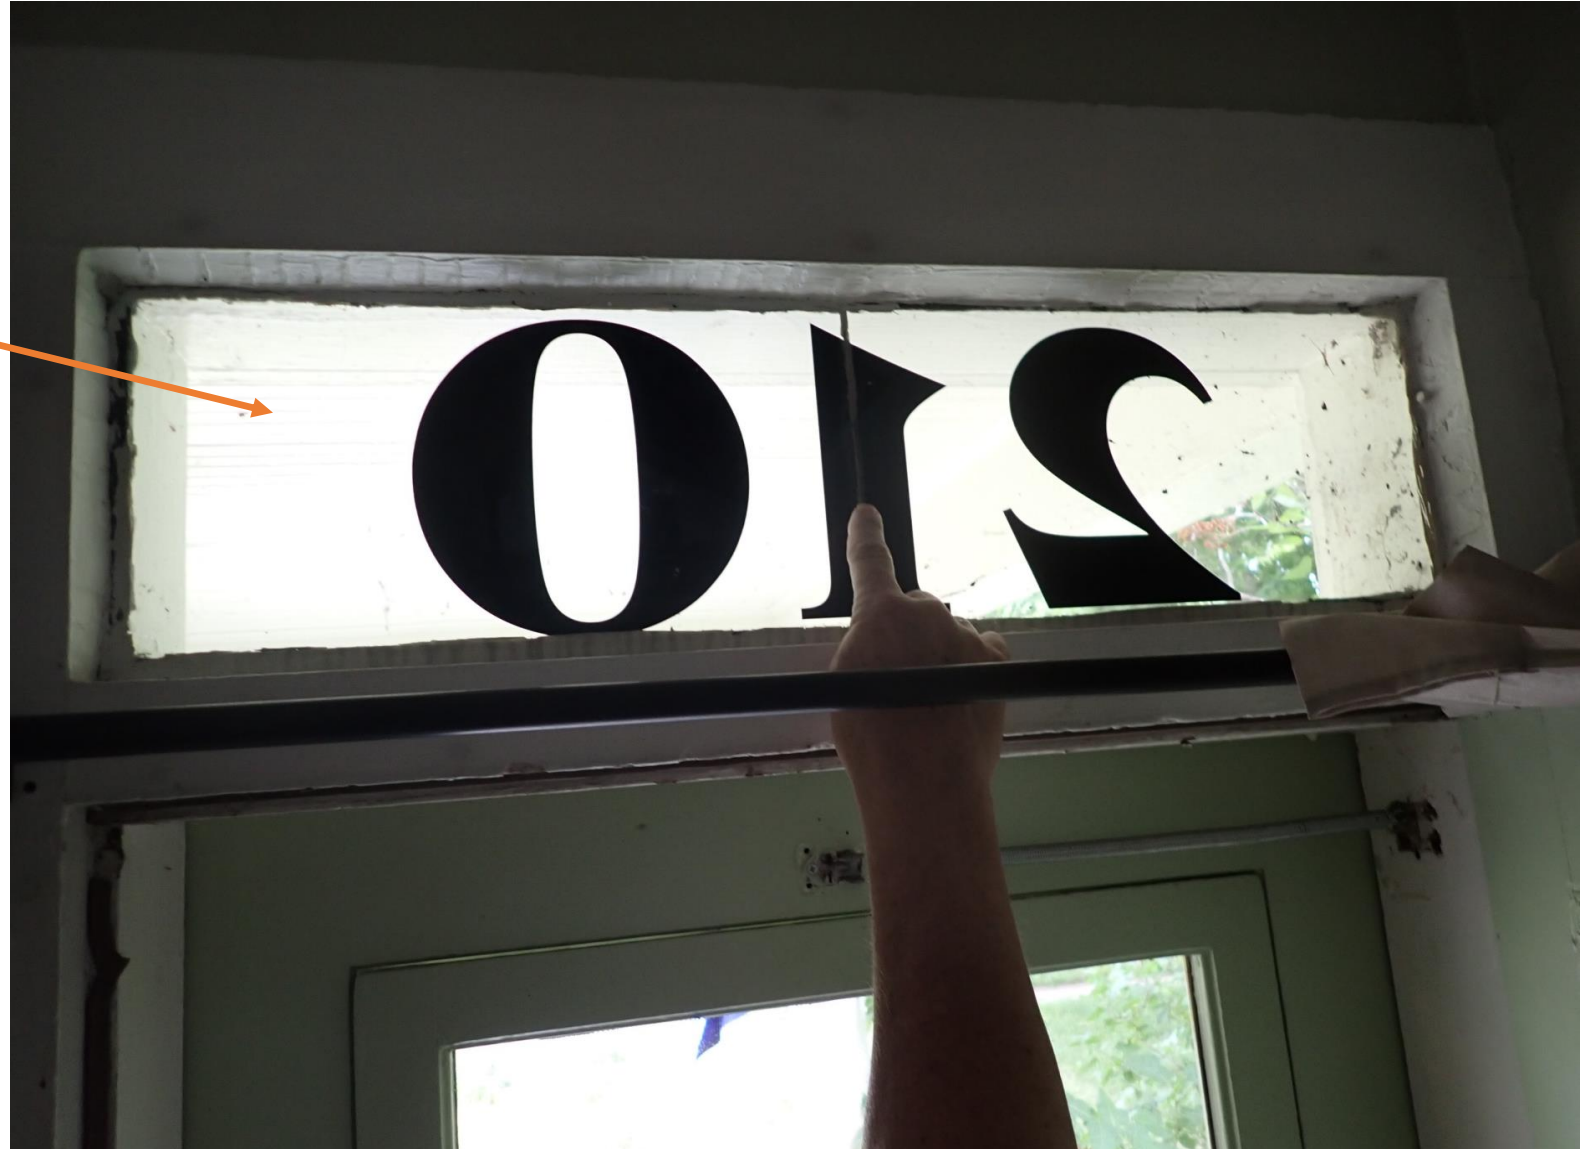
## ENTRY DOOR

We believe that this slab was replaced At some time due to the fitment inside the frame

Also possible is the window above this door was shortened as well – which would explain why it doesn't line up like the neighboring house

This house has been sided over and probably had wood siding like the other houses at some point

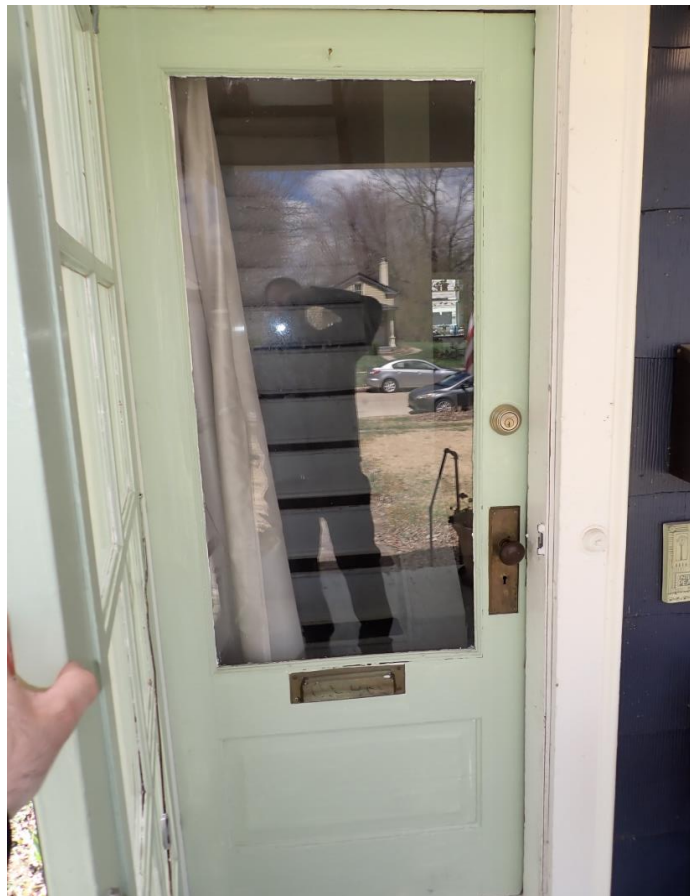
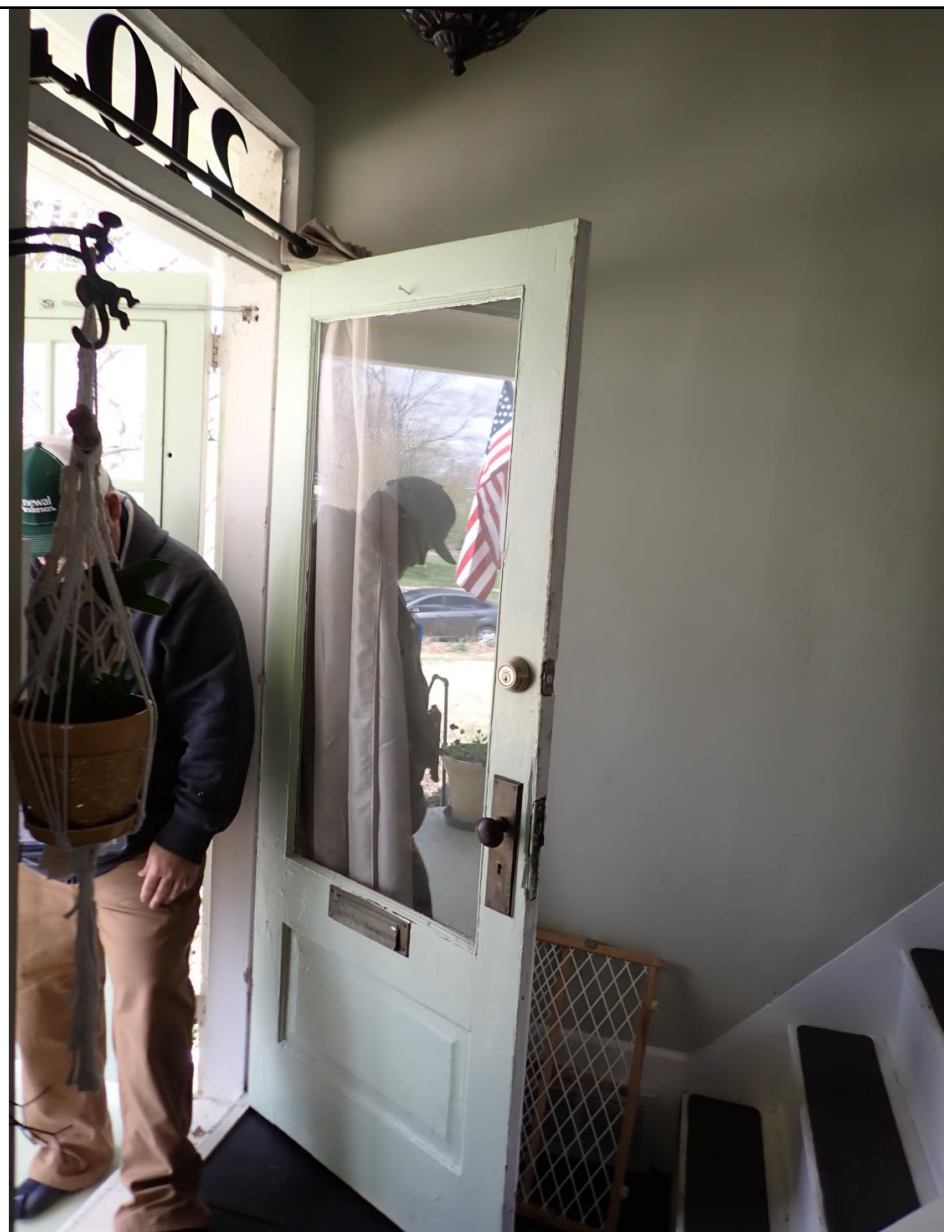
Storm door is not original to the house and uses the same hinges as an interior door that we found.

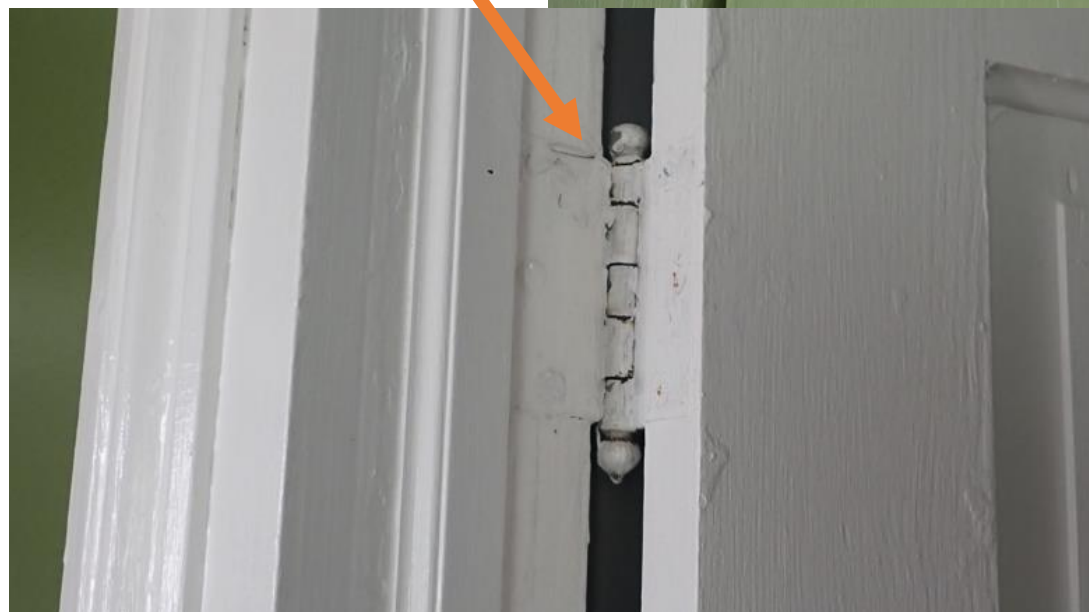
This door closure marking that has been painted over several times does not line up with the current storm door

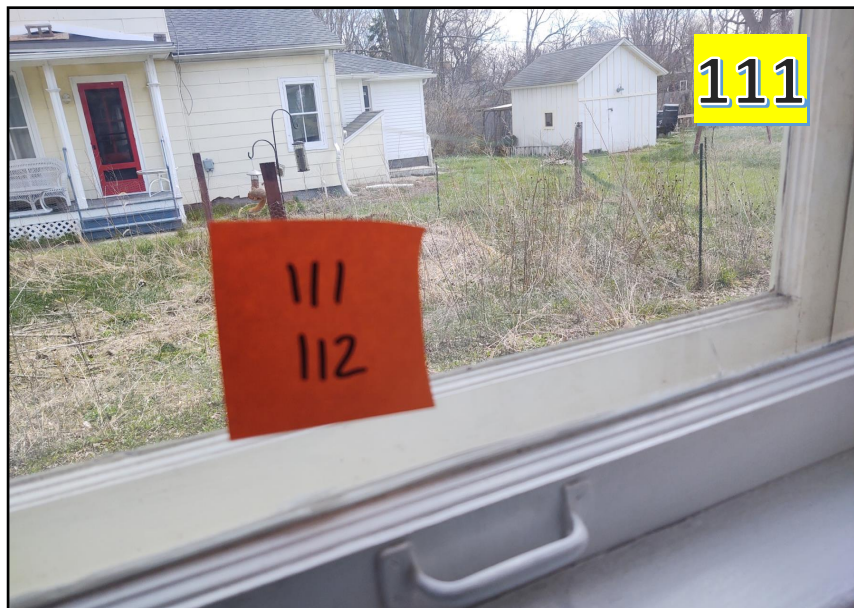
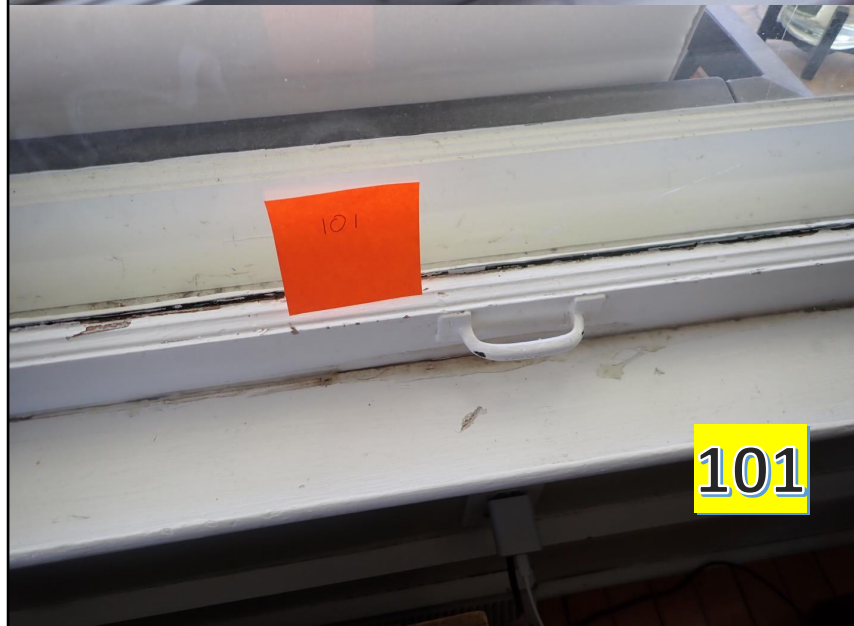
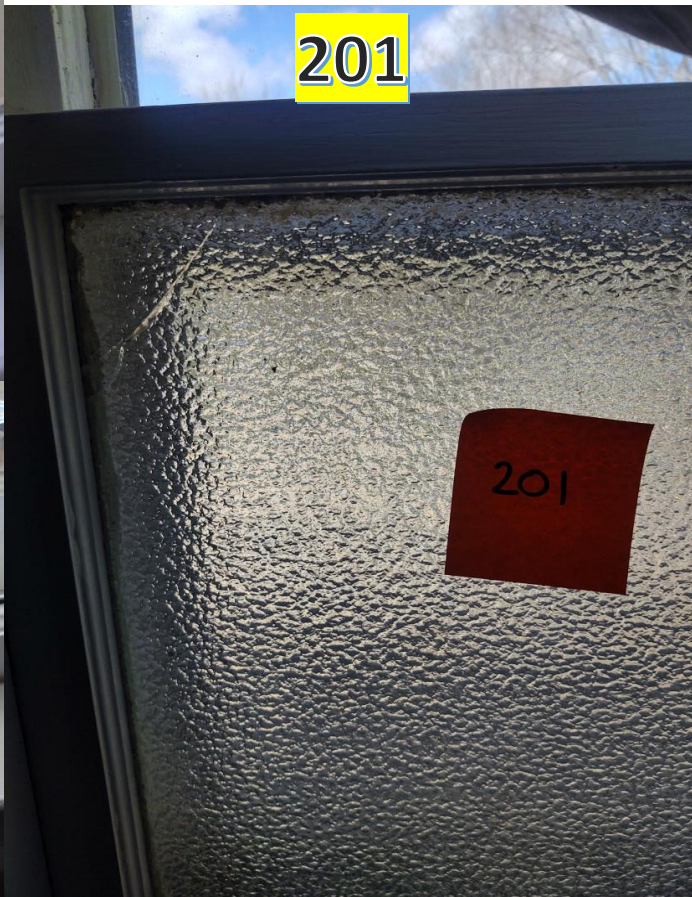
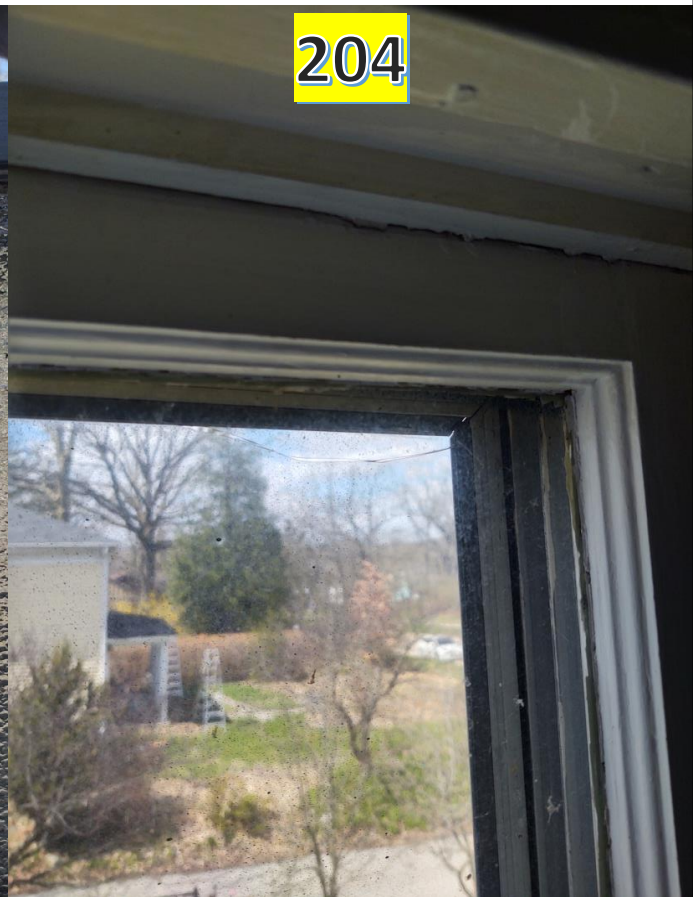
101, 111, 201, 204 have cracked glass

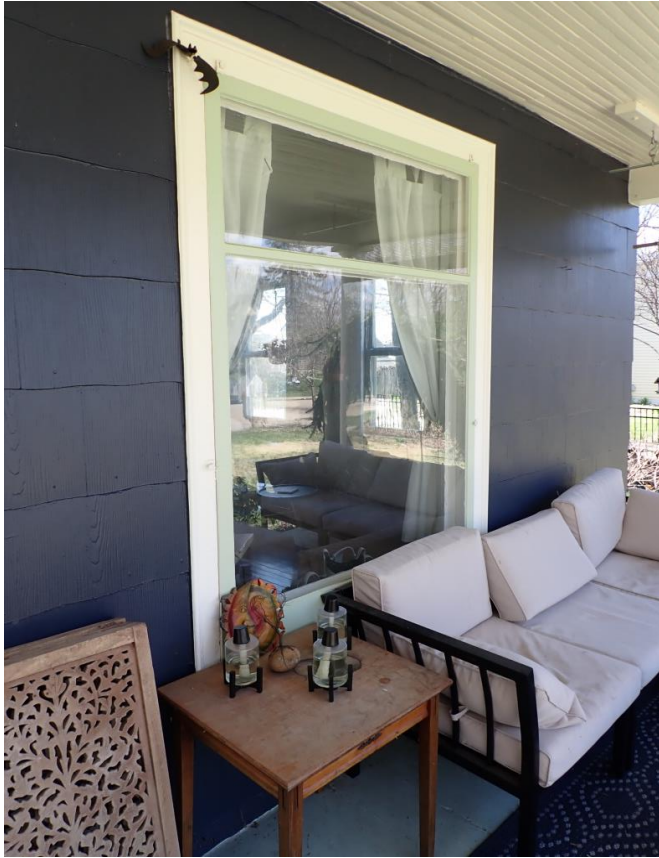
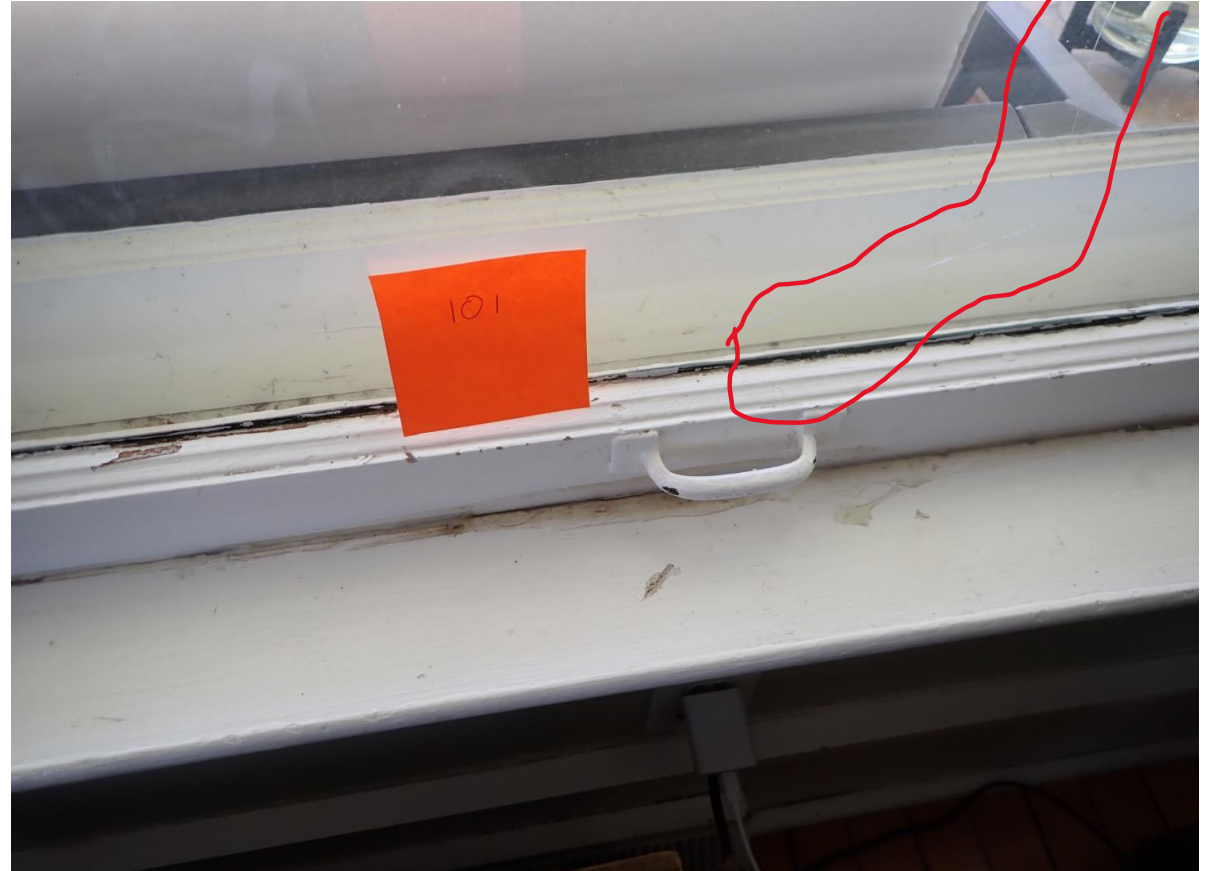
**210 Oak Street**

101 (Living Room) – 1:3 Double Hung – lower window pane is cracked and interior string missing

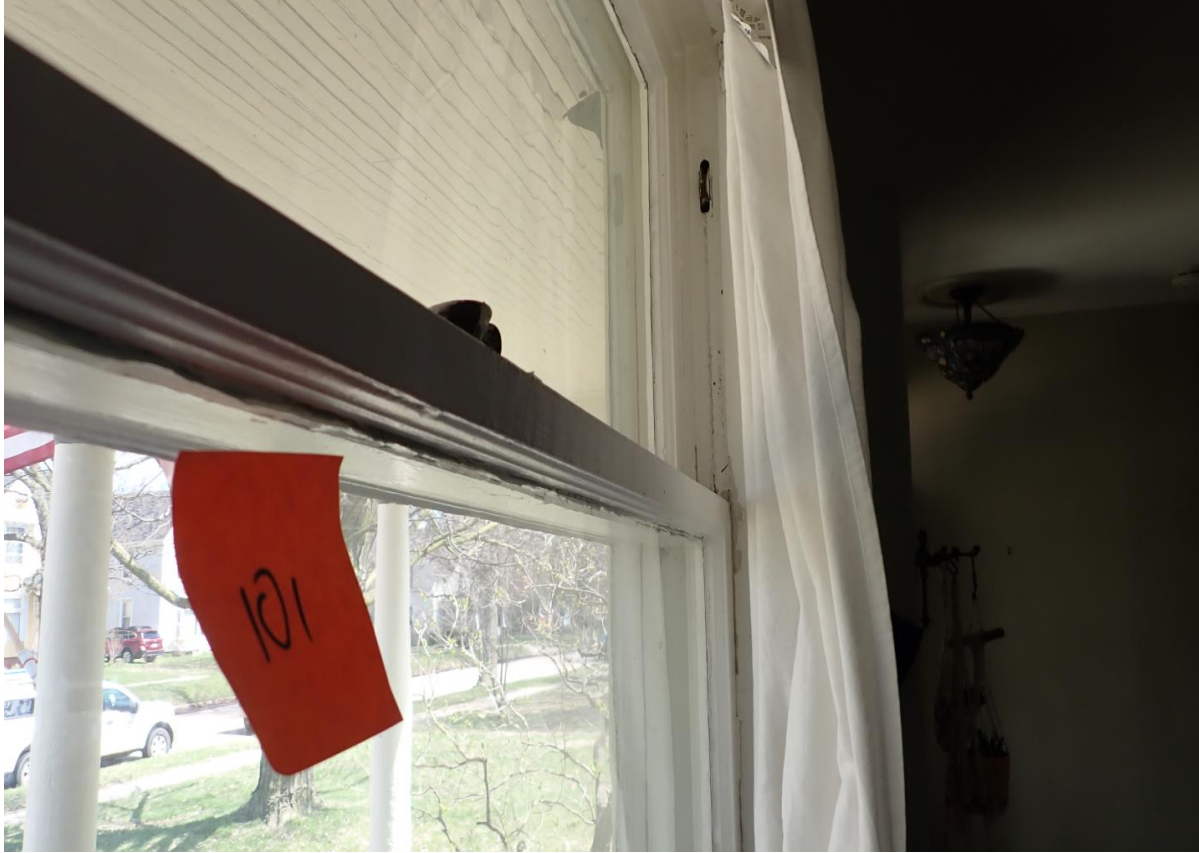
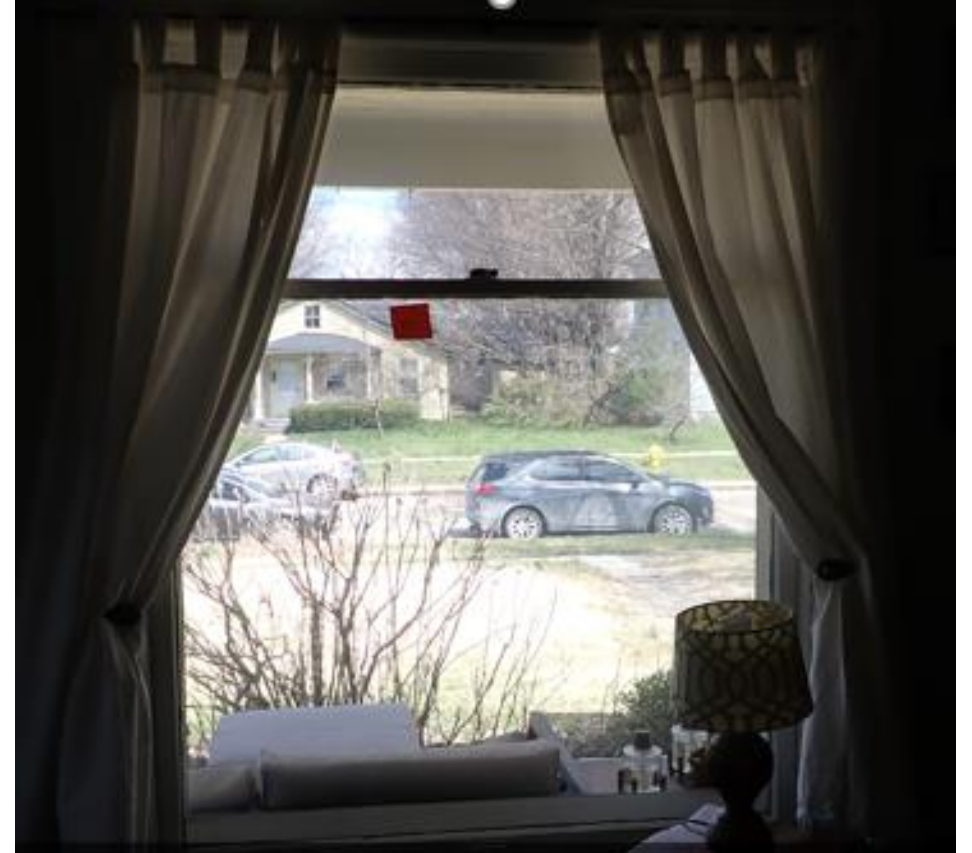
### 210 Oak Street

101 (Living Room) – 1:3 Double Hung – lower window pane is cracked and interior string missing

Wood Window – String tyle

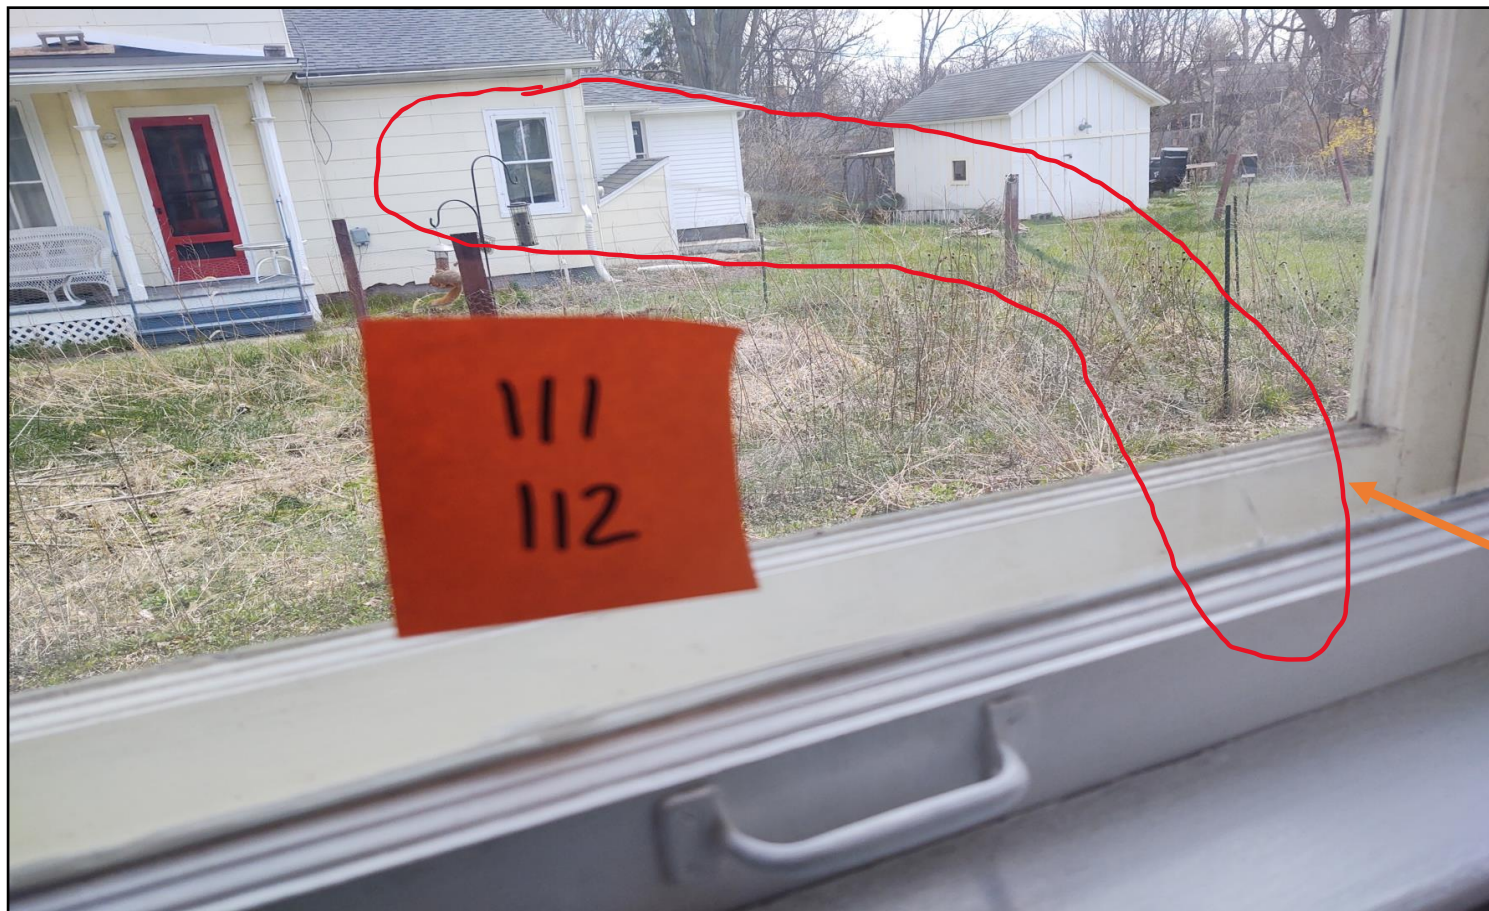
210 Oak Street  
111 & 112 (Dining Room) – Double Hung

Crack

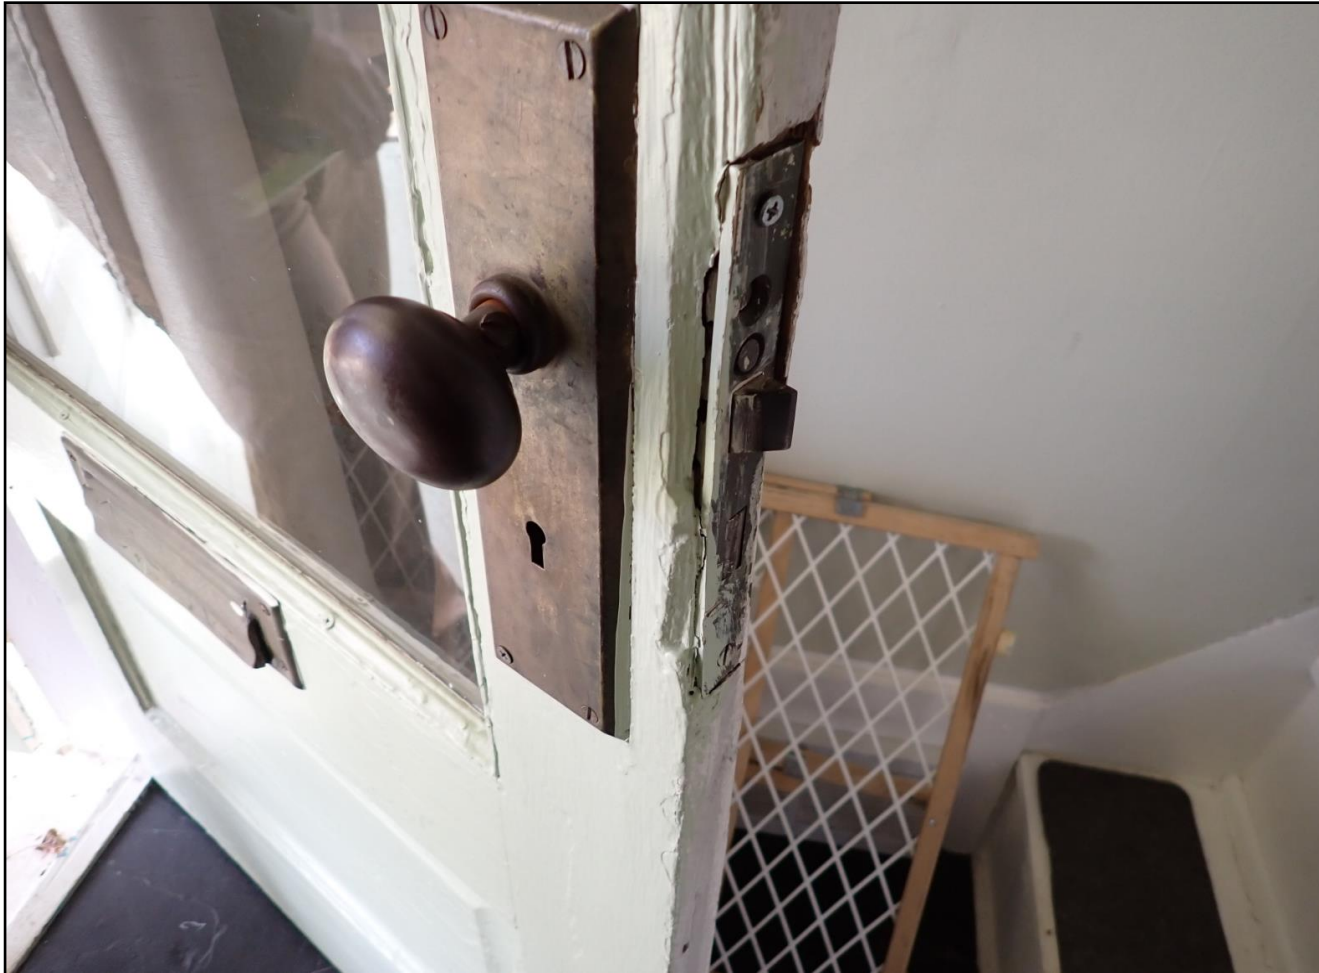
210 Oak Street  
114 (Front Entrance) – Entry Door

Deadbolt was added on from original – door locks into 1x4 casing – reinforcement board was bolted over deadbolt locking area

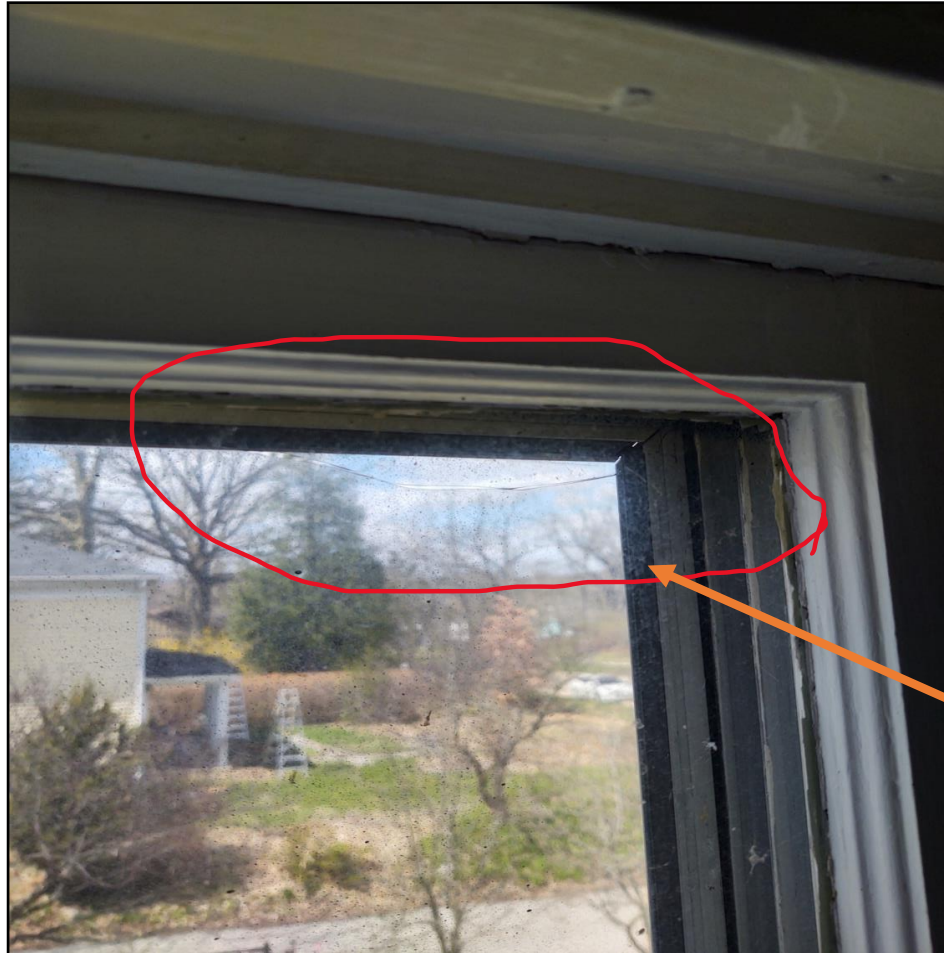
Crack

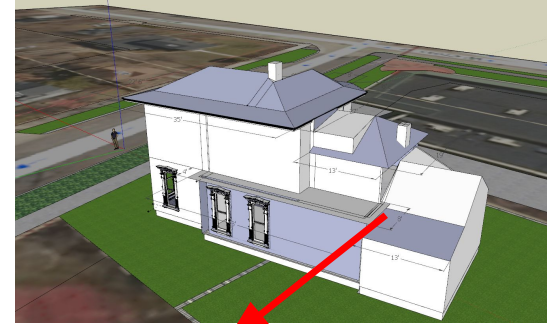
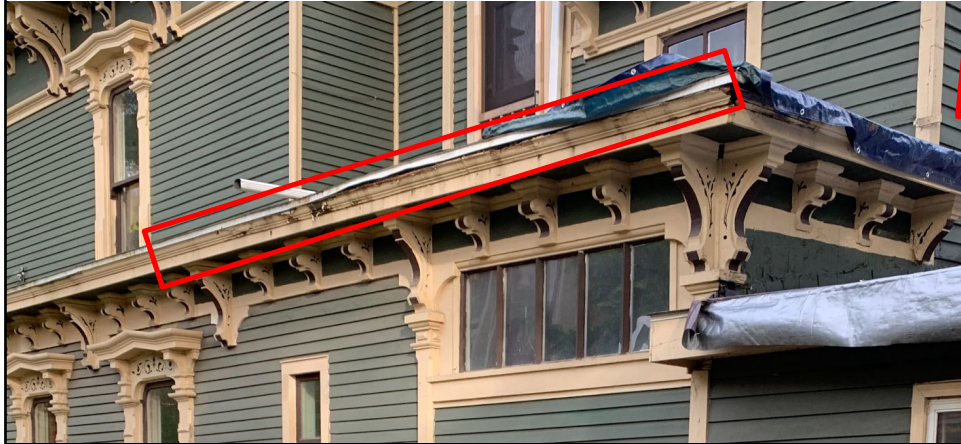
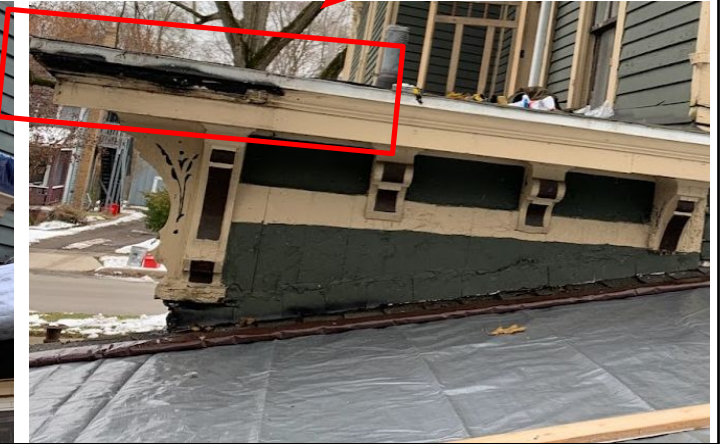
# Fascia Board and Cornice Moulding Repair

- Prepare, prime (if needed), and paint fascia boards prior to gutter installation
- Replace/Repair rotten moulding on North Flat Roof toward rear of the house
  - Some may be **salvageable** and with repainting and polywood, however some is outright **destroyed** by rot and must be replicated and replaced.
  - Approx. 10 ft is rotten and another 10 ft may be salvageable.

4x1" cedar to be used. Cedar selected for its resistance to rot and straight grain

- End of the board to be milled using chamfer router bit
- Inside flats to be milled using a dado blade on a table saw
- Rounds and hollows to be milled using round and hollow moulding planes
