# AGENDA

## Historic District Commission Meeting

7:00 PM - Tuesday, July 11, 2023

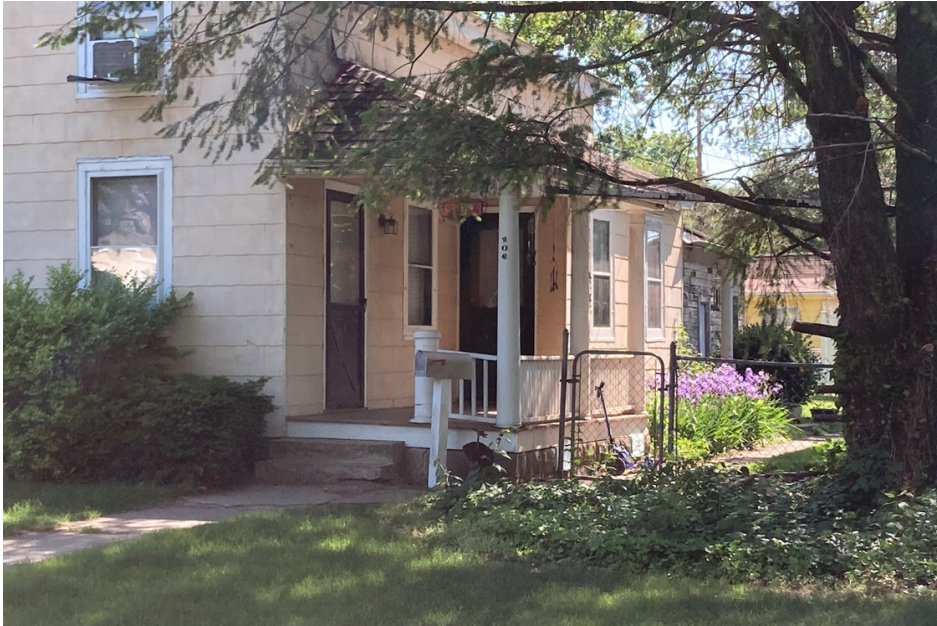
206 N River, north side and northwest corner. Wood-sided portion to rear is portion where siding is proposed to be replaced.

The wood siding on this garage/rear-most addition is in poor condition. Applicant states that the workmanship on the installation of the siding about 1915 was not high quality—some planks are short and there are a lot of seams—and the siding currently allows squirrels to get into the house.

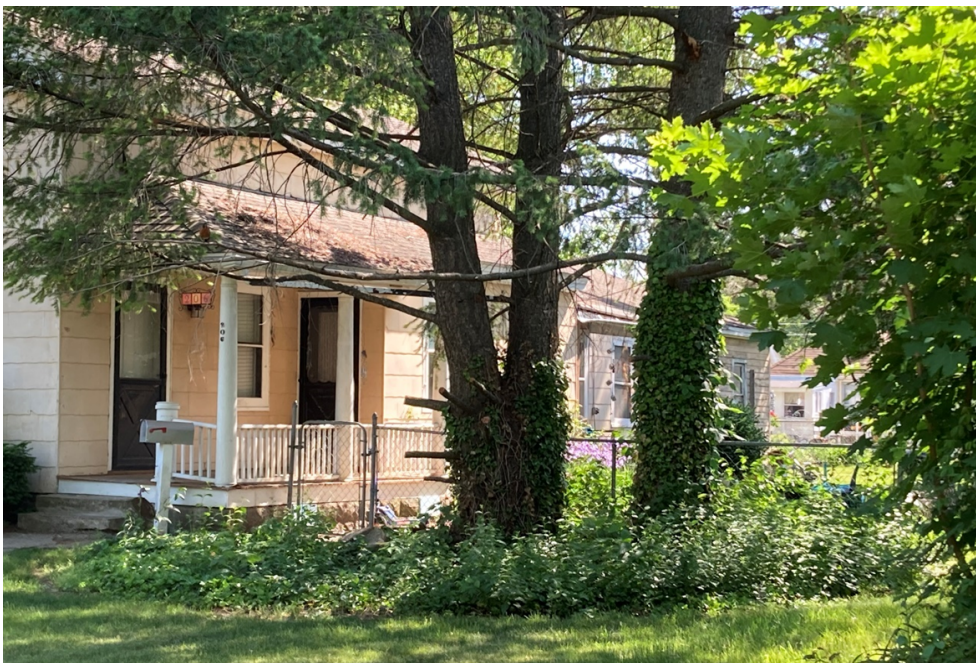
206 N River, southwest corner and southern side of house. Wood-sided portion at very rear of house barely visible here is where the replacement siding is proposed.

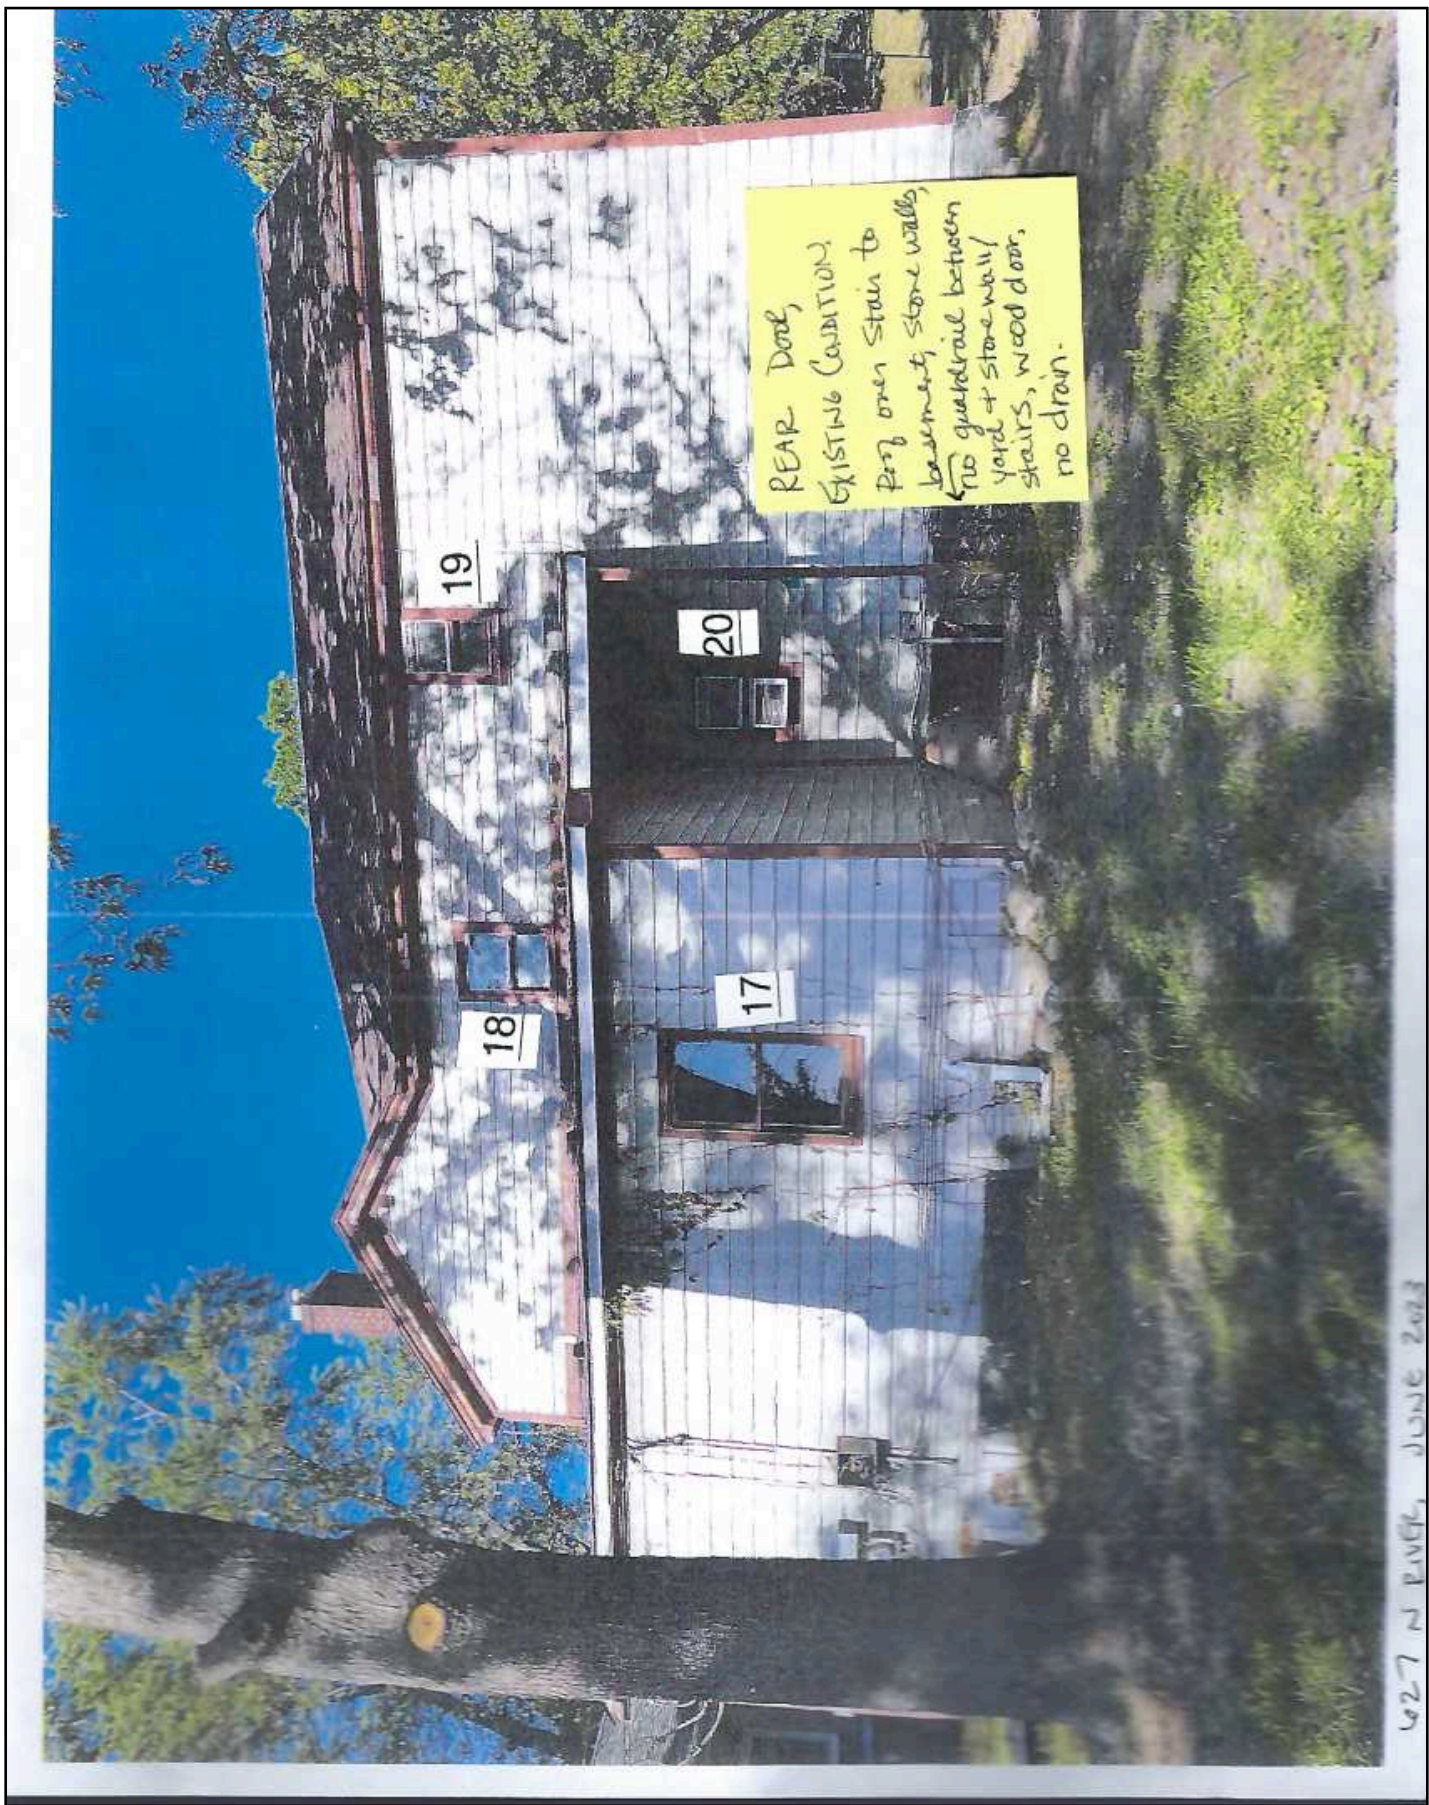
4-27 N. RIVER, JUNE 2023

REAR DOOR,  
EXISTING CONDITION:  
Peg over stain to  
basement, stone walls,  
no guardrail between  
yard + stone wall/  
stairs, wood door,  
no drain.

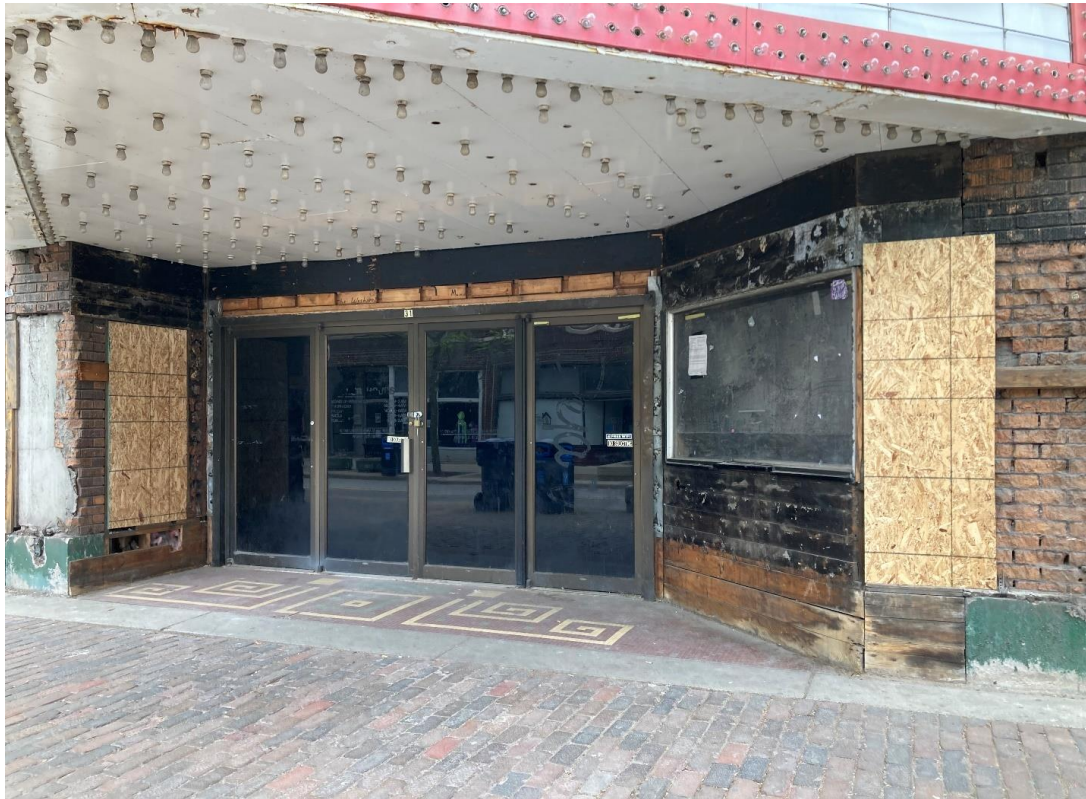
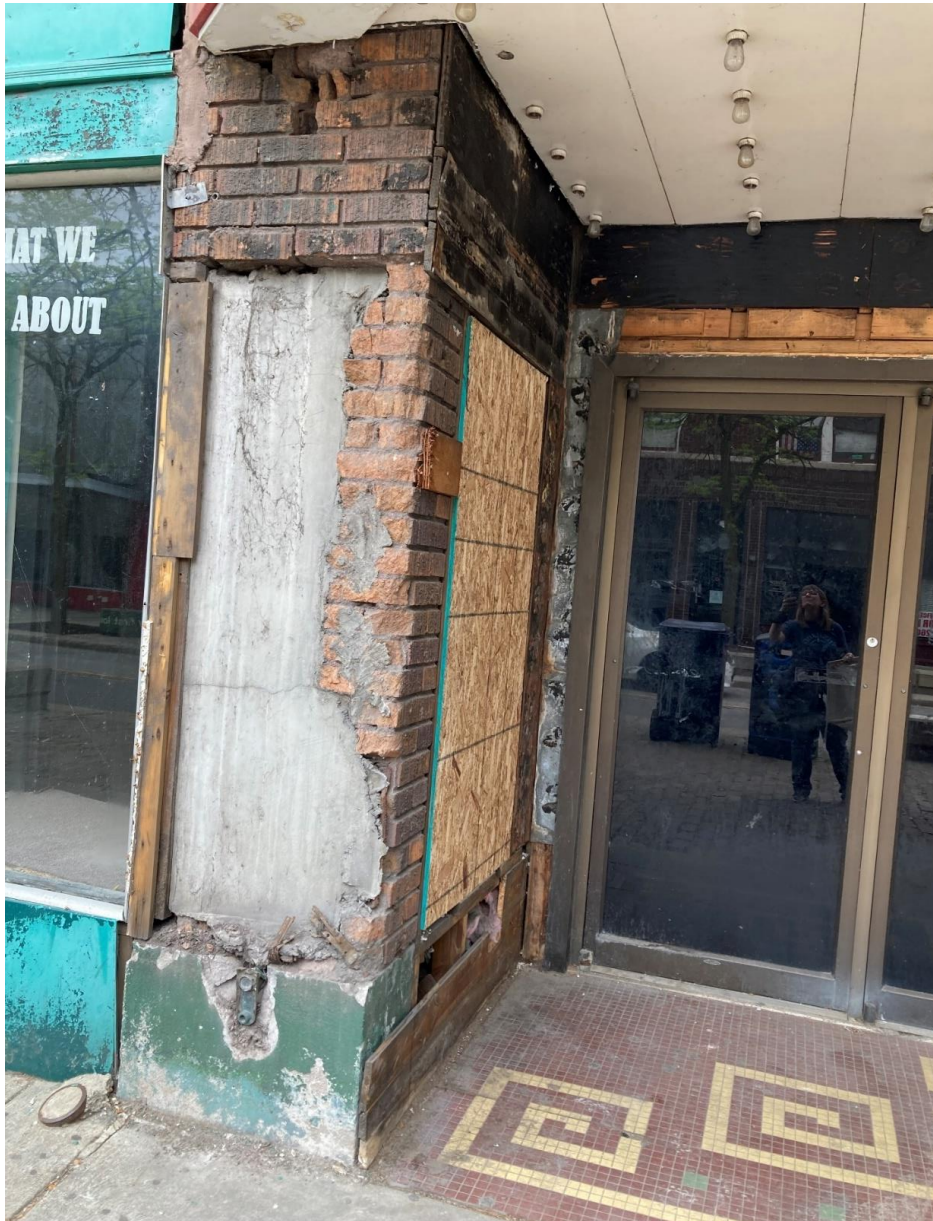
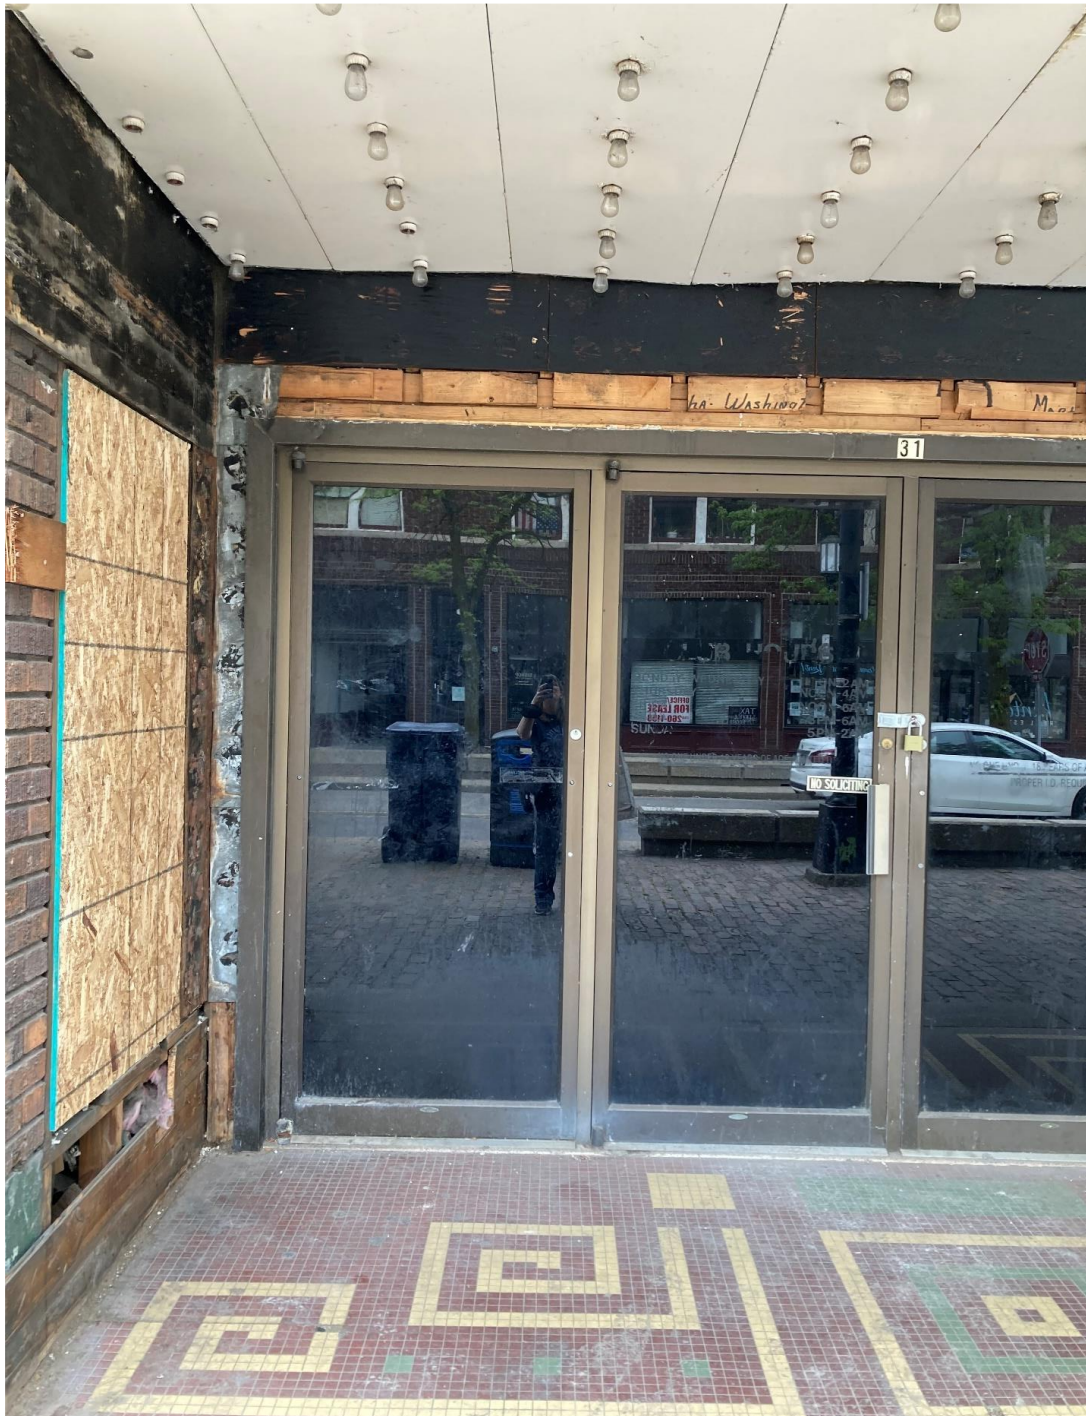
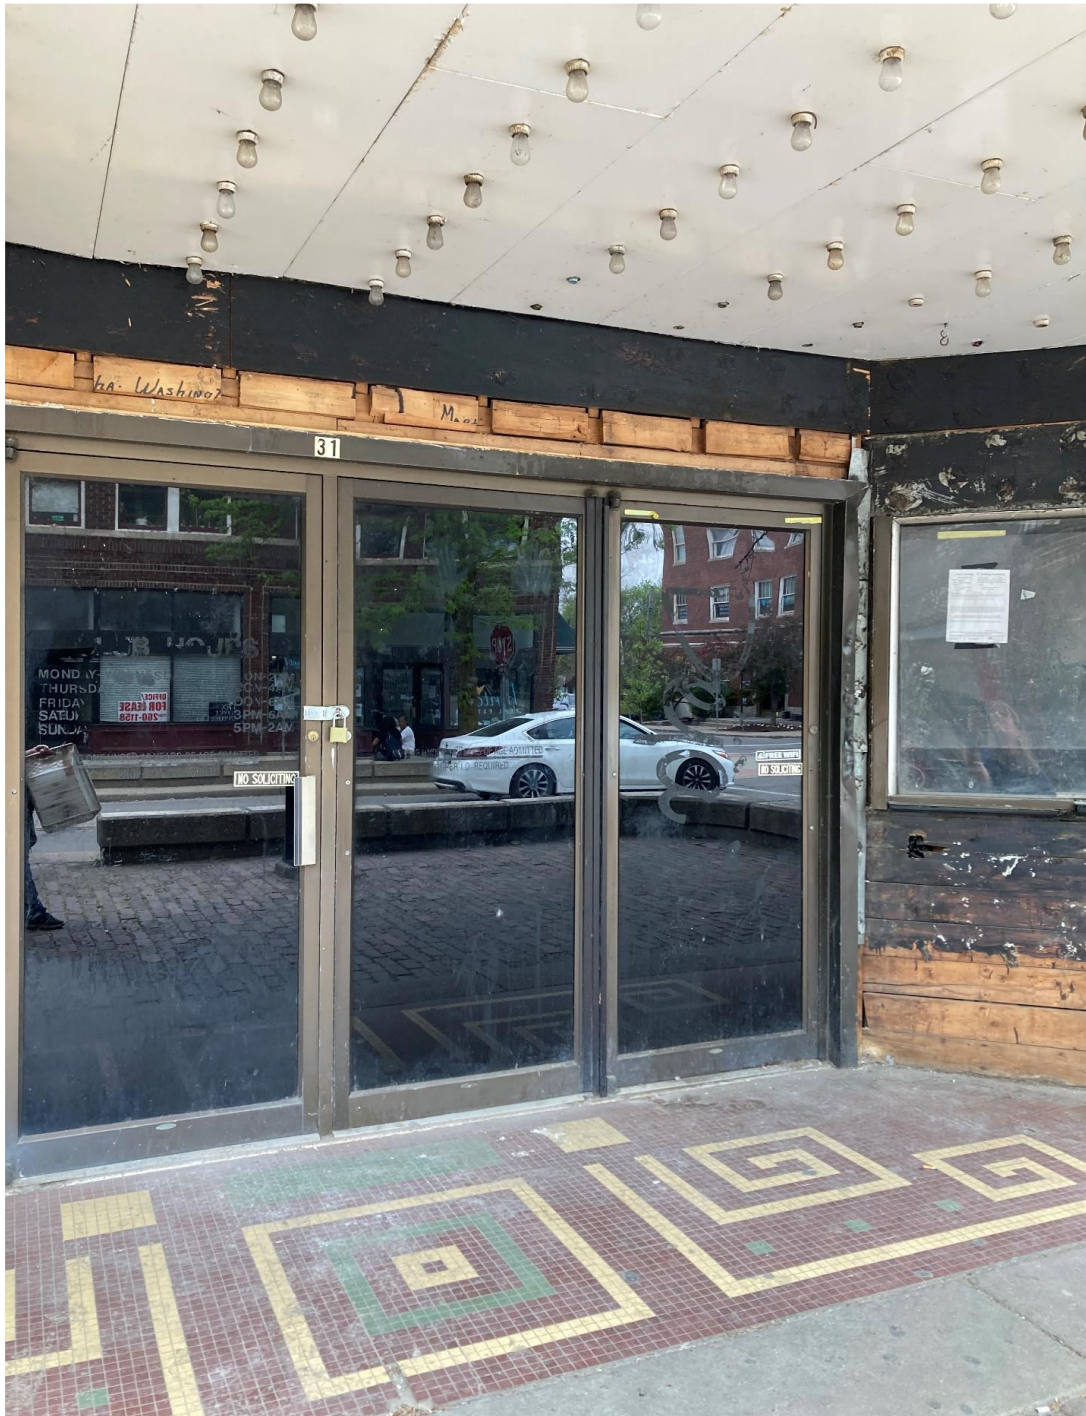
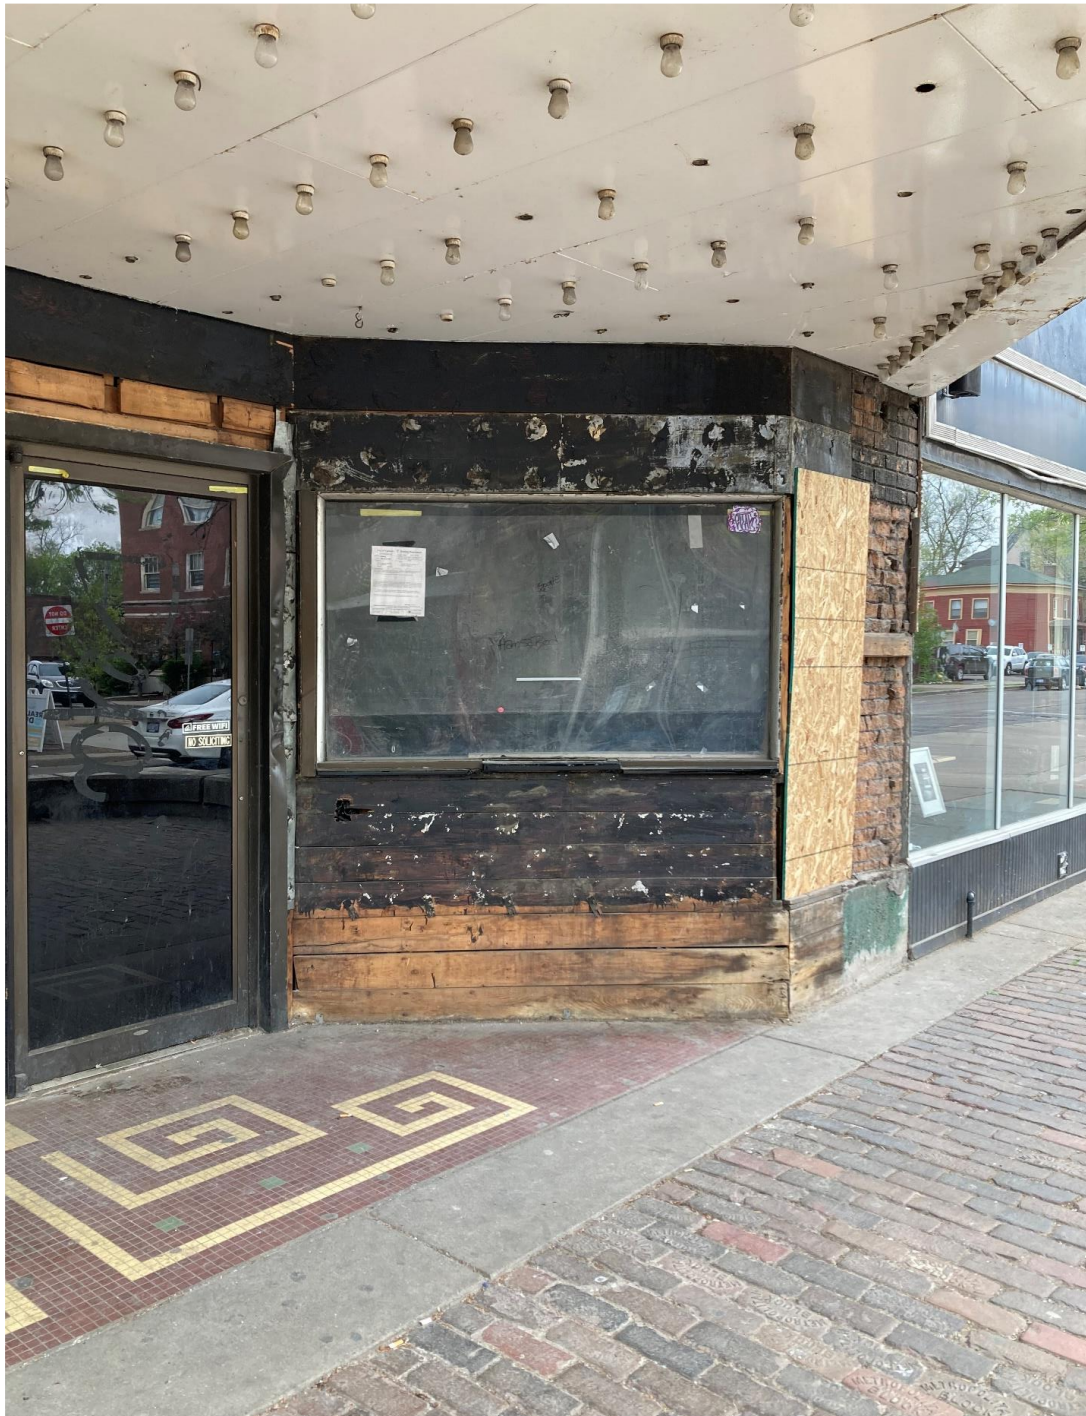
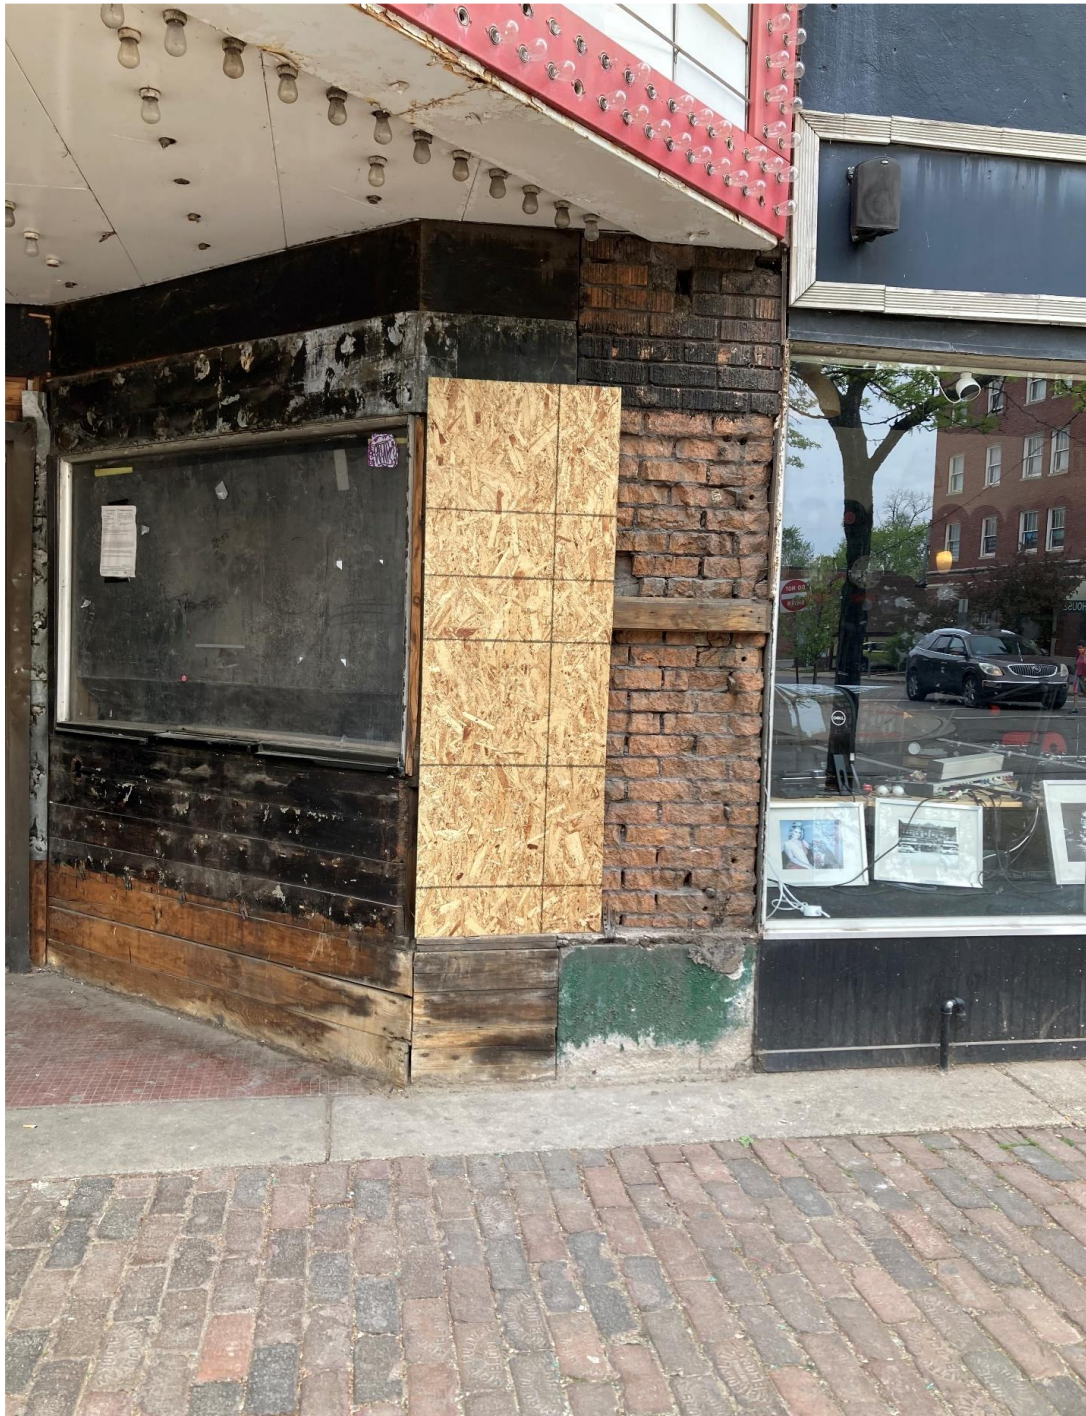
9. Repair is always preferable to replacement, but many bricks are severely damaged or missing in this case. (*See Figures 2 through 7.*) Because of the extent of the damage, staff believes that replacing the bricks that are damaged beyond repair or are missing with bricks that match the old in color, texture and will have the same mortar and joints meets Standard 6.

Figures 2- 7, below. Photos showing damage from removing the gravel veneer that had been applied to the walls of the alcove under the marquee.

Move to approve Application PHDC 23-0056 and issue a certificate of appropriateness for the work proposed at 31 N Washington to repair and replace damaged bricks below the marquee (including the column faces and the entire alcove to and around the doors) with bricks laid in a running bond pattern, with the conditions that the bricks used will match the existing as closely as possible and are exterior bricks, the mortar composition will match the historic mortar composition, the masonry joints will match the historic masonry joints on the building, and the appropriate building department permit is obtained. This proposed work meets the Secretary of the Interior's Standard for Rehabilitation #6.

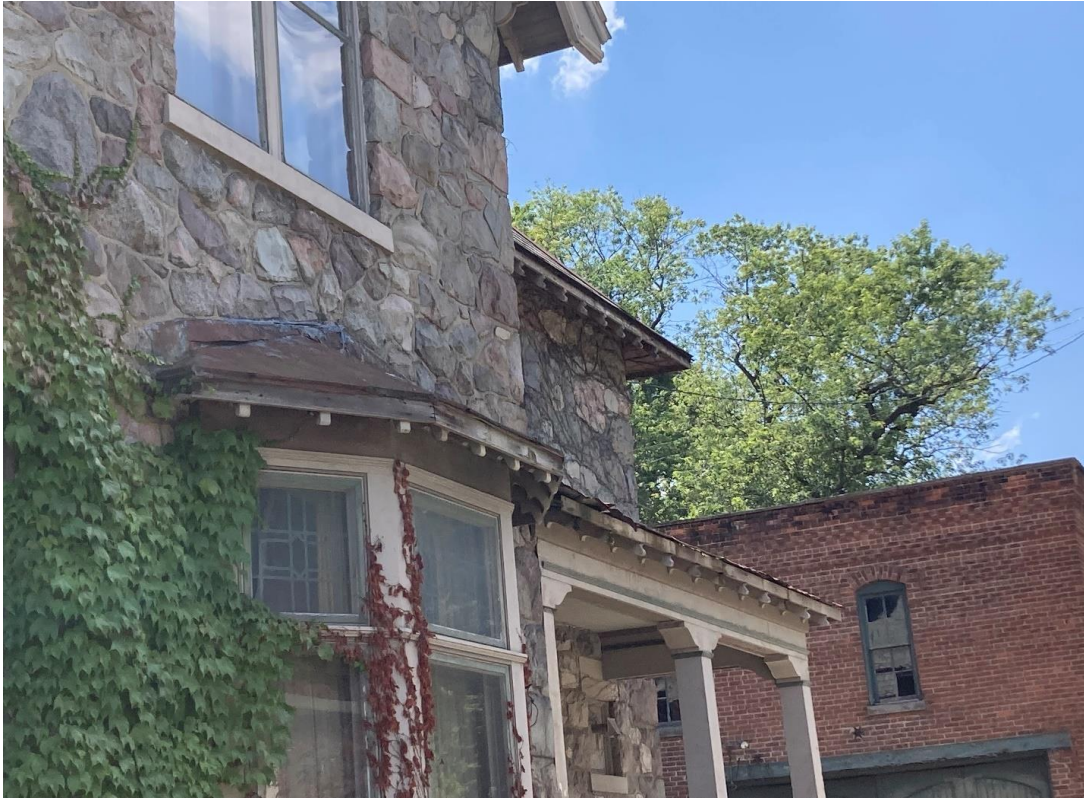
Fig. 3. 212 S Huron, north side in slightly more detail than Fig 2.

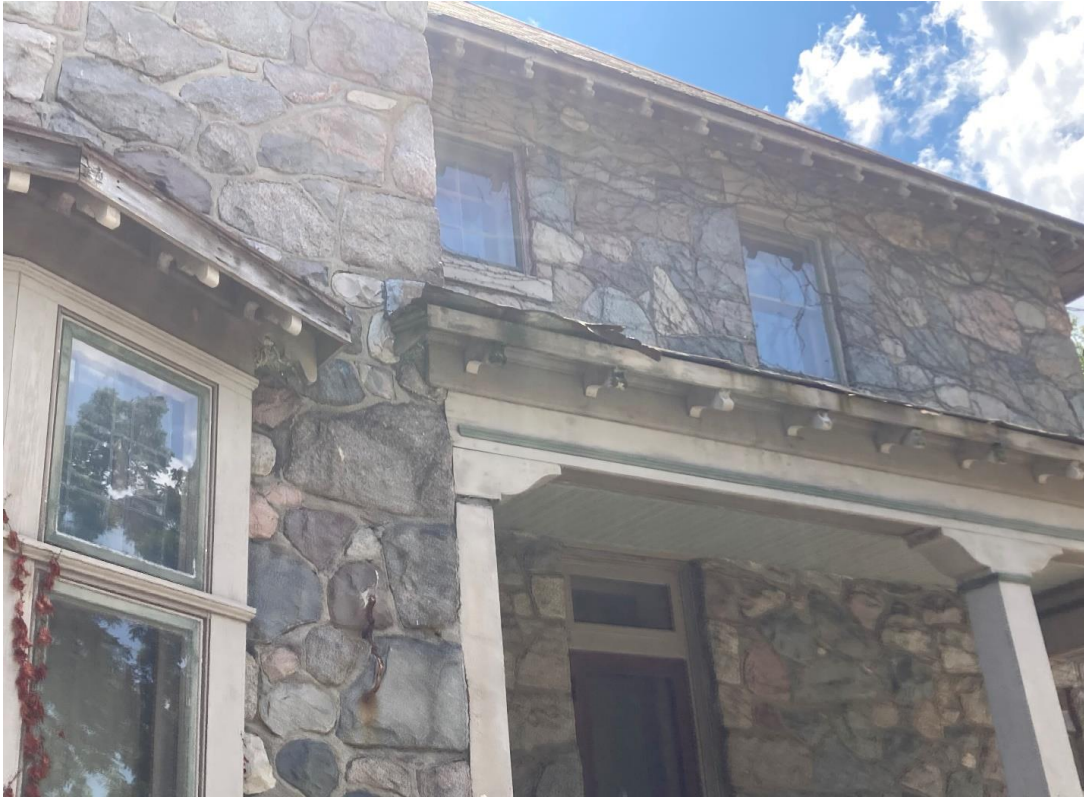
The condition assessments show that the roofs on the porches and bay window are in bad condition. Staff finds that replacing the deteriorated metal roofs (like on the bay window and the porch at the house's northwest corner) with a metal standing seam roof meets Standard 6. The current roofs aren't seamed, but staff thinks the metal for metal is materially and visually close. A possible consideration: how will standing seams look above exposed rafter tails?

Fig 4. More detailed photo of north side porch roof and bay window roof, both deteriorated metal. Carriage house in background.

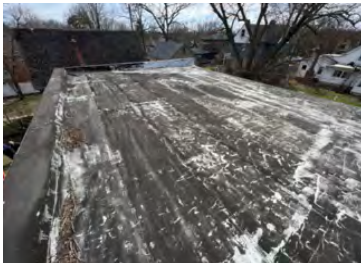
Erosion Of Coating (Emergency) - 04/12/2023  
Quantity: 1500 Sq Ft

Deficiency: The protective layer of aluminum coating is starting to erode. This allows the UV rays to deteriorate the membrane .

Corrective Action: Clean the repair area to a suitable surface. Apply a new layer of protective coating over the prepared area.

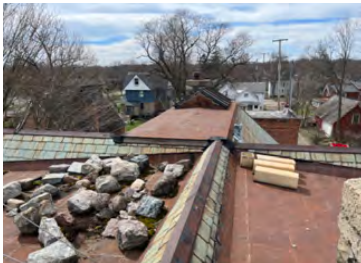
Oxidation or Rust (Emergency) - 04/12/2023  
Quantity: 1000 Sq Ft

Deficiency: On upper flat lock steel roof the protective coating has broken down and the metal is exposed to the elements, oxidation or rust will take over and reduce the materials integrity. It has all ready started to get small holes in it from the rust

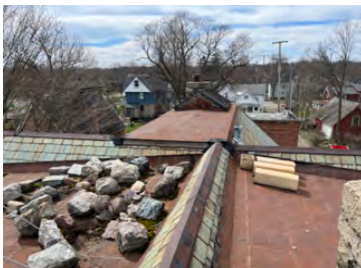
(Remedial) - 06/28/2023  
Quantity: 300 Sq Ft

Deficiency: The flat roof is rusted and has deteriorated with age.

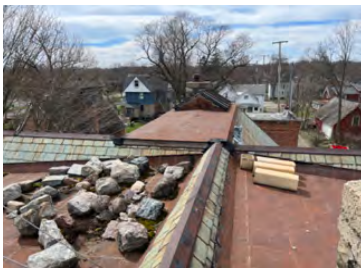
(Remedial) - 06/28/2023  
Quantity: 150 Sq Ft

Deficiency: The flat roof is rusted and has deteriorated with age.

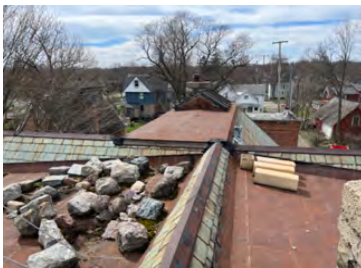
(Remedial) - 06/28/2023  
Quantity: 125 Sq Ft

Deficiency: The flat roof is rusted and has deteriorated with age.
