**CITY OF YPSILANTI AND  
YPSILANTI PARKS AND RECREATION JOINT MEETING  
SENIOR CITIZENS CENTER  
1015 N. CONGRESS, YPSILANTI, MI 48197  
TUESDAY, DECEMBER 11, 2018  
7:00 P.M.**

The purpose of this report is to evaluate the existing conditions at several park facilities, provide recommendations to make operational again, and provide an opinion of probable cost of the work required to correct the condition for the City's use in future planning efforts.

At the invitation of the City, representatives from OHM Advisors visited the City Park's restroom facilities, on various dates in August and September 2018, to observe the existing conditions; no architectural or structural drawings were available for these structures.

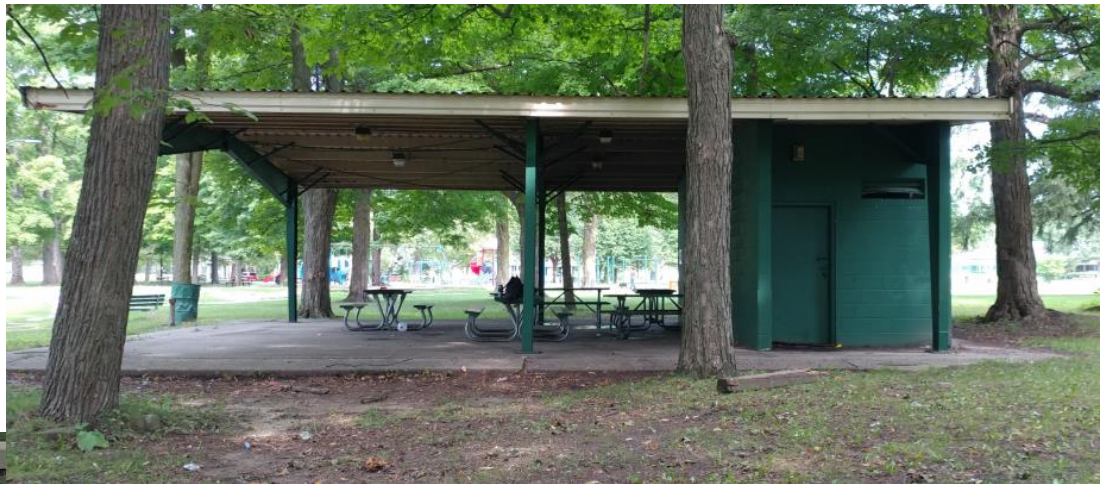
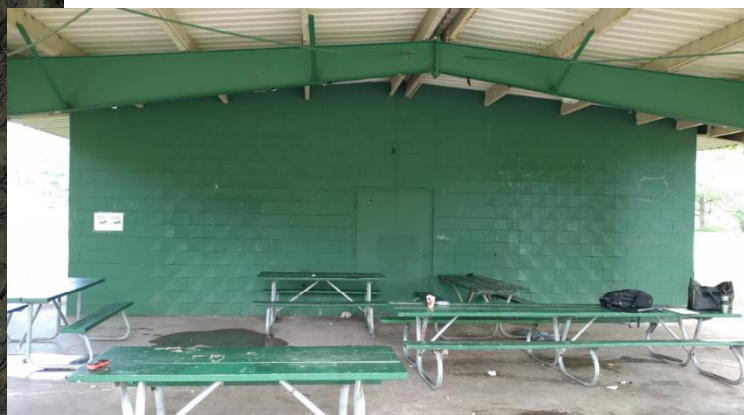
The Prospect Park restroom building is constructed of single-wythe masonry walls, concrete floor slab, and metal roof. The roof extends from the building to cover a concrete slab on grade picnic area adjacent to the building. The building itself consists of two single occupant toilet rooms on either side of a storage area. Each restroom has a louvered opening to allow natural ventilation, and a glass block window for natural light. Restroom fixtures are stainless steel.

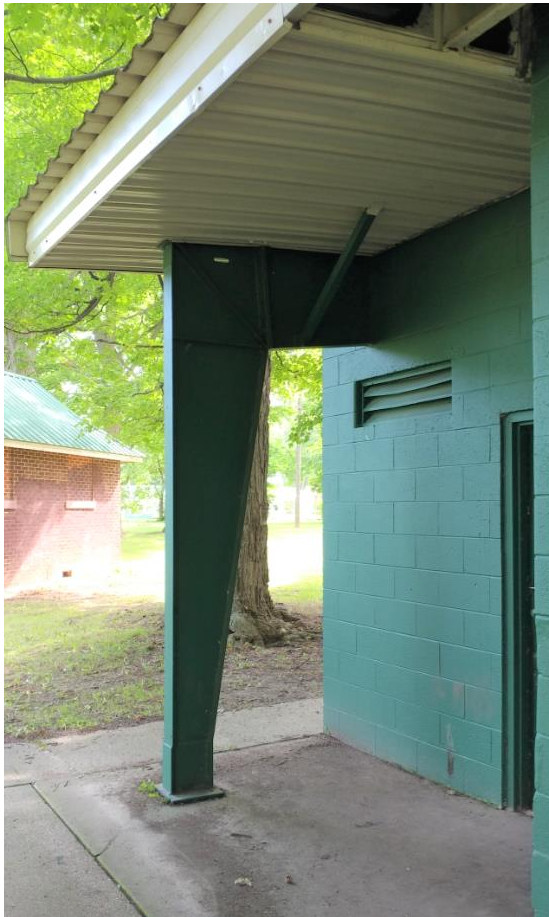
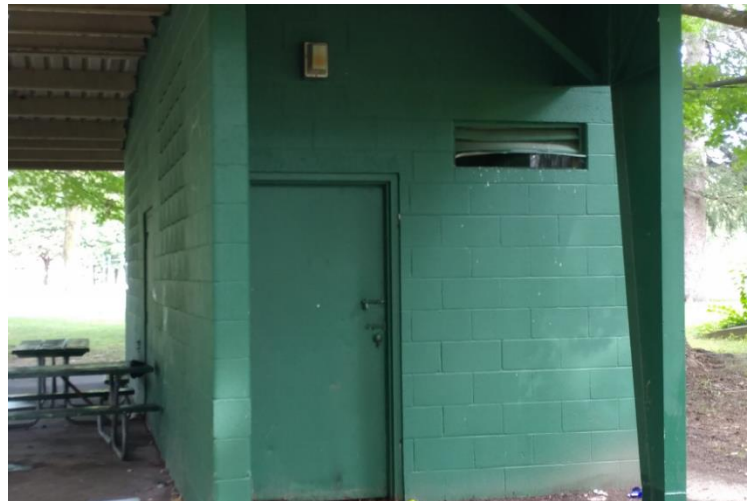
The masonry walls are structurally in good condition but they need to be repainted and coated with a graffiti resistant material. The underside of the roof needs to be repainted also. The paint on the purlins supporting the roof is deteriorating and causing the purlins to rust. The rust needs to be removed from the steel and the purlins need to be repainted. The concrete pad at the picnic area is in acceptable shape. Exterior lighting should be replaced with LED fixtures.

All the hollow metal doors are in poor condition and need to be replaced. The ventilation louvers are bent and damaged and need to be replaced. The glass block windows are missing much of the glazing due to vandalism and should be replaced with a more vandle resistant glazing option.

All restroom fixtures are damaged and need to be replaced, however, the plumbing and electrical infrastructure is in good condition. Interior lighting should be replaced with LED fixtures. The interior plaster walls are in in good condition but need to be repainted and coated with a graffitti resistant material. The concrete floor slab in both of the bathrooms and storage room is in good condition but should be sealed. The plaster ceiling in the bathrooms needs to be repainted.

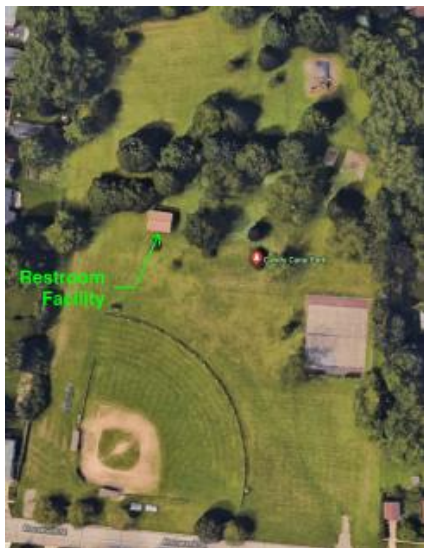
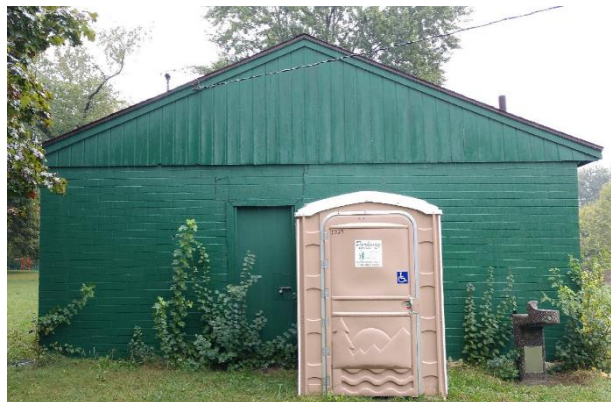
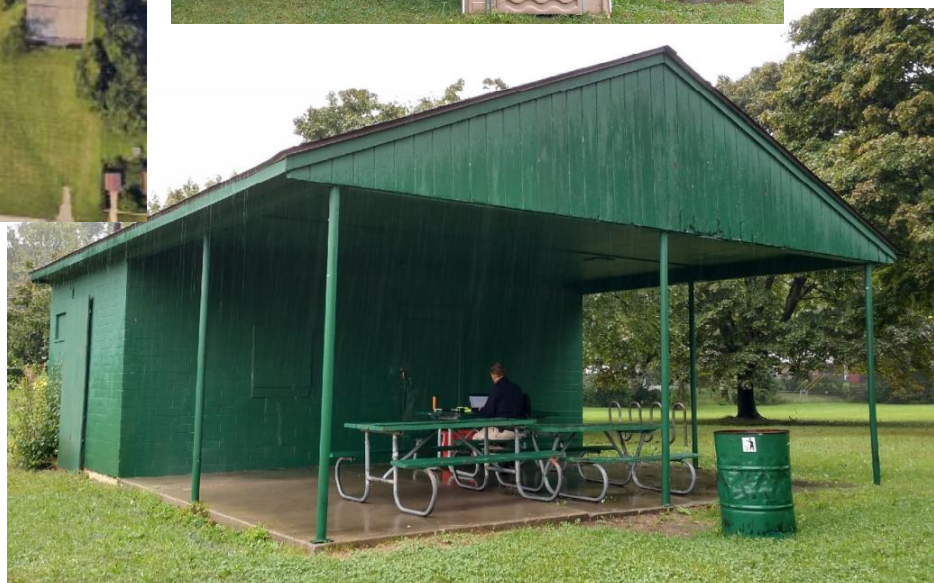
The Candy Cane Park restroom building is constructed of single-wythe masonry walls, concrete floor slab, wood roof trusses, and an asphalt shingle roof. The roof extends from the building to cover a concrete slab on grade in the covered picnic area adjacent to the building. The building itself consists of two single occupant toilet rooms on the far side (west) of the L-shaped storage area that abuts the pavilion.

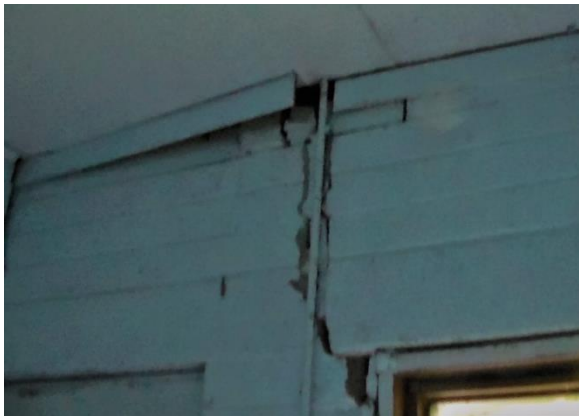
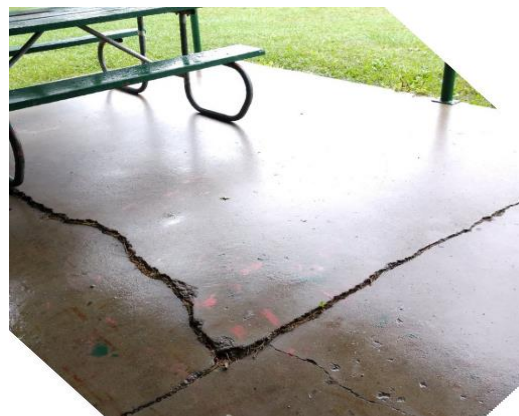
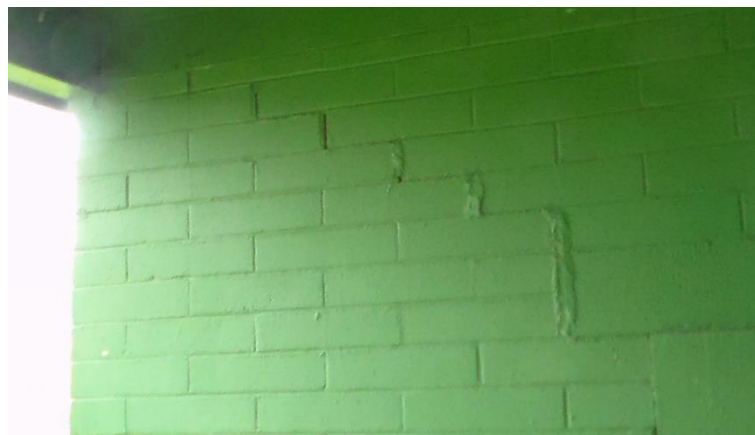
The masonry walls show signs of foundation settlement along the south wall and the south slab in the pavillion area. There are diagonal cracks on the East wall inside the pavillion starting at the top in the Southeast corner extending downward to the North and in the Southwest corner along the south wall. The slab in the pavillion did not have contraction joints when it was poured, and has now formed contraction cracks with the Southeast slab settling on the south edge, thereby lifting up its north edge creating a one inch trip hazard. The masonry wall on the inside of the pavillion (East wall) needs the two diagonal cracks pointed up with mortar and needs to be repainted and coated with a graffiti resistant material. The concrete pad in the picnic area is in marginal shape. If the slab is not removed and replaced, it is recommended to have the trip hazard ground down (15 ft of grinding) and the cracks routed and sealed (65 ft). The masonry around the building has cracks on all sides that need to be routed and pointed, then needs to be repainted and coated with a graffiti resistant material.

The underside of the roof in the pavillion needs to be repainted. The paint on the steel posts supporting the roof are in good condition, however, could use repainting as part of its regular maintenance. The column in the NE corner of the pavillion has been bent. It either needs to be replaced or repaired. The plywood underside of the roof in the pavillion has two holes for light fixtures that are boarded up. Exterior lighting should be added under the pavillion and on the outside of the structure on four sides with LED fixtures. The West and East side lighting could be added at the top of the roof peak to provide better coverage and to deter vandalism.

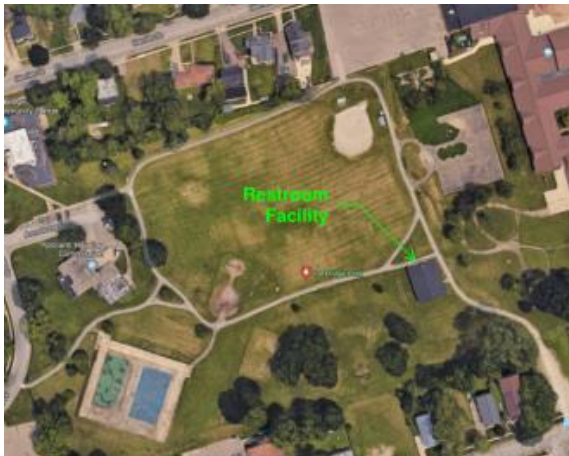
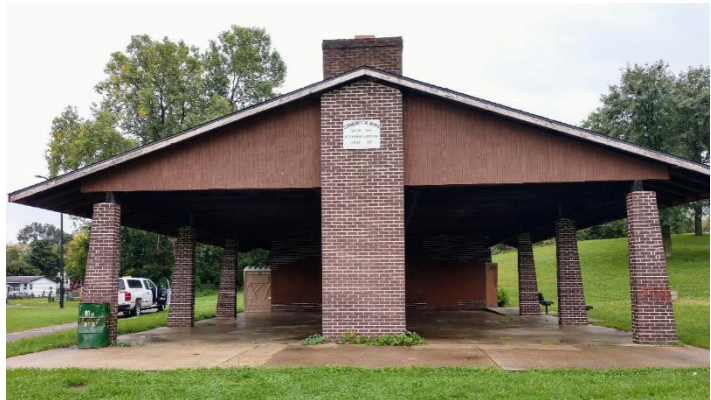
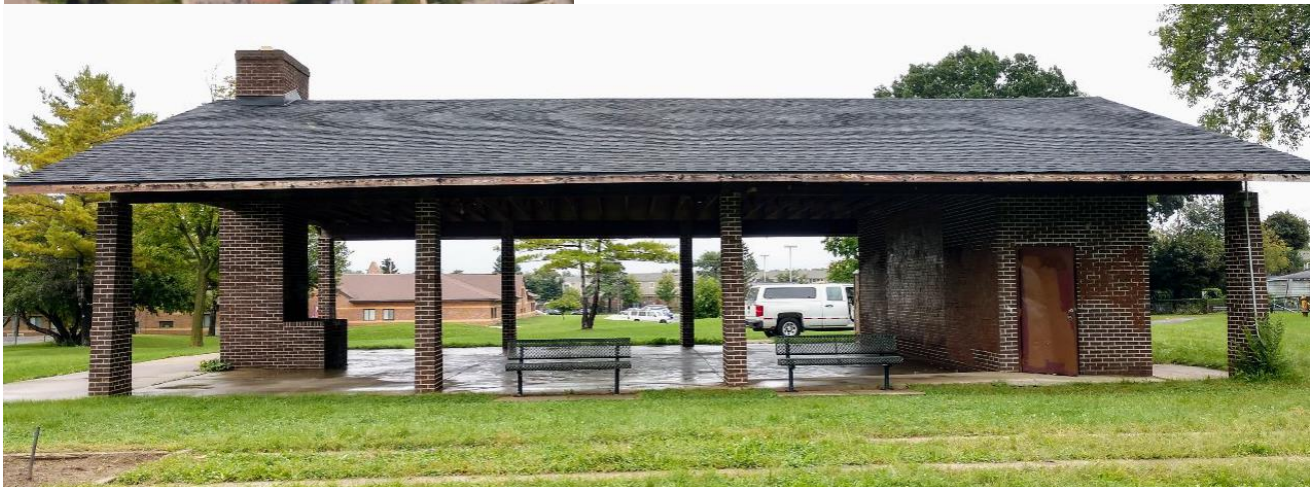
The Parkridge Park restroom building is constructed of CMU walls with brick facade, concrete floor slab, wood roof trusses, and an asphalt shingle roof. The supporting columns have been capped in a brick façade before the column connects to the engineered beams. The roof extends from the building to cover a concrete slab on grade in the covered picnic area adjacent to the building. The building consists of two toilet rooms in the Southeast and Southwest corner of the building and a storage room. There is a utility cavity between the two bathrooms. The two bathrooms and the storage room have 36" steel doors. Each restroom has a glass block window with vent to allow natural light and ventilation. Restroom fixtures are steel. One bathroom consists of a toilet with a partition, sink, paper towel dispenser/garbage container, and urinal. The other bathroom has a sink, a toilet with partition, a plated appurtenance, and paper dispenser/garbage container. The pavilion has a fireplace at the far end.

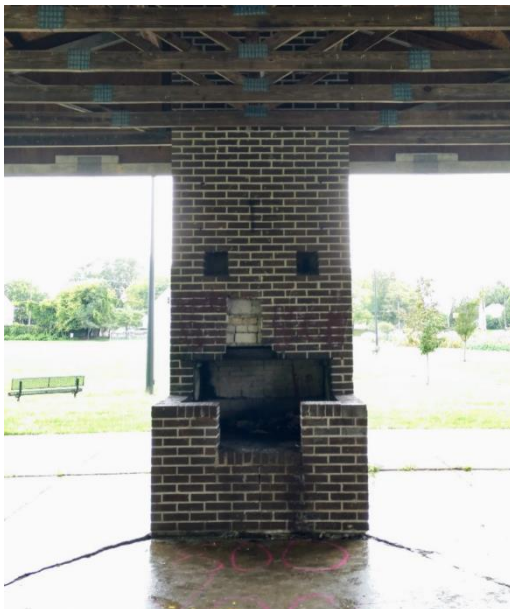
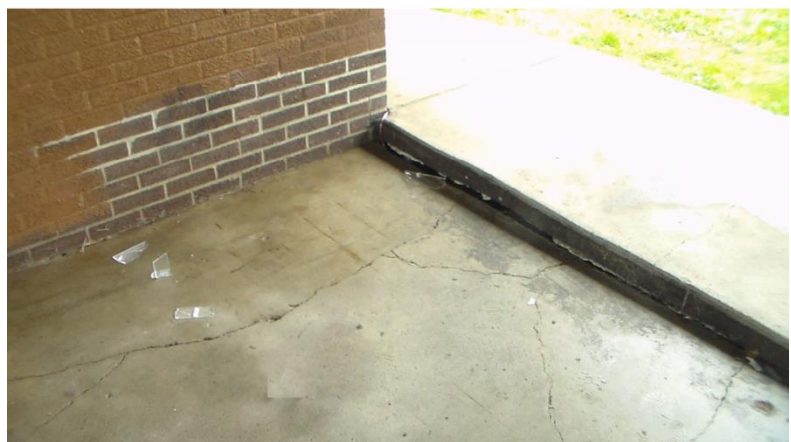
The masonry walls are in good condition when viewed from the inside. There is a gap opening up between the inside CMU, that has a maintenance cavity between the bathrooms for sewer and water, and the outside masonry wall (south). The brick façade is in excellent condition. There is a brick repair needed inside the pavilion on the building wall.

Although the fireplace will require some brick work on the face above the opening, generally the fireplace brick is in good condition outside and inside starting at the corbel working its way up to chimney. In the body of the firebox, below the corbel, pointing up needs to occur. The flue appears to have at least one cracked liner piece, however, its joint is tight. Not all of the flue is accessible for inspection and will need to be carefully televised to determine the repairs necessary. The fireplace should be inspected by an expert for recommended repairs. The fireplace flue should have a cap installed.

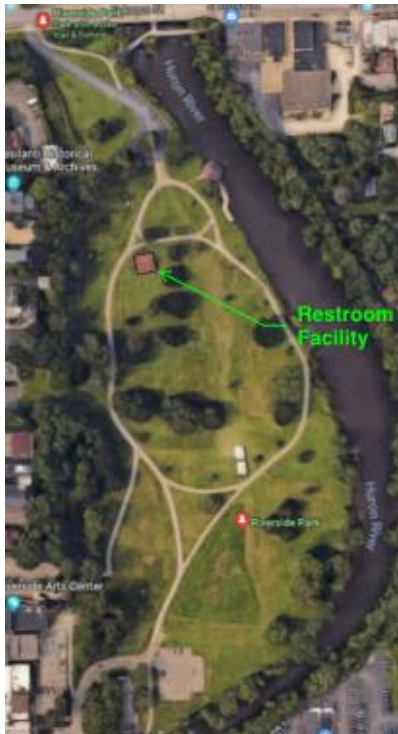
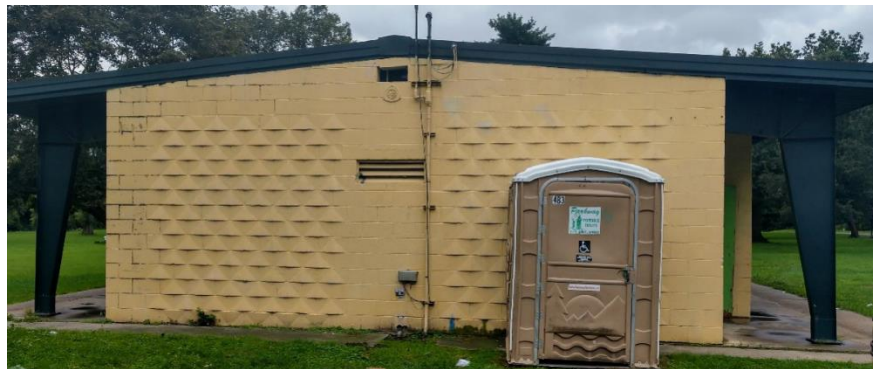
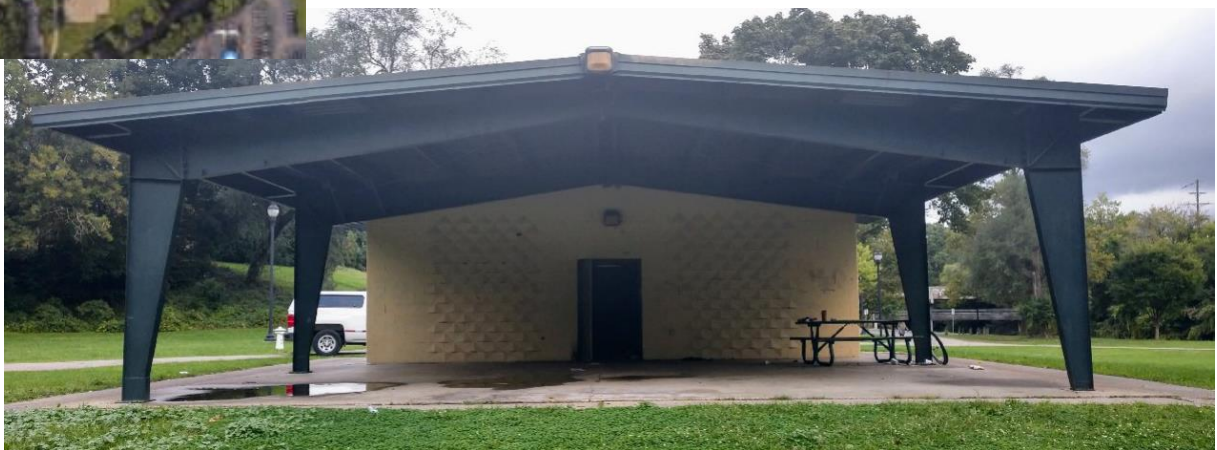
The Riverside Park restroom building is constructed of single-wythe masonry walls, concrete floor slab, and metal roof. The roof extends from the building to cover a concrete slab on grade picnic area adjacent to the building. The building itself consists of two toilet rooms on the north side of a storage area. Each restroom has a louvered opening to allow natural ventilation. Restroom fixtures were likely ceramic.

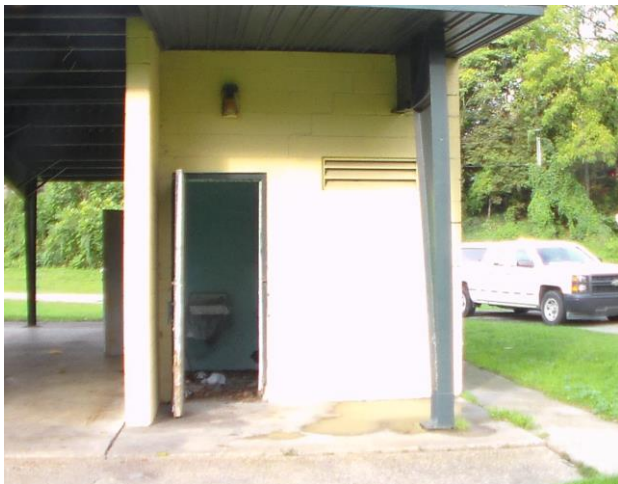
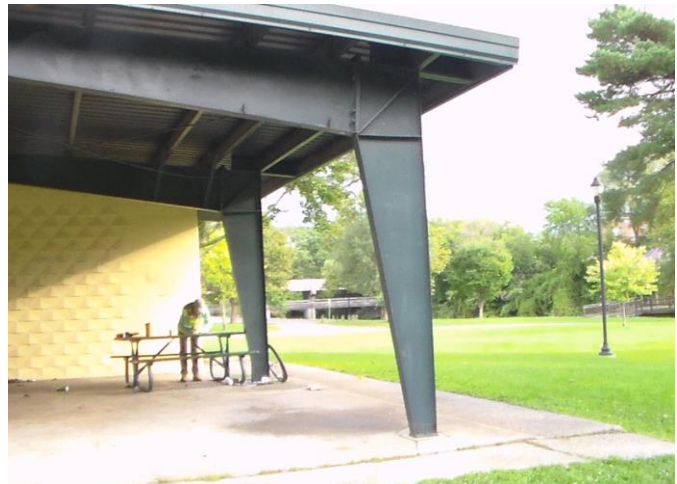
The masonry walls are structurally in good condition but they need to be repainted and coated with a graffiti resistant material. The underside of the roof needs to be repainted also. In some areas the paint on the metal posts supporting the roof is deteriorating and causing rust. The rust needs to be removed from the steel and the posts need to be spot painted, at a minimum.

The concrete pad at the picnic area is in acceptable shape. It is recommended that the joints be blown out and sealed, and the cracks routed and sealed. There is a 3' wide concrete perimeter slab around the building and pavillion that has settled and shifted in places. It could be removed and not replaced or removed and replaced. There needs to be a hard surface installed from the bike path to the pavillion. Exterior lighting should be replaced with LED fixtures. There is a block missing on the north wall for the photo-eye sensor which is located inside the storage room. This could be moved outside and blocked up, or insect screen installed over the opening.

All the hollow metal doors, hinges, and frames are in poor condition and need to be replaced. The bathroom doors are not 3' wide and need to be opened up for ADA access. The ventilation louvers are either damaged or missing, and need to be replaced. The insect screening in many places is damaged and needs to be replaced in the following places – the louvered ventilation, steel beams for access to ventilation above the bathroom ceilings, inside the storage room to the outside, and to the ventilation cavity above the bathroom ceilings. Glass block windows for natural light would be a valuable addition to the bathrooms.

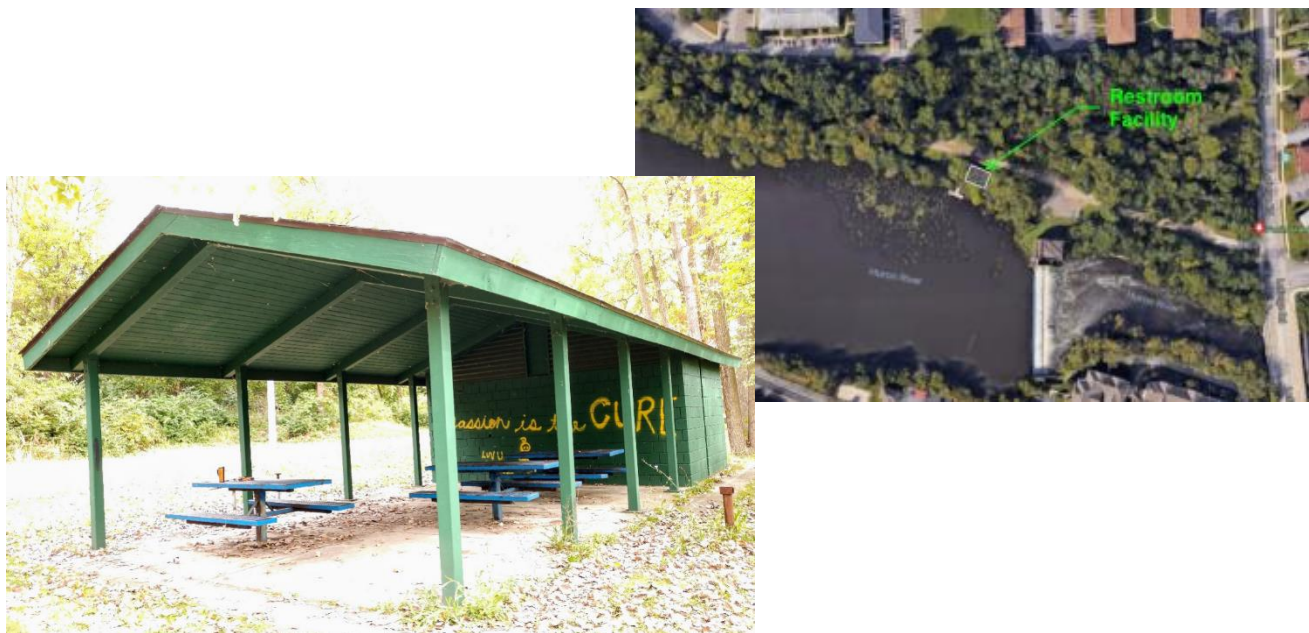
The Peninsular Park restroom building is constructed of single-wythe masonry walls, concrete floor slab, steel frame supports and steel beams, and a tongue and groove roof with asphalt shingles. The roof extends from the building to cover a concrete slab on grade picnic area adjacent to the building. The roof appears to have been redone in the last couple of years and a patch completed in the tongue and groove sheathing. The building itself consists of two single occupant toilet rooms. Each restroom has a louvered opening on two sides to allow natural ventilation. Restroom fixtures are ceramic. The fixtures have been carefully winterized with the traps blown out and the Sloan valves disassembled.

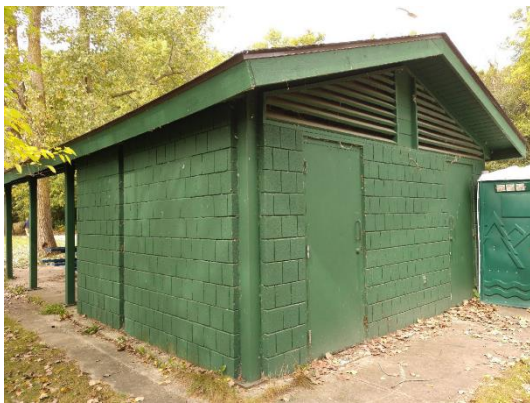
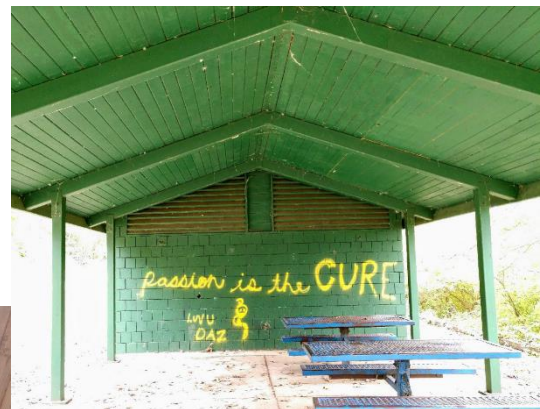
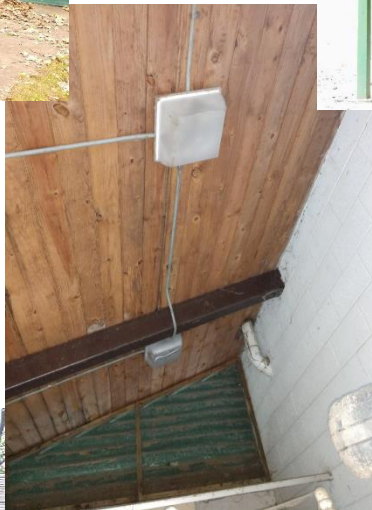
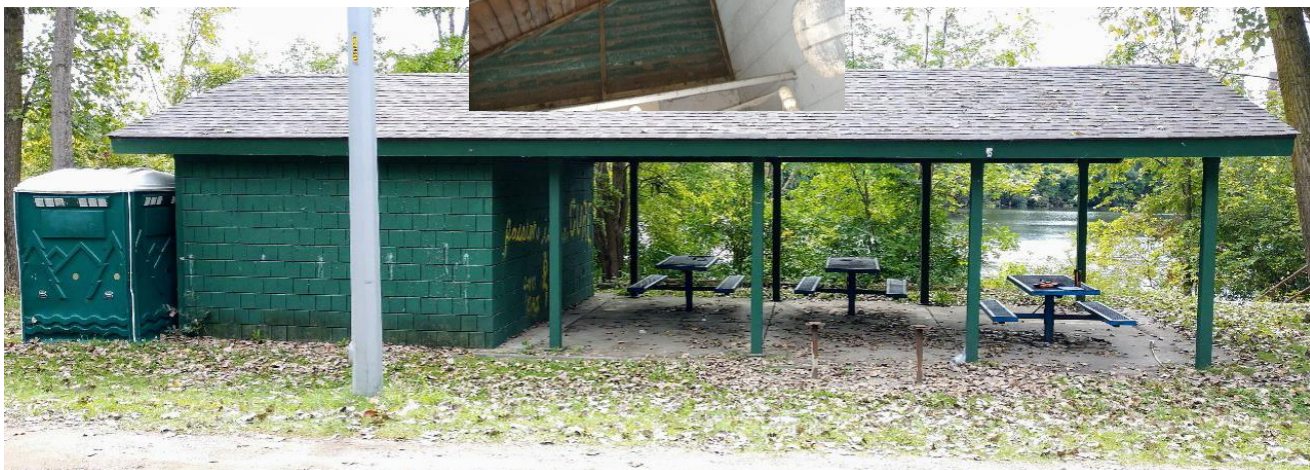
The masonry walls are structurally in good condition but need to be repainted with a graffiti resistant material. The underside of the roof in the pavillion needs to be repainted. The paint on the steel frame supports is deteriorating in a few areas, causing the supports to rust. The spot rust needs to be removed from the steel and repainted with a graffiti resistant paint. The concrete pad at the picnic area is in acceptable shape. The joints should be sealed with a polyurethane sealer. Exterior lighting should be replaced with LED fixtures. The plastic coated steel picnic tables are in decent conditon, however, rust removal and painting is required. The interior floor in both bathrooms needs to be sealed.

Both hollow metal doors are in poor condition and need to be replaced along with the hinges and frame. The wooden ventilation louvers need to be sanded and painted, or replaced. The insect screens are intact, however, to address the louvers, they will need to be removed and thus should be replaced. Glass block

All restroom fixtures are antiquated, however, the plumbing and electrical infrastructure appears to be in good condition. The sloan valves, water supply lines, and fixtures should be replaced. It's possible that the ceramic fixtures could be reused and replumbed. The interior masonry walls are in in good condition, but need to be repainted and coated with a graffiti resistant material. The concrete floor slab in both of the bathrooms and storage room is in good condition but should be sealed. The original wood tongue and groove ceiling in the bathrooms needs to be painted.

Interior lighting should be replaced with LED fixtures. The electrical wiring needs to be assessed by an electrician, and the switches updated. The electrical panels need to be locking boxes.

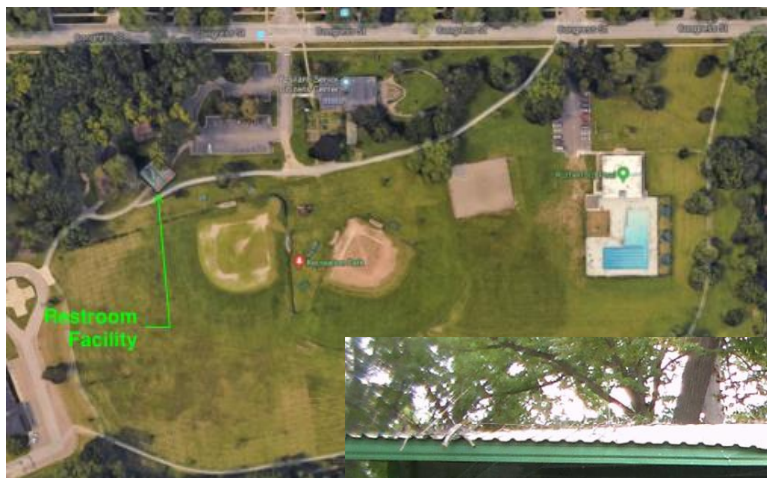
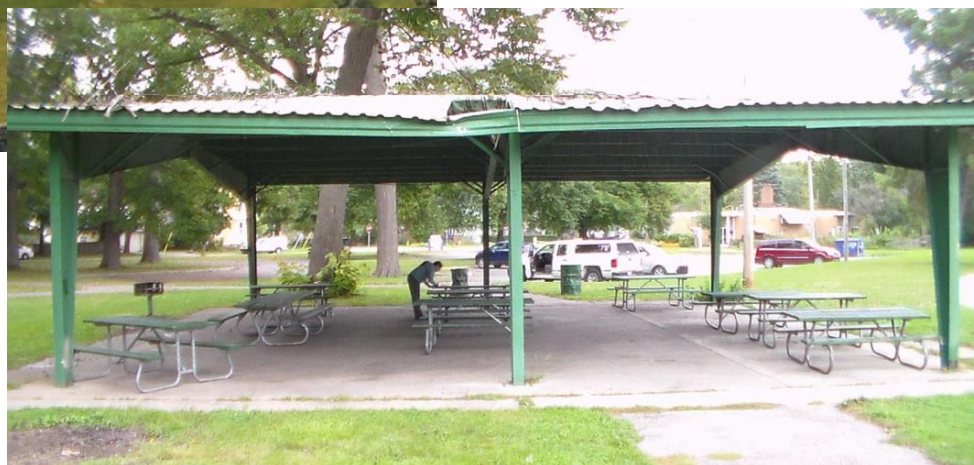
Recreation Park does not currently have a restroom building. The existing covered picnic area is constructed of a concrete floor slab, metal columns and beams, and a metal roof. The roof has been damaged, likely by a tree. The roof covers a concrete slab on grade with picnic tables. It appears there used to be a building, based on evidence on the concrete slab. There are signs of walls that were removed, and utilities coming up through the floor. It looks as if there were two single occupant toilet rooms on either side of a storage or utility area. At this time all that remains are the floor drains (3), the toilet drops (4), the sink drops inside walls (2), and what is likely a sanitary clean out headed for Congress Street.

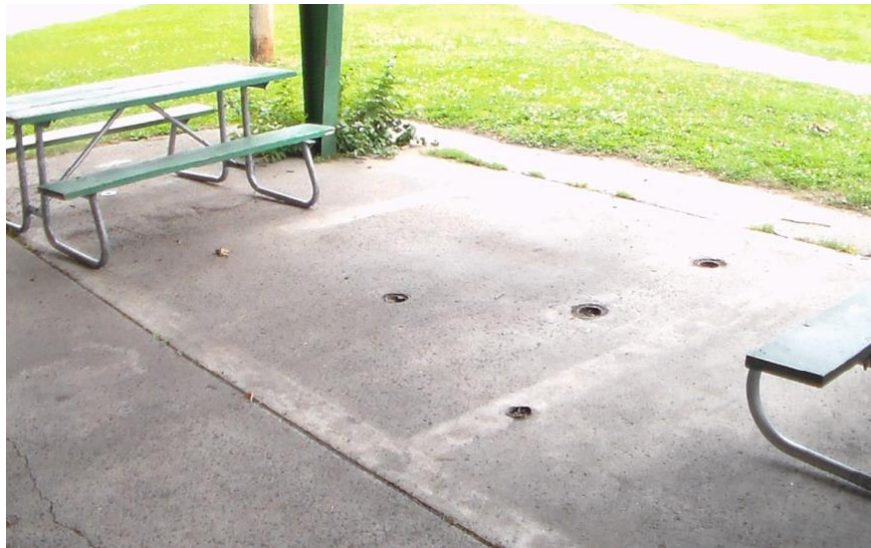
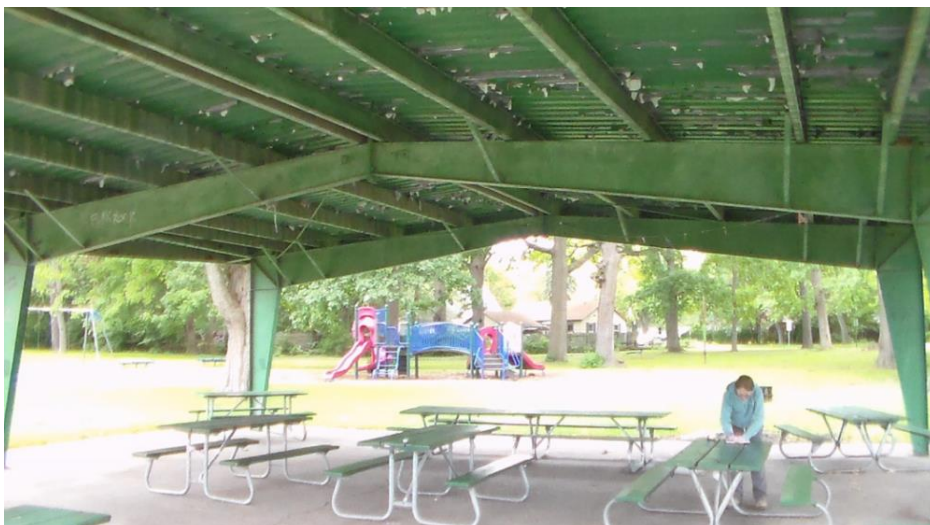
The paint on the roof (top and bottom), columns, and beams is flaking and rust is beginning to damage the steel. There are holes caused by rust at the base of the columns. The roof appears to have been damaged by a tree. Two roof support beams, four roof panels, and one angle support have been damaged. The rust needs to be removed from the steel, the holes will have to be soldered with plates, and the structure needs to be repainted. Those areas that are reachable need to have graffiti resistant paint. There are two cross members that are loose and need to be tightened or likely replaced if rusted through. One half of the

structure does not have cross member support, which will need to be installed. One angle brace is bent and should be repaired and reinforced. The concrete pad within the picnic area is in acceptable shape and will need the joints sealed. It appears the bathrooms were removed before the steel roof was put up as the roof does not have a ventilation port.

It is recommended that this site have a prefabricated bathroom unit installed. It will need the sanitary line cleaned and televised, and the sanitary relocated to the new building pad. The water service will need to be located and installed into the building pad, and ADA access provided. The prefabricated building could be located next to the existing structure, as it likely could not be installed within the structure. The drains in the current structure should be abandoned or removed if a new slab is poured in those areas.

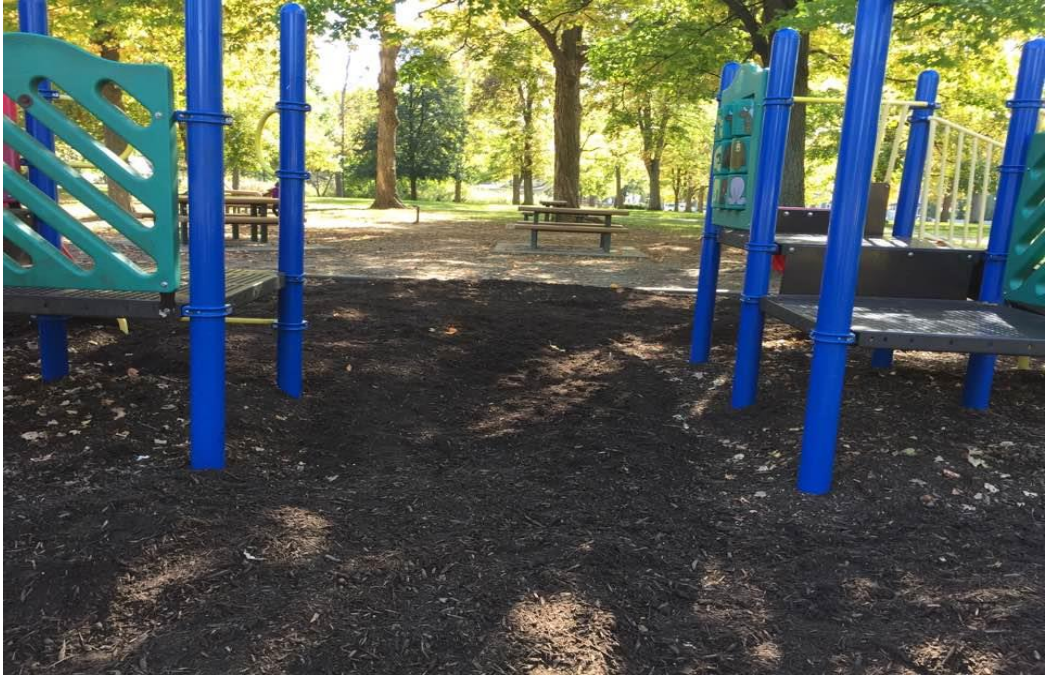
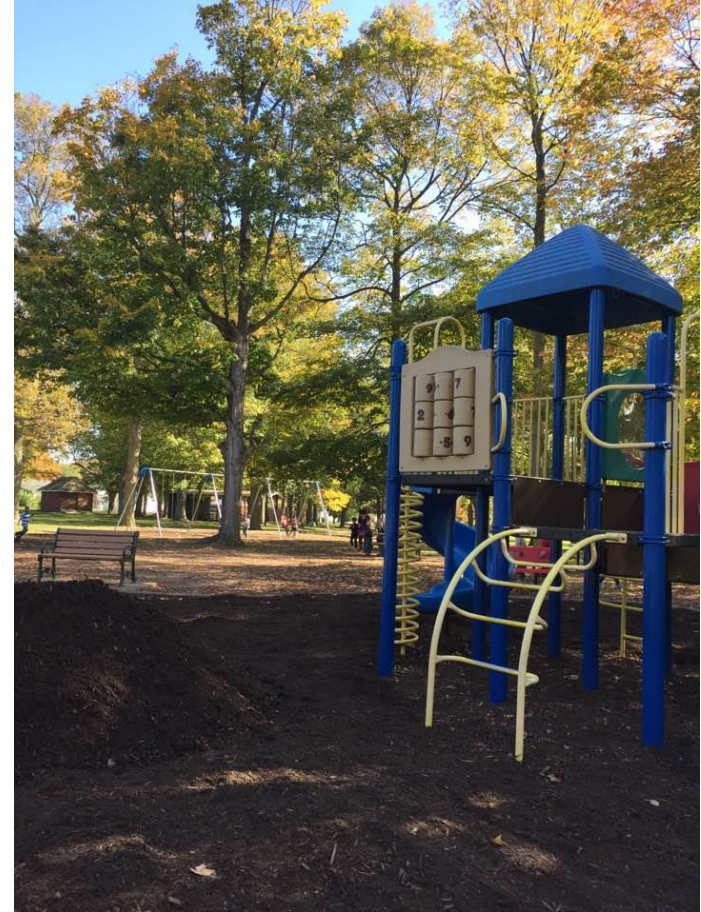
# BROKEN PLAYGROUND EQUIPMENT

## Missing Rope Bridge and Double Slide

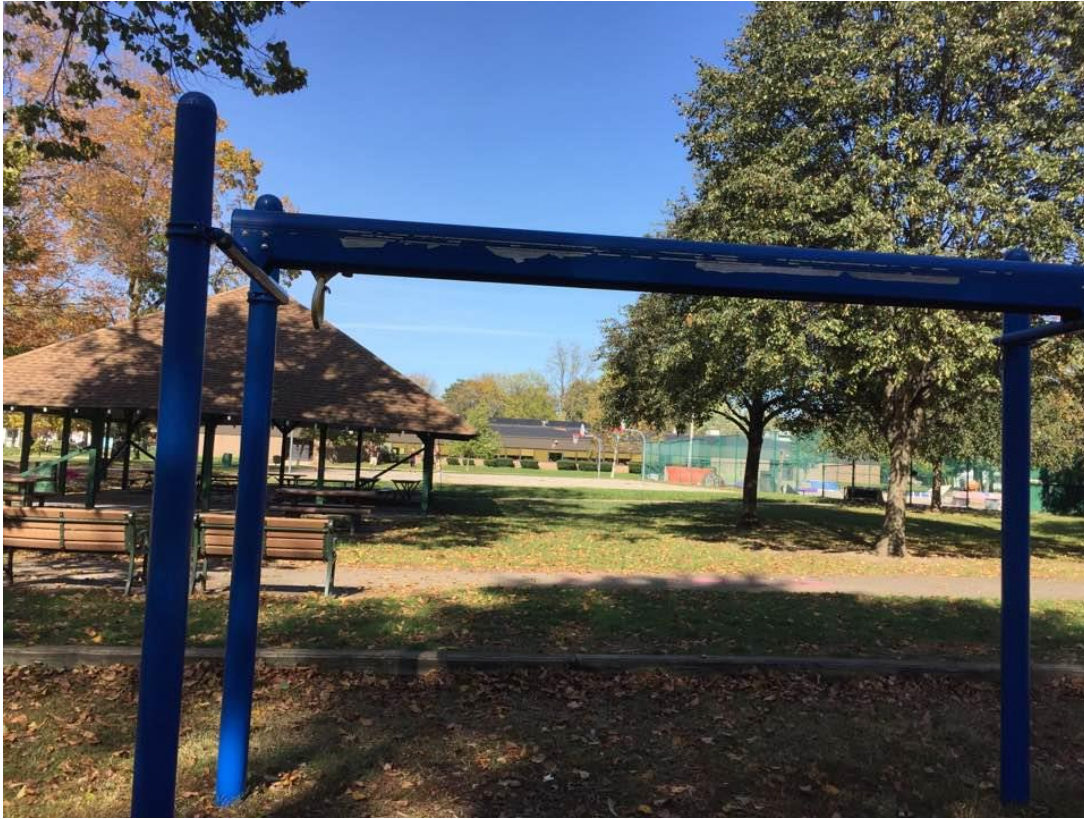
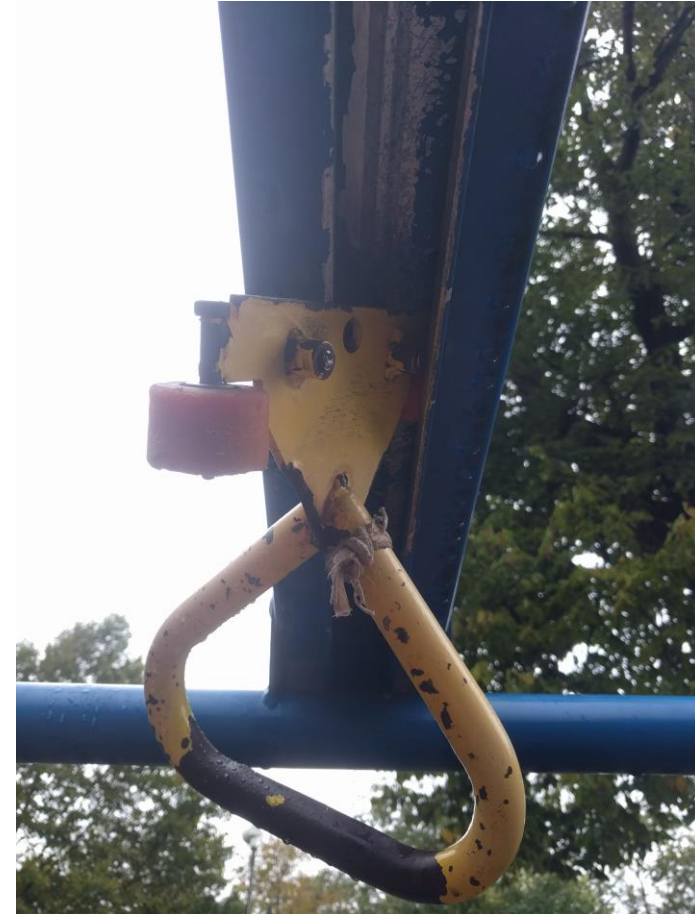
# MORE BROKEN PLAYGROUND EQUIPMENT

## Glide Handle Broken

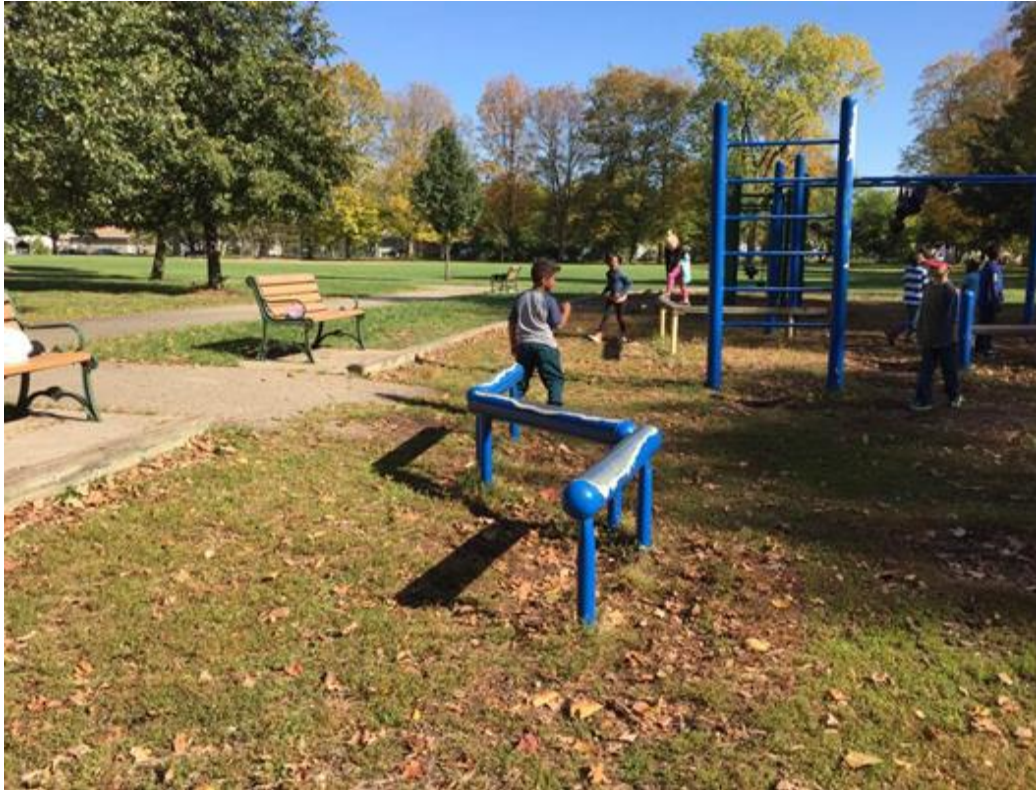
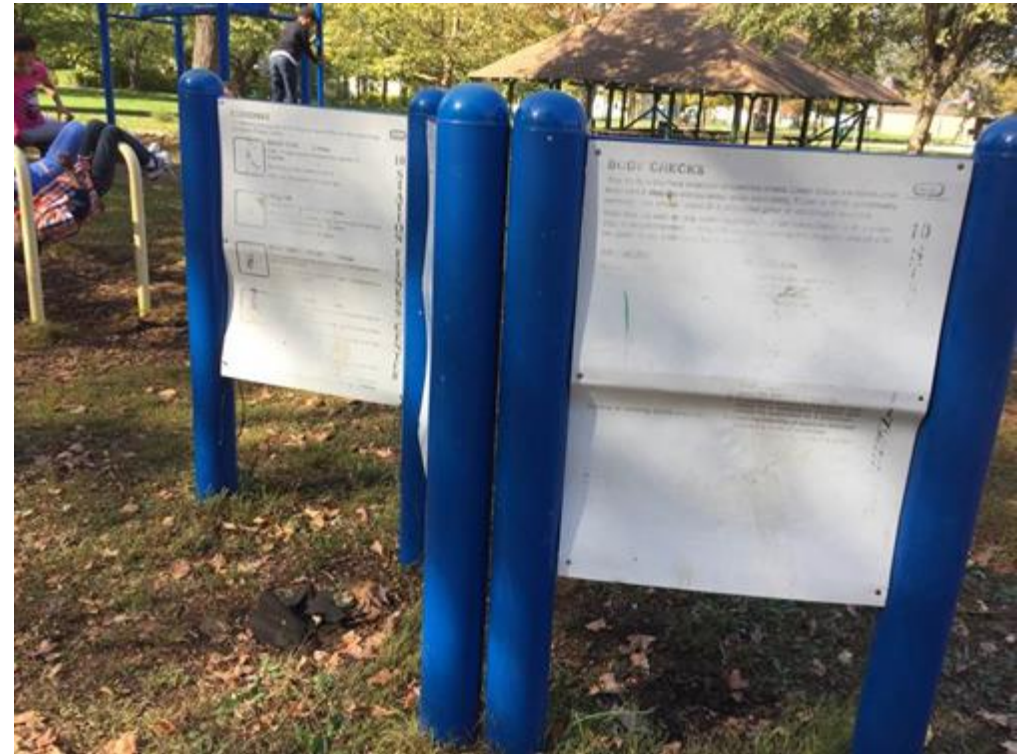
# EXERCISE EQUIPMENT NEEDS MAINTENANCE

Needs Repainting and Instructions Need to be Redone or Replaced

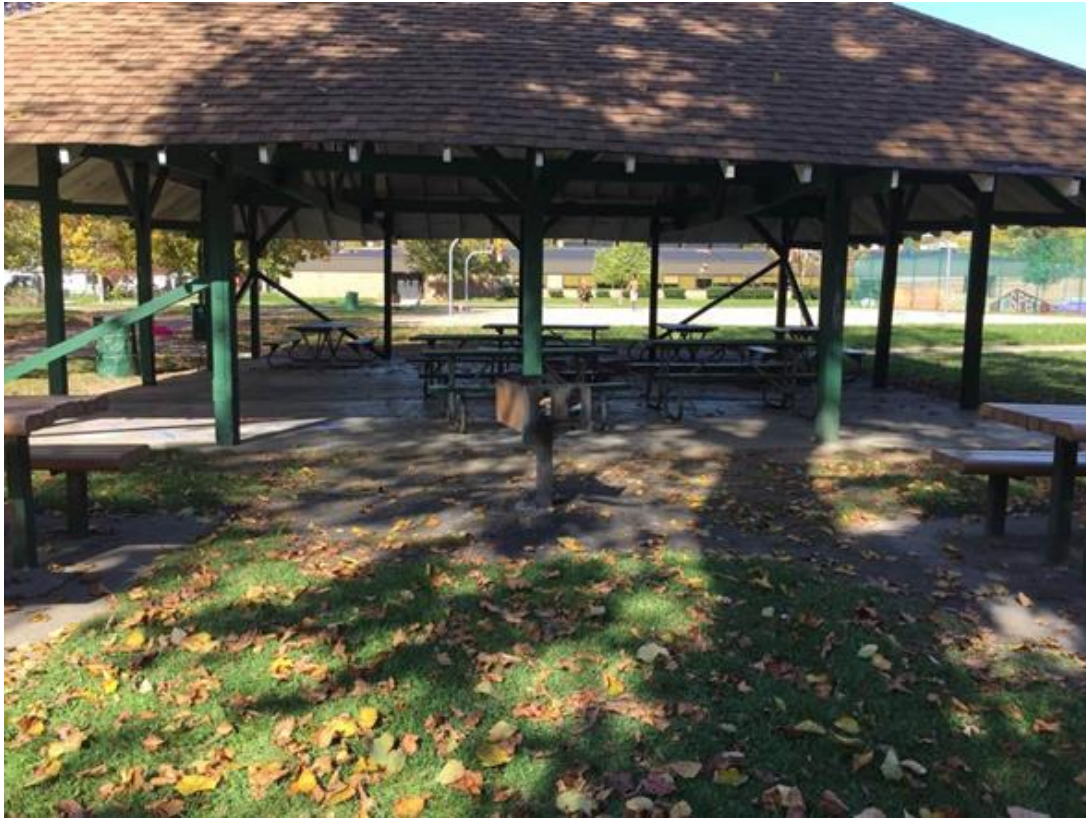
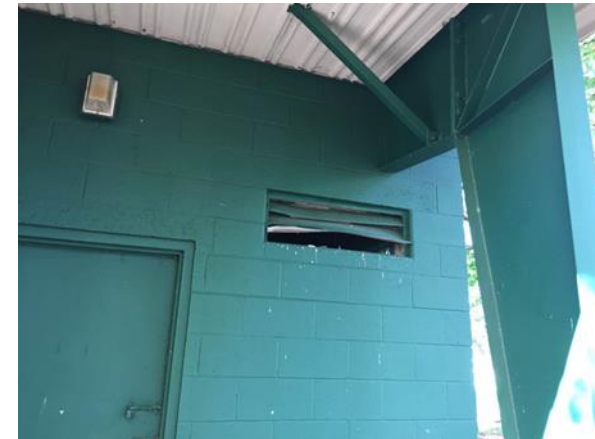
# PAVILLIONS BOTH NEED PAINTING AND REPAIRS

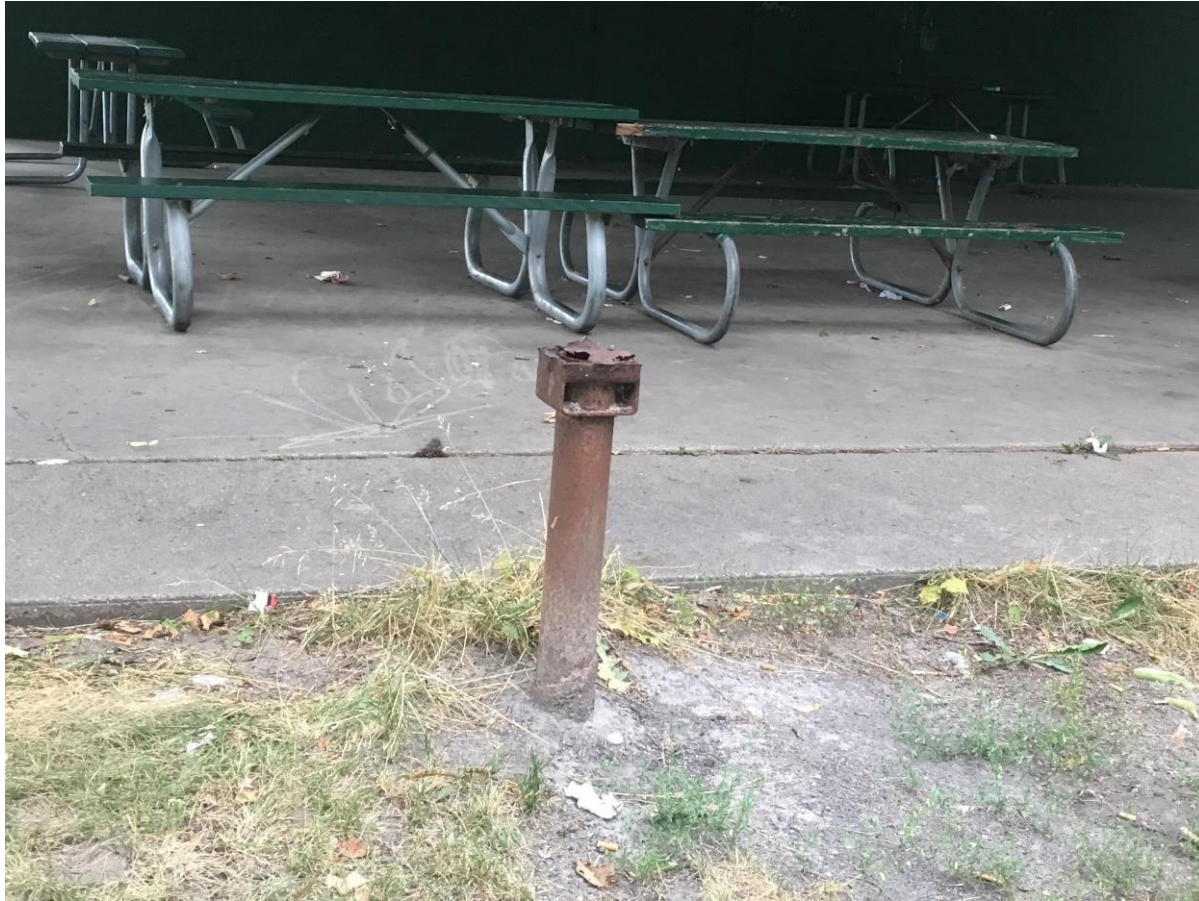
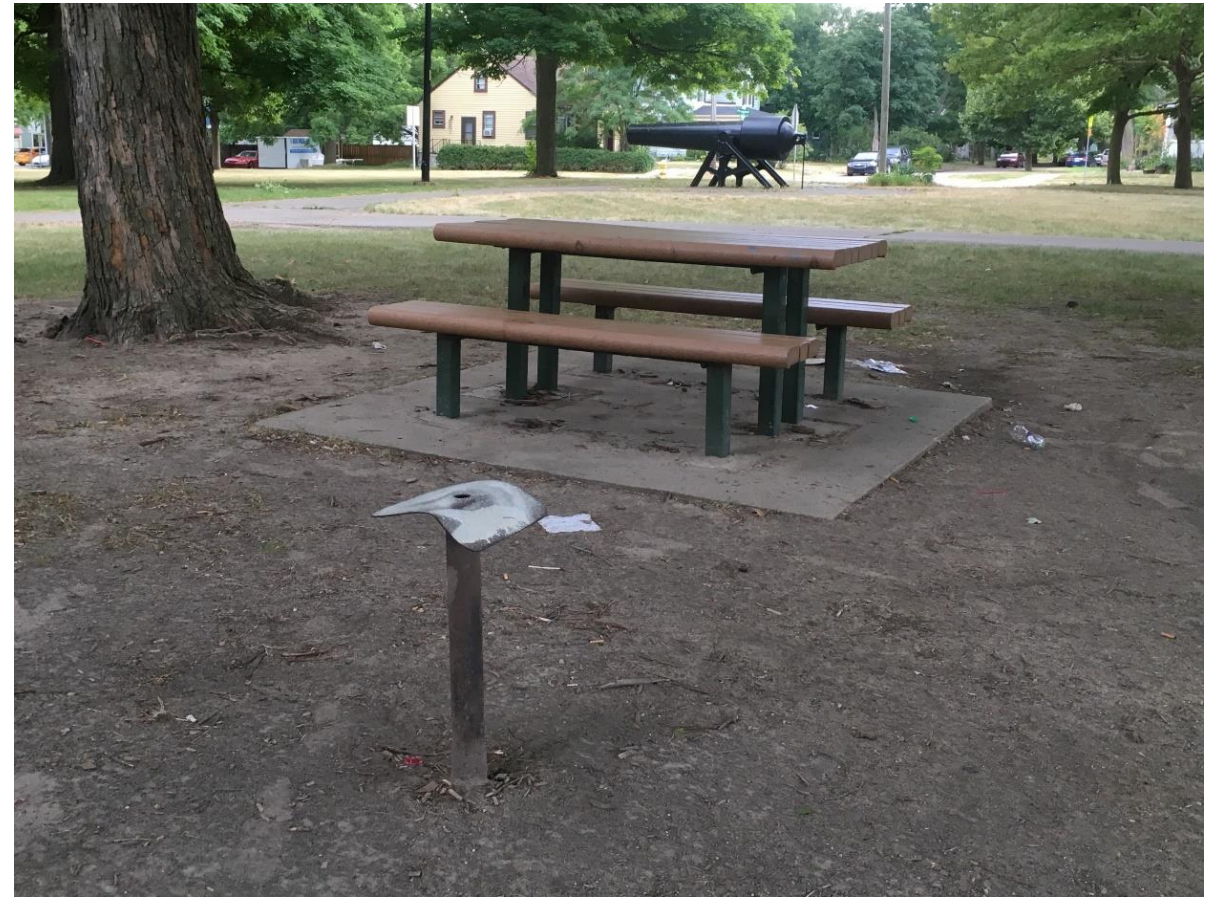
# Missing and Broken BBQs Picnic Tables and Benches Need Repair and Repainting
