**CITY OF YPSILANTI  
CITY COUNCIL SPECIAL MEETING  
APRIL 12, 2022 @ 7:00 PM  
COUNCIL CHAMBERS - CITY HALL  
One South Huron, Ypsilanti, MI 48197  
[VIRTUAL ACCESS](#)**

## **Parks Bathrooms Discussion:**

The purpose of this report is evaluate the existing conditions at several park facilities, provide recommendations to make operational again, and provide an opinion of probable cost of the work required to correct the condition for the City's use in future planning efforts.

At the invitation of the City, representatives from OHM Advisors visited the City Park's restroom facilities, on various dates in August and September 2018, to observe the existing conditions; no architectural or structural drawings were available for these structures.

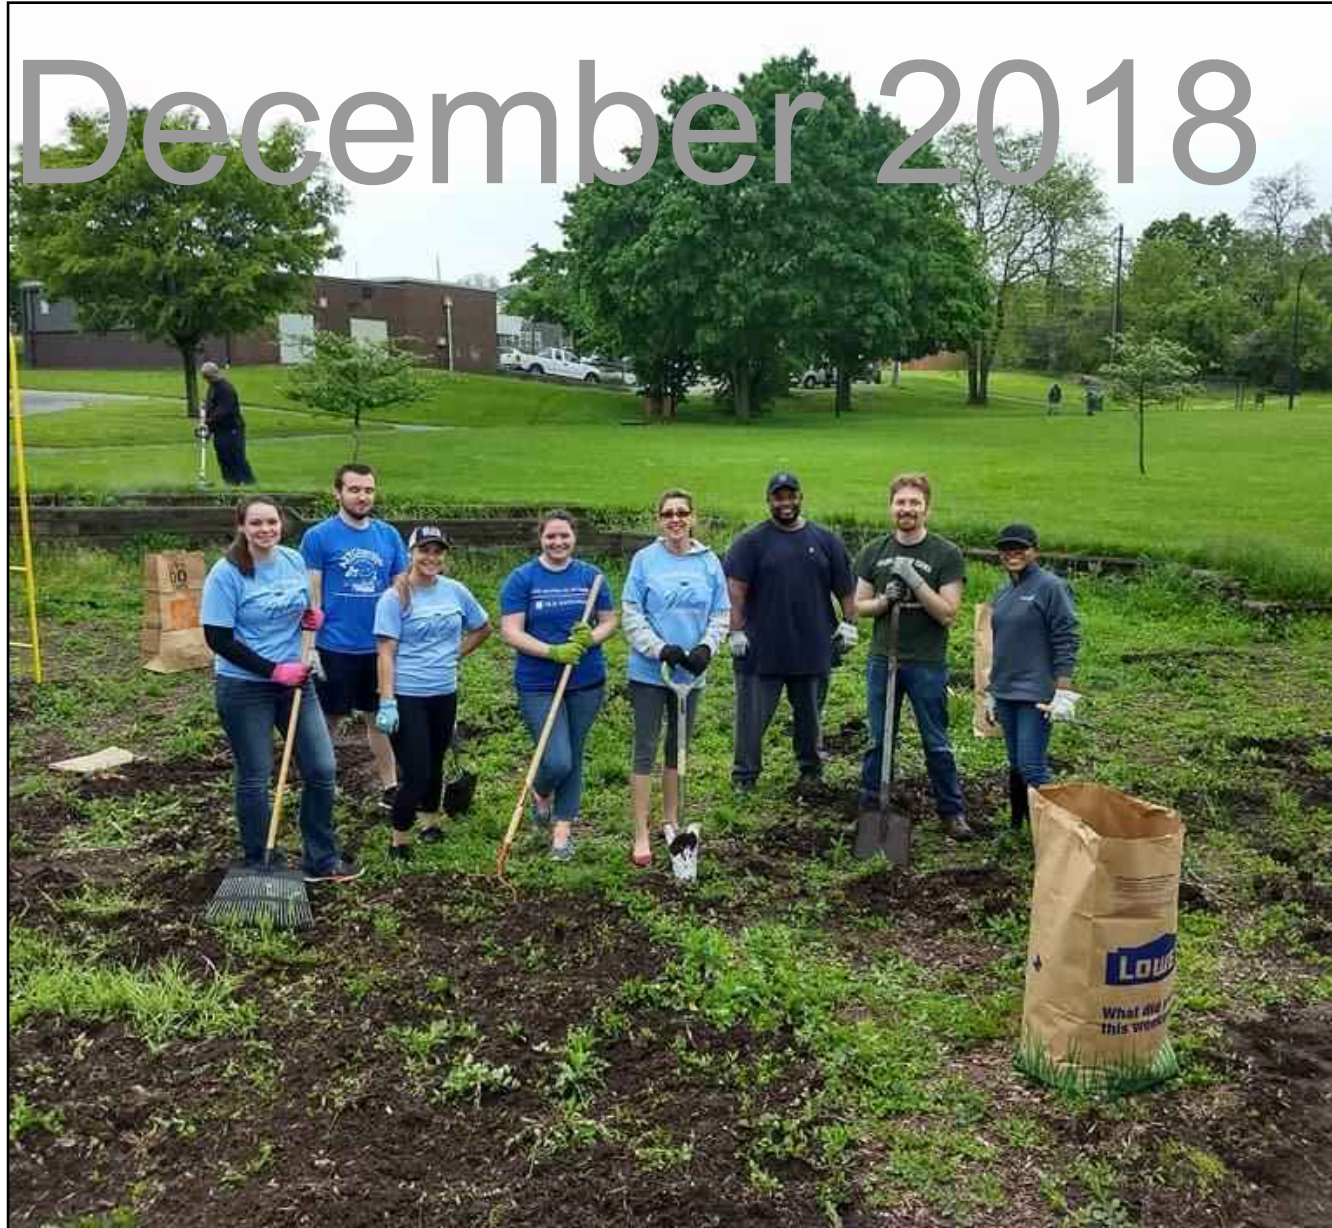
## Parkridge Park

### Safety & Usability Concerns

Replace door on storage closet on park pavilion

Replace/repair broken picnic tables

Replace/repair guardrail in parking lot near Perry School

Repair/restore water fountain

Repair tennis courts, including cracks, and court surfacing

Replace/repair broken and outdated grills

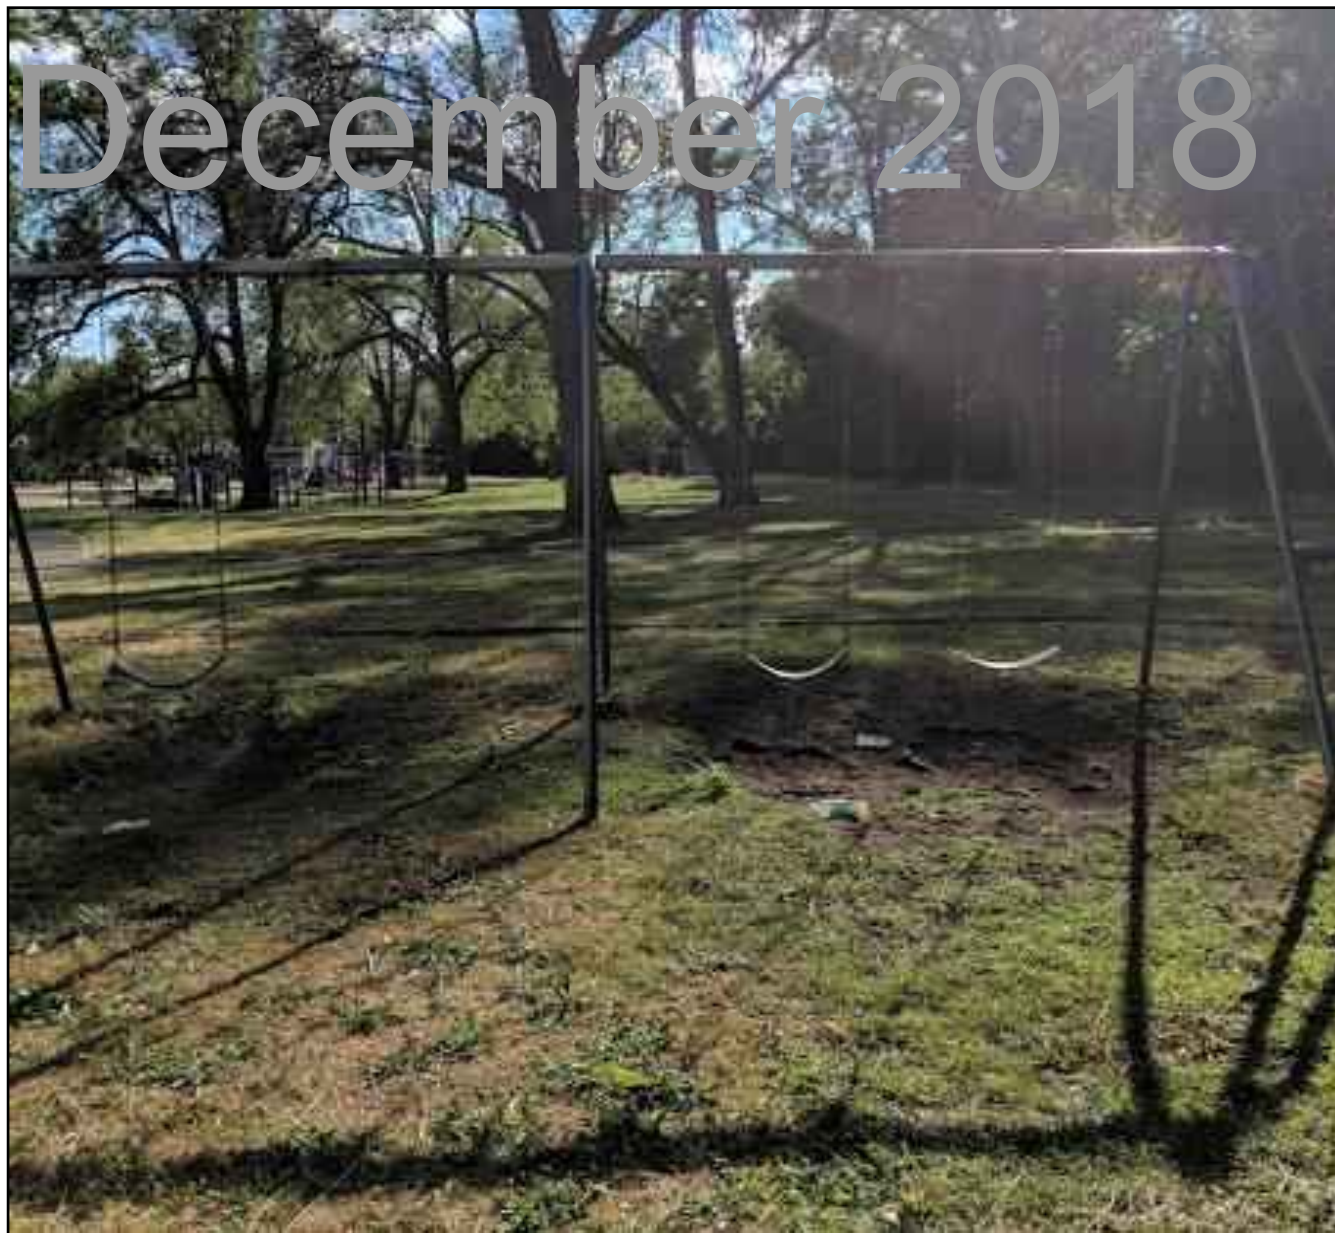
## Recreation Park

### **Safety & Usability Concerns**

Replace/repair broken picnic tables

Repair fence that is leaning/falling on baseball diamond

Remove curbing from basketball courts and fill cracks

Paint basketball court lines

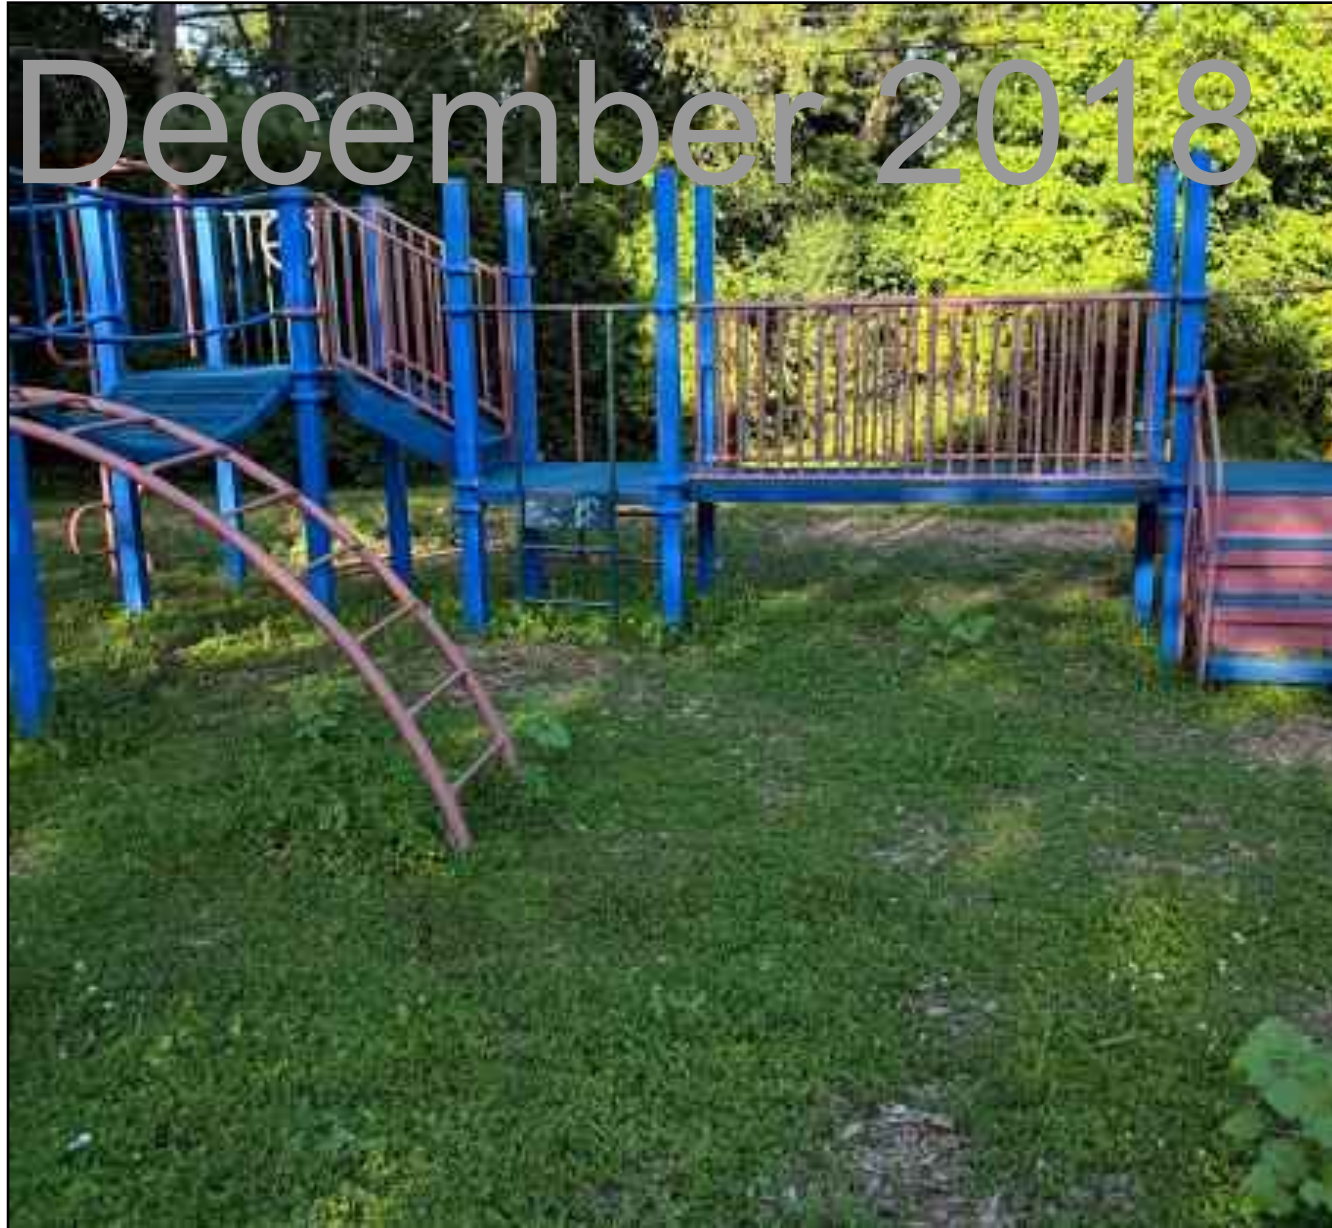
## Candy Cane Park

### **Safety & Usability Concerns:**

Replace old wooden bleachers with new boards

Address crack in wall on restroom/pavilion facility or determine usability and remove restroom/storage area to make open air pavilion.

Replace/repair broken picnic tables

Replace/repair broken benches

Seal cracks in tennis court surface

Replace broken and outdated grills

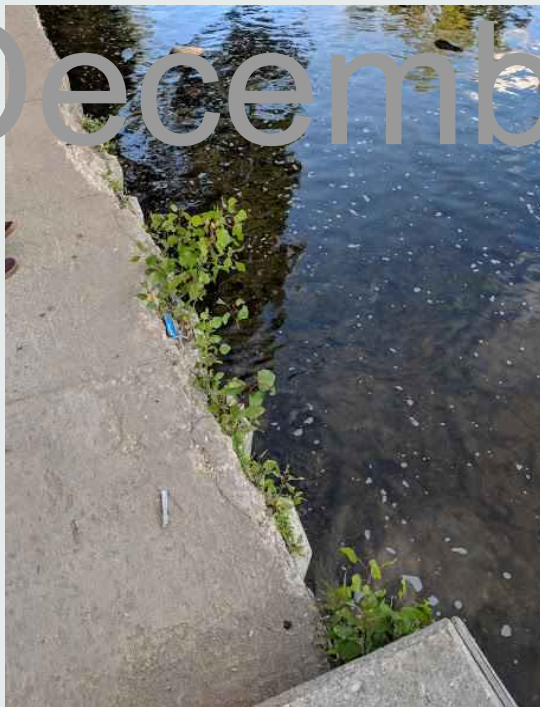
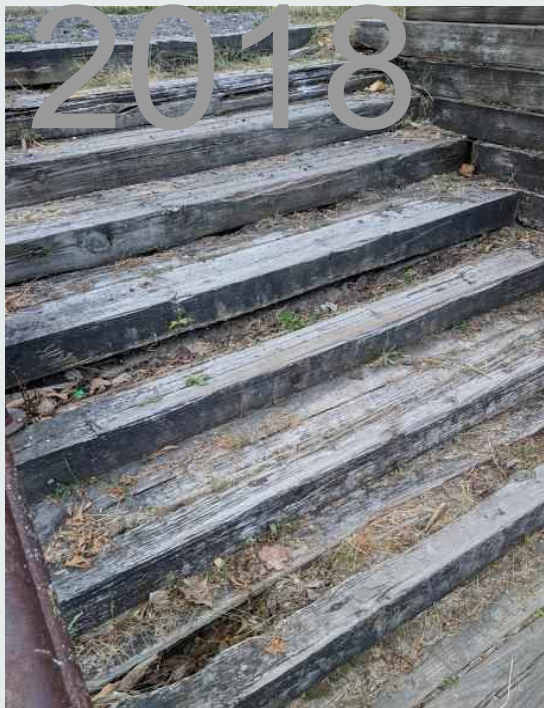
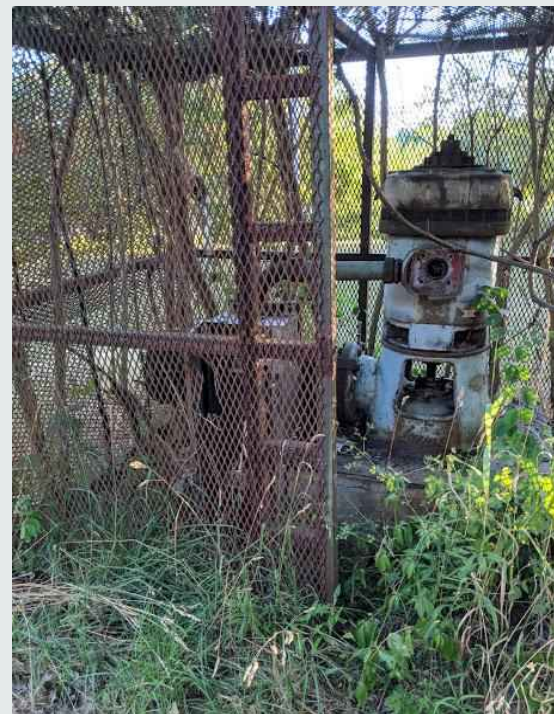
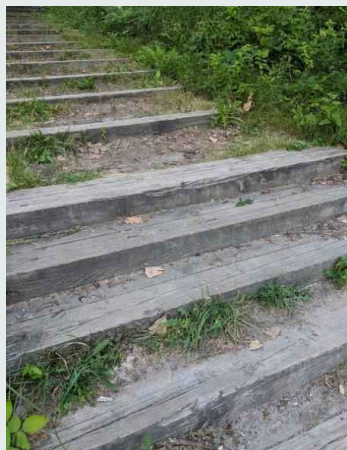
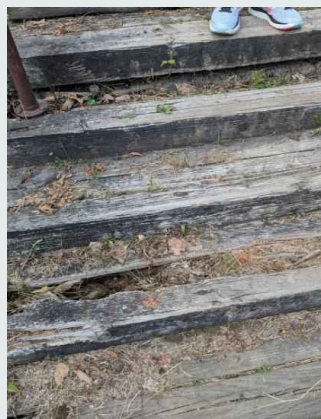
Replace/repair stairs leading to Huron River

Repair concrete on walkway near Huron River

Replace/repair broken picnic tables

Clear brush that is encroaching on walkways to Huron River, and brush in open areas of the park to help improve sightlines

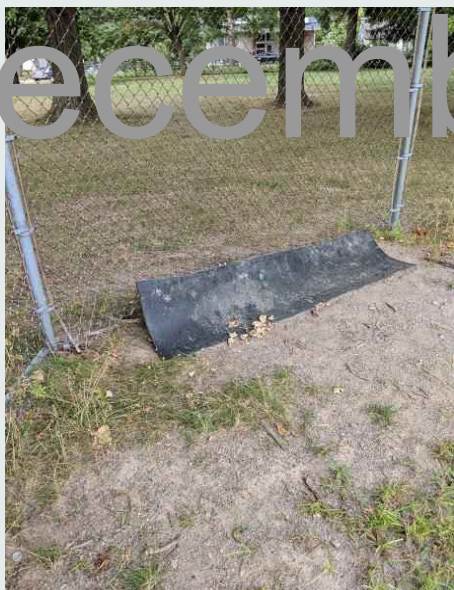
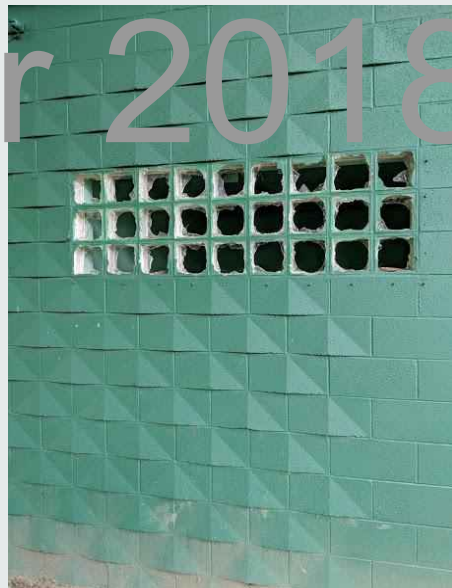
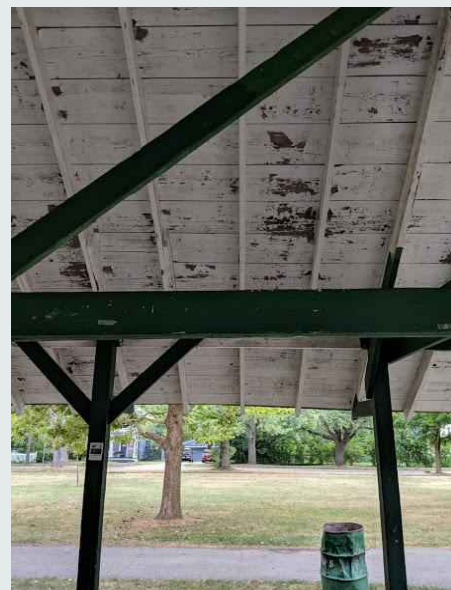
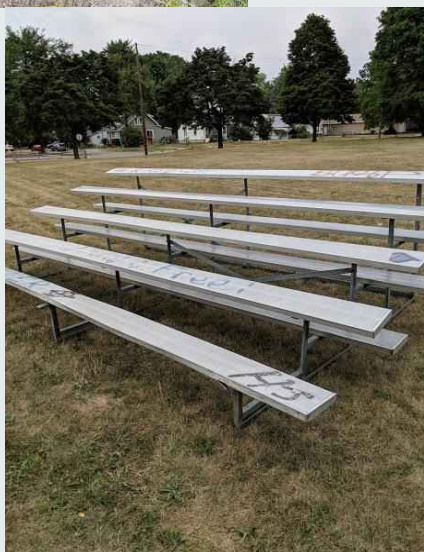
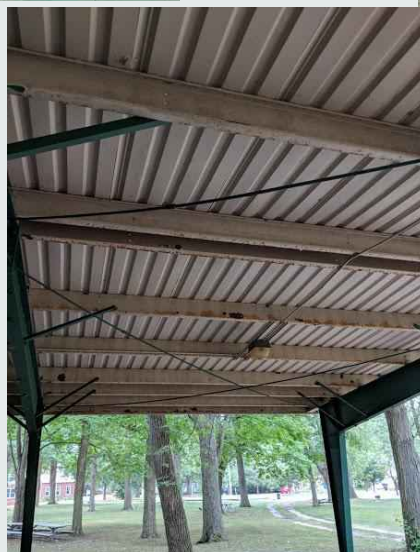
Replace or remove broken glass block windows on pavilion

Repair fencing surrounding tennis court/skatepark

Repair/replace broken grills

Repair/replace broken picnic tables

Seal cracks in basketball courts

Replace/repair broken benches

Repair broken bleachers

Repaint pavilions

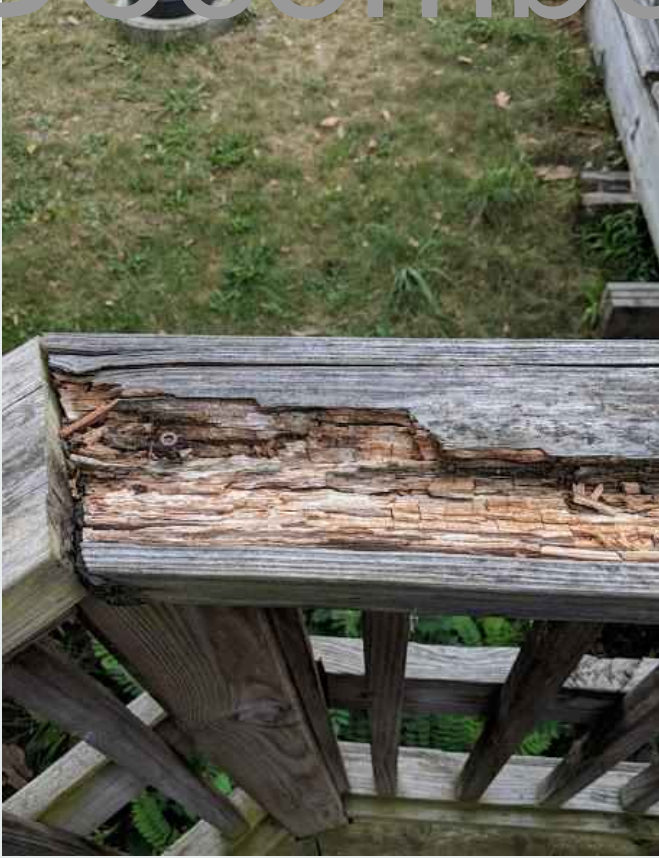
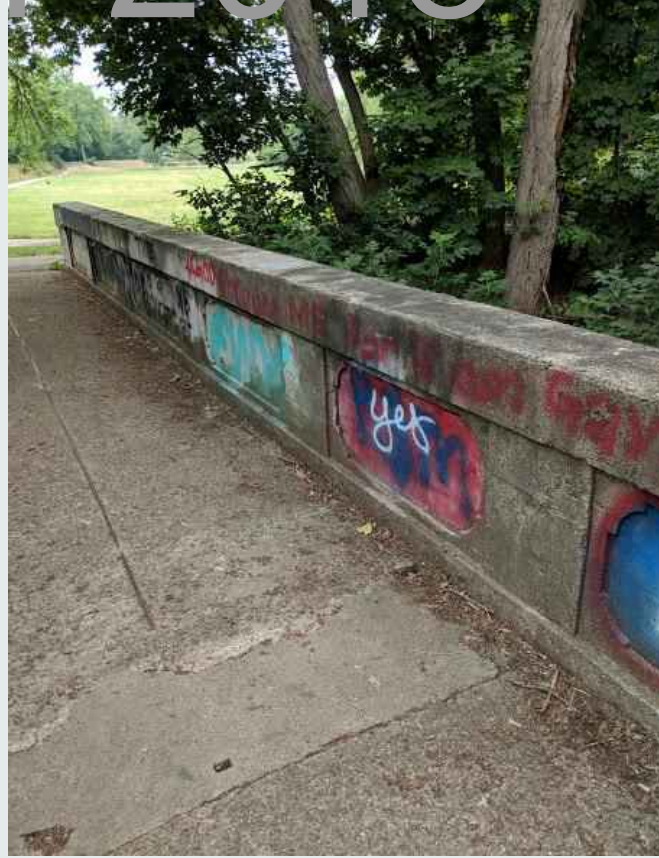
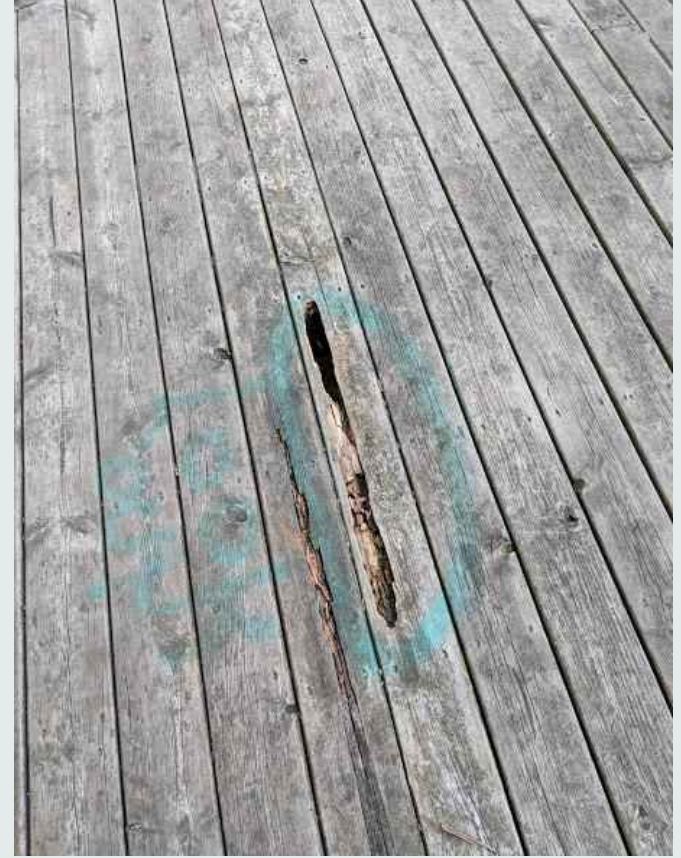
Replace/repair picnic tables

Replace unsafe wood/boards in Gazebo

Add additional trash cans, and pet clean up/pick up stations

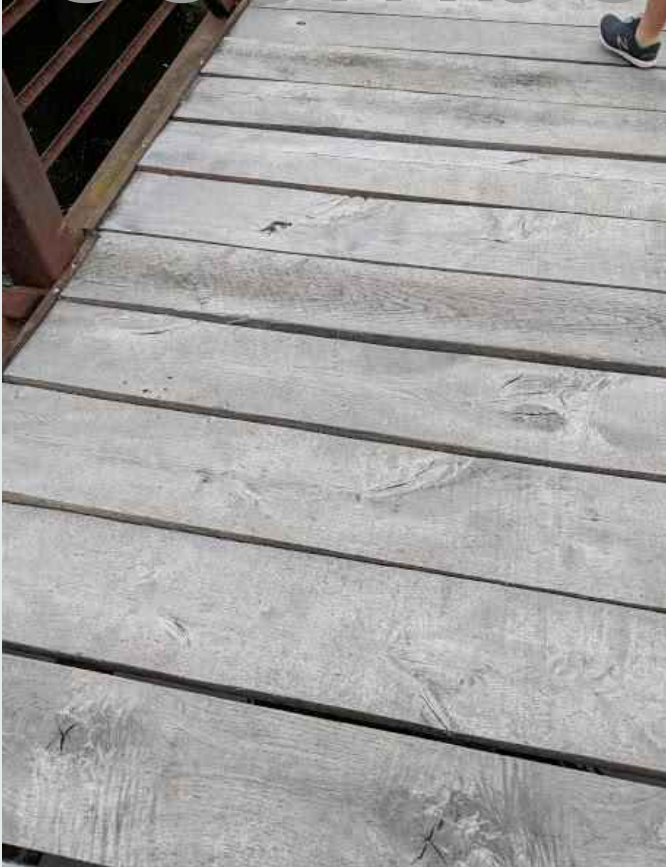
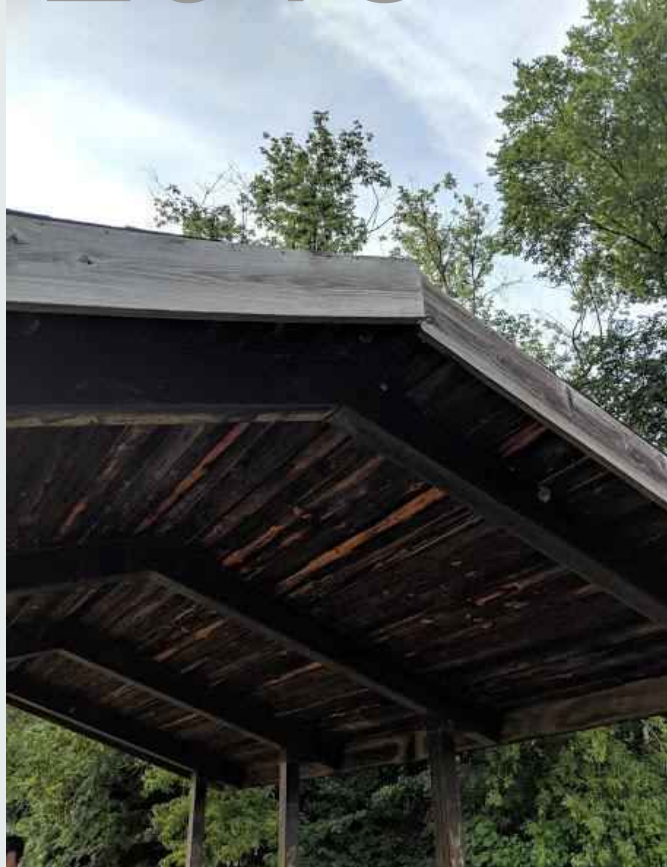
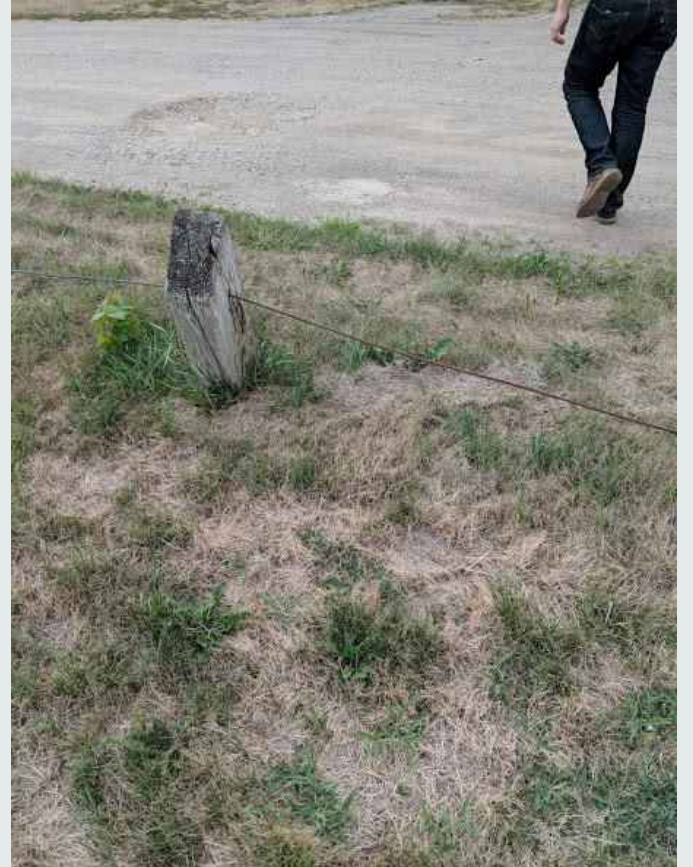
Address loose boards on footbridge

Replace pavilion wood in needed areas

Additional trash cans

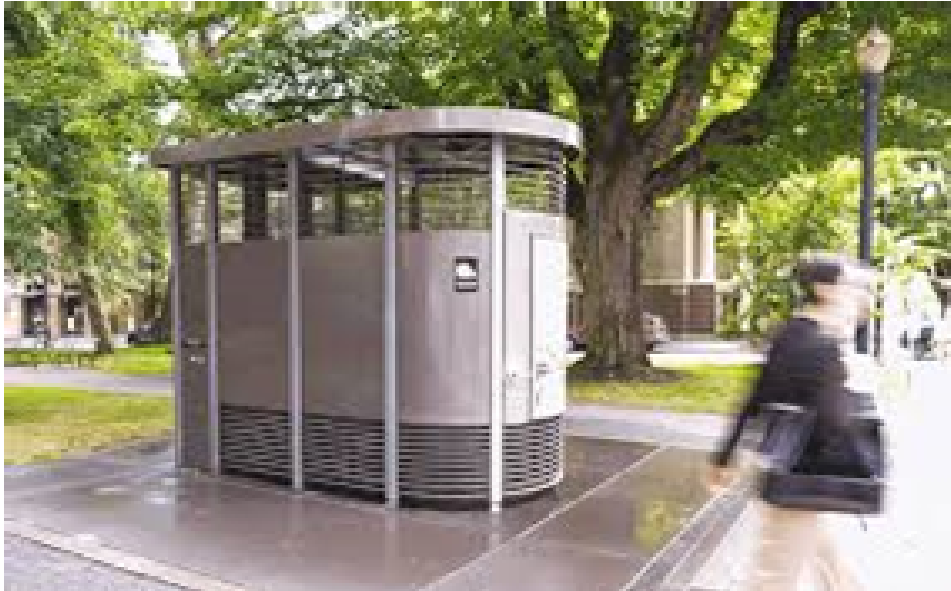
Portland Loo Public Toilet

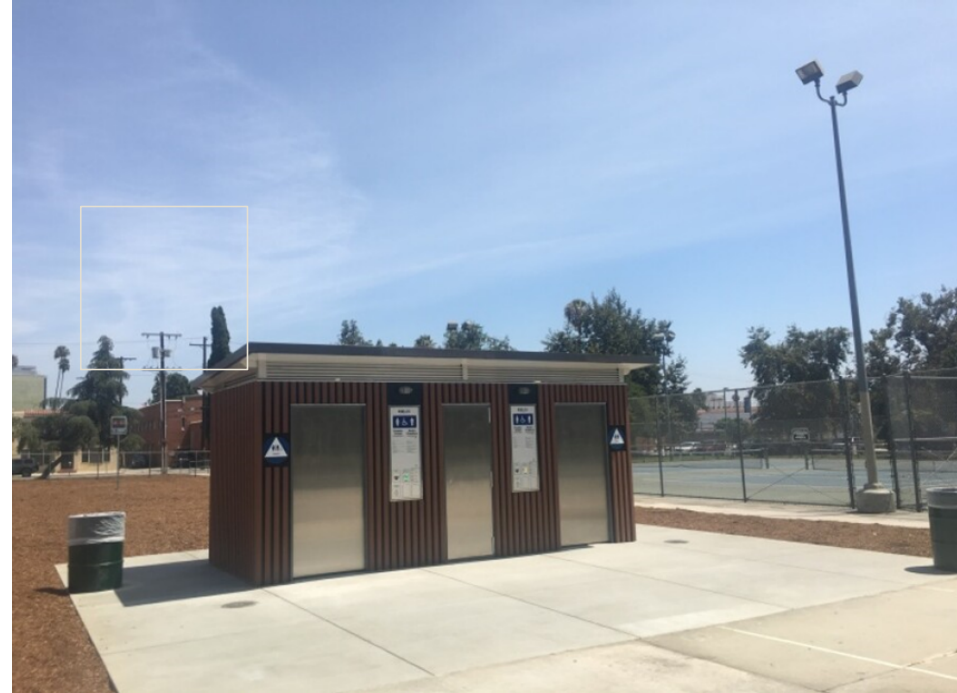
Exeloo Self Cleaning Toilet

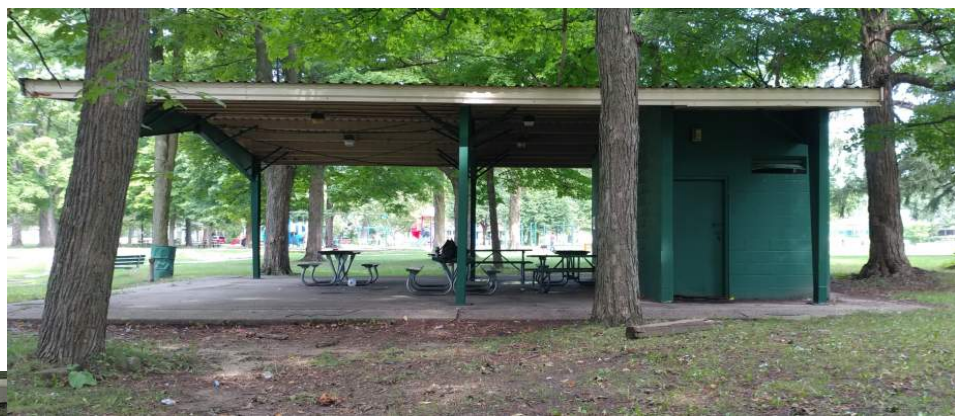
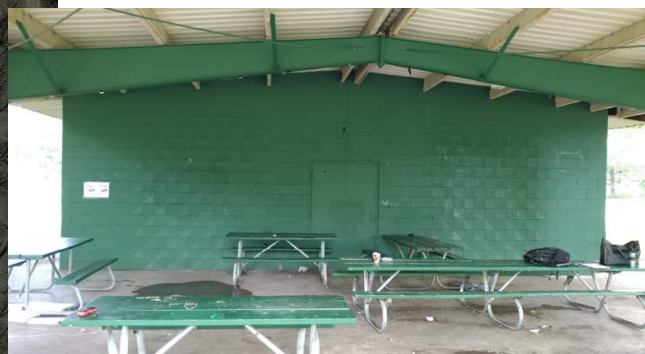
The Prospect Park restroom building is constructed of single-wythe masonry walls, concrete floor slab, and metal roof. The roof extends from the building to cover a concrete slab on grade picnic area adjacent to the building. The building itself consists of two single occupant toilet rooms on either side of a storage area. Each restroom has a louvered opening to allow natural ventilation, and a glass block window for natural light. Restroom fixtures are stainless steel.

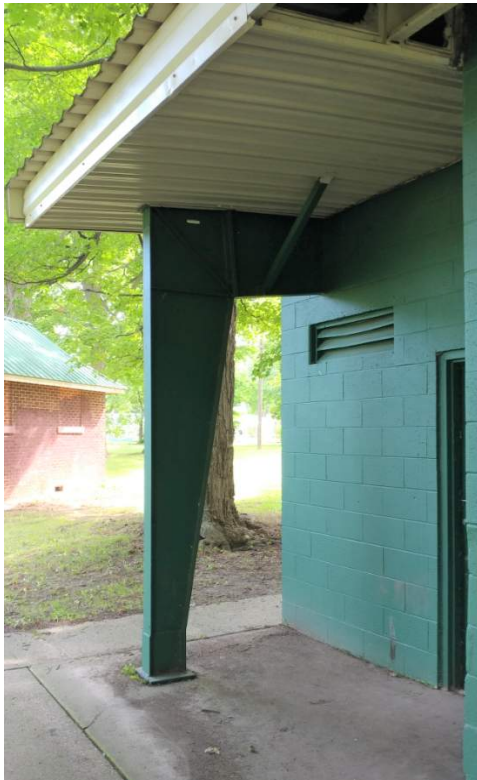
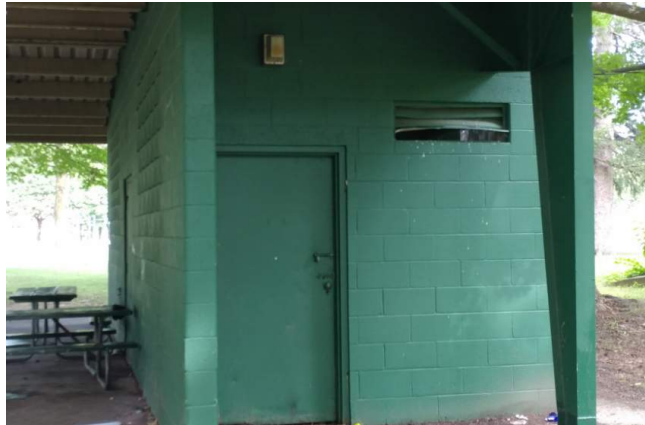
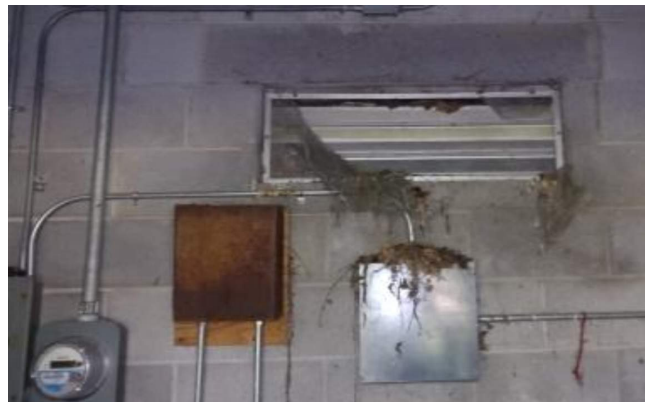
The masonry walls are structurally in good condition but they need to be repainted and coated with a graffiti resistant material. The underside of the roof needs to be repainted also. The paint on the purlins supporting the roof is deteriorating and causing the purlins to rust. The rust needs to be removed from the steel and the purlins need to be repainted. The concrete pad at the picnic area is in acceptable shape. Exterior lighting should be replaced with LED fixtures.

All the hollow metal doors are in poor condition and need to be replaced. The ventilation louvers are bent and damaged and need to be replaced. The glass block windows are missing much of the glazing due to vandalism and should be replaced with a more vandle resistant glazing option.

All restroom fixtures are damaged and need to be replaced, however, the plumbing and electrical infrastructure is in good condition. Interior lighting should be replaced with LED fixtures. The interior plaster walls are in in good condition but need to be repainted and coated with a graffiti resistant material. The concrete floor slab in both of the bathrooms and storage room is in good condition but should be sealed. The plaster ceiling in the bathrooms needs to be repainted.

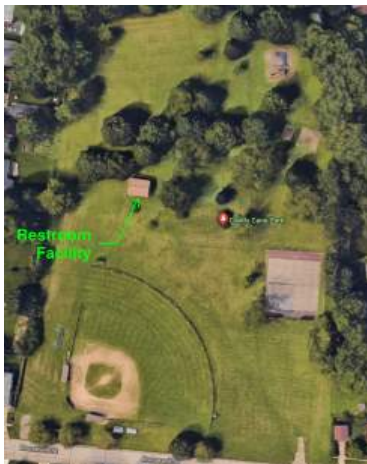
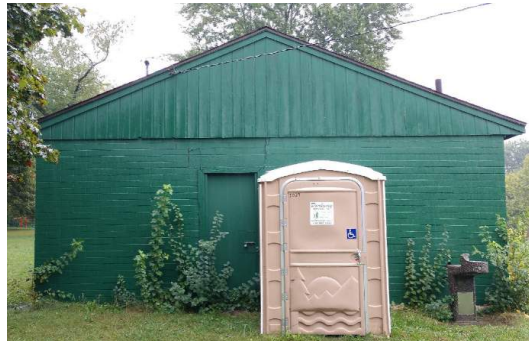
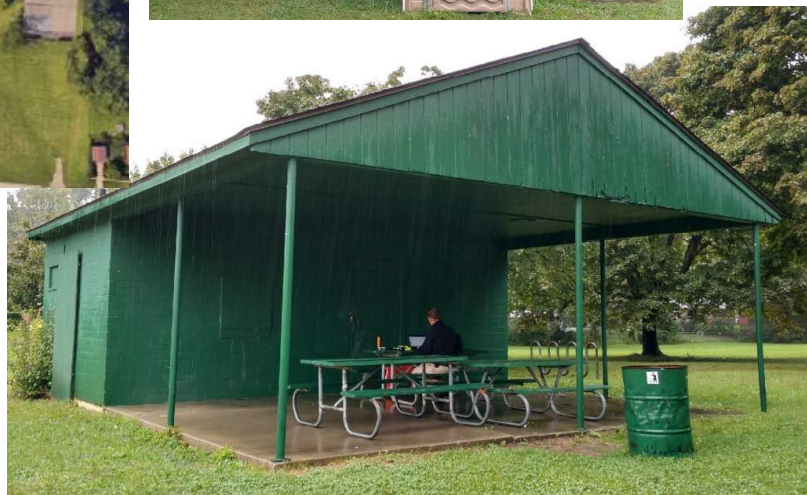
The Candy Cane Park restroom building is constructed of single-wythe masonry walls, concrete floor slab, wood roof trusses, and an asphalt shingle roof. The roof extends from the building to cover a concrete slab on grade in the covered picnic area adjacent to the building. The building itself consists of two single occupant toilet rooms on the far side (west) of the L-shaped storage area that abuts the pavilion.

The masonry walls show signs of foundation settlement along the south wall and the south slab in the pavillion area. There are diagonal cracks on the East wall inside the pavillion starting at the top in the Southeast corner extending downward to the North and in the Southwest corner along the south wall. The slab in the pavillion did not have contraction joints when it was poured, and has now formed contraction cracks with the Southeast slab settling on the south edge, thereby lifting up its north edge creating a one inch trip hazard. The masonry wall on the inside of the pavillion (East wall) needs the two diagonal cracks pointed up with mortar and needs to be repainted and coated with a graffiti resistant material. The concrete pad in the picnic area is in marginal shape. If the slab is not removed and replaced, it is recommended to have the trip hazard ground down (15 ft of grinding) and the cracks routed and sealed (65 ft). The masonry around the building has cracks on all sides that need to be routed and pointed, then needs to be repainted and coated with a graffiti resistant material.

The underside of the roof in the pavillion needs to be repainted. The paint on the steel posts supporting the roof are in good condition, however, could use repainting as part of its regular maintenance. The column in the NE corner of the pavillion has been bent. It either needs to be replaced or repaired. The plywood underside of the roof in the pavillion has two holes for light fixtures that are boarded up. Exterior lighting should be added under the pavillion and on the outside of the structure on four sides with LED fixtures. The West and East side lighting could be added at the top of the roof peak to provide better coverage and to deter vandalism.

The West side has a hole in the masonry where a drinking fountain was mounted that needs to be patched. It also has a drain coming out through the wall that needs to be cut back and capped before patching. The new free standing drinking fountain appears to be in good condition. As there is no water meter installed, it is not anticipated that it is in working order.

All the hollow wood doors are in poor condition and need to be replaced, as well as the hinges and frames. The four windows are boarded up and need to be replaced with glass block windows that are vandal resistant.

All restroom fixtures are damaged and need to be replaced, however, the plumbing and electrical infrastructure appears to be in good condition. The shut off gate valve on the water service coming through the floor in the North bathroom needs to be replaced (1" L copper coming through the floor). It is recommended that a ball valve be installed and a security box be put over the water meter. We could not access the electric panel on the inside of the storage room. Interior lights (2) in the bathrooms should be replaced with LED fixtures as well as any lights located in the storage room. All lights should be put on countdown timers. The interior masonry walls are in good condition but need to be pointed up and repainted and coated with a graffiti resistant material. The concrete floor slab in both of the bathrooms is in good condition but should have the cracks routed and sealed and a floor paint applied. The ceilings in the bathrooms need to be repainted.

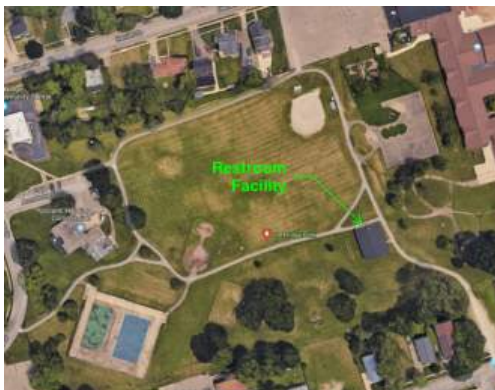
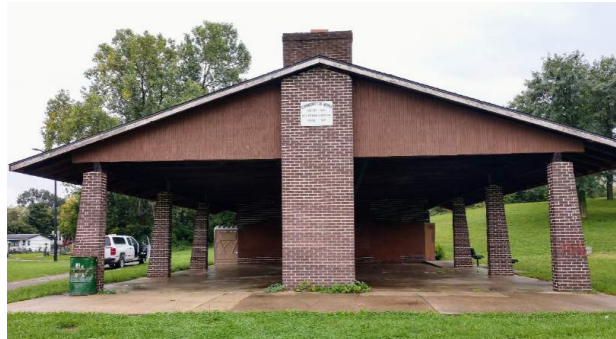
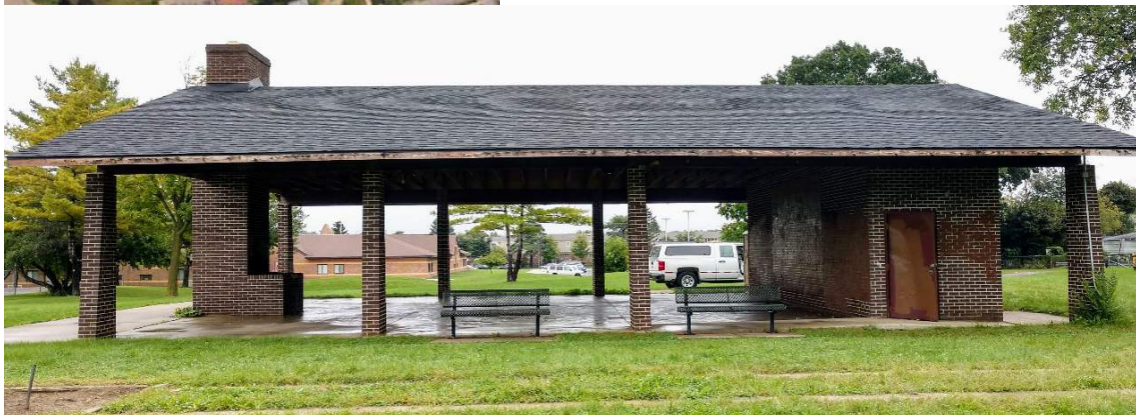
The Parkridge Park restroom building is constructed of CMU walls with brick facade, concrete floor slab, wood roof trusses, and an asphalt shingle roof. The supporting columns have been capped in a brick façade before the column connects to the engineered beams. The roof extends from the building to cover a concrete slab on grade in the covered picnic area adjacent to the building. The building consists of two toilet rooms in the Southeast and Southwest corner of the building and a storage room. There is a utility cavity between the two bathrooms. The two bathrooms and the storage room have 36" steel doors. Each restroom has a glass block window with vent to allow natural light and ventilation. Restroom fixtures are steel. One bathroom consists of a toilet with a partition, sink, paper towel dispenser/garbage container, and urinal. The other bathroom has a sink, a toilet with partition, a plated appurtenance, and paper dispenser/garbage container. The pavilion has a fireplace at the far end.

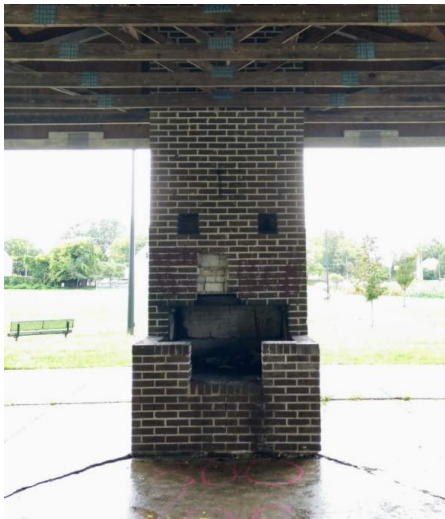
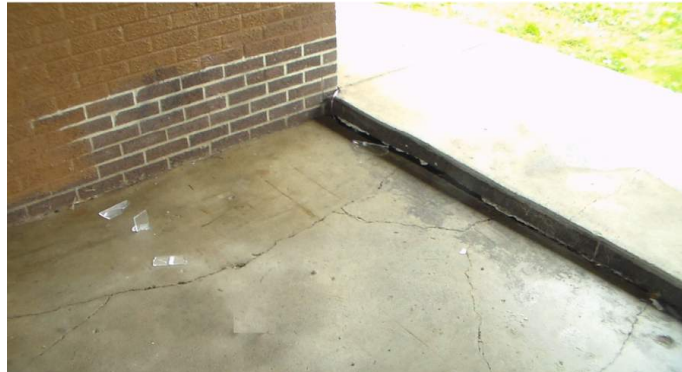
The masonry walls are in good condition when viewed from the inside. There is a gap opening up between the inside CMU, that has a maintenance cavity between the bathrooms for sewer and water, and the outside masonry wall (south). The brick façade is in excellent condition. There is a brick repair needed inside the pavilion on the building wall.

Although the fireplace will require some brick work on the face above the opening, generally the fireplace brick is in good condition outside and inside starting at the corbel working its way up to chimney. In the body of the firebox, below the corbel, pointing up needs to occur. The flue appears to have at least one cracked liner piece, however, its joint is tight. Not all of the flue is accessible for inspection and will need to be carefully televised to determine the repairs necessary. The fireplace should be inspected by an expert for recommended repairs. The fireplace flue should have a cap installed.

The roof appears to have new sheathing and new shingles. It is anticipated that they are from the 2007 renovation. The fascia board needs to be sheathed or painted. It is beginning to show signs of deterioration. Mold and staining is present along the outside and the bottom edge where it is exposed to water. The truss cavity has a plywood block installed between the sheathing and the top of the CMU walls on the outside and under the pavilion. In many places it has shifted or fallen. The wood blocking appears to have prevented birds and other animals from sheltering in the bathroom, storage room, or the plumbing cavity.

The concrete on grade around the building needs to be removed and replaced. It has heaved or settled in some locations, and the remaining is heavily broken up. At one point by the NW corner of the building, between settlement and heaving, there is a five-inch lip at the building (See pic above). Expansion should be installed between the building and the slab on grade, then ripped down and sealed with polyurethane upon completion of the work.

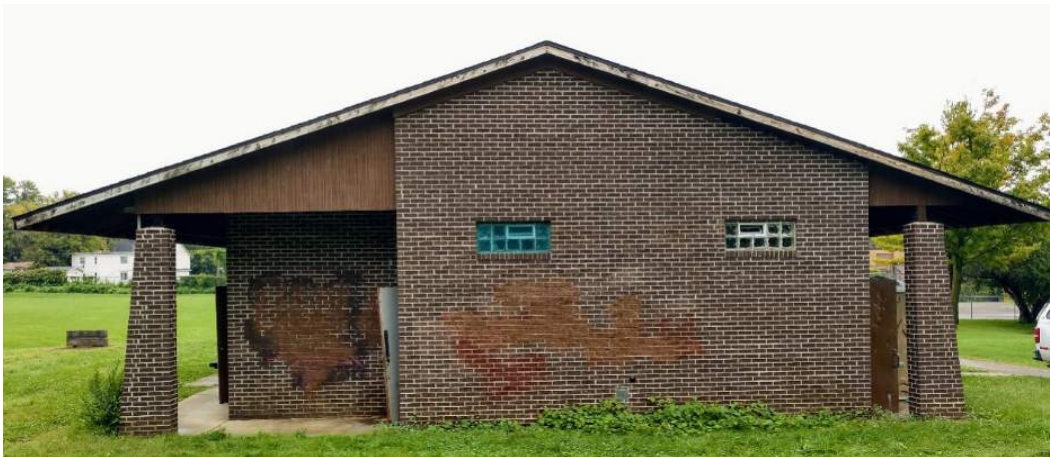
The plumbing and electrical infrastructure appears to be in decent condition. The shut off gate valve on the 2" plastic water service coming through the floor in the service cavity needs to be replaced. It is recommended that all the galvanized piping be removed before and after the meter horn, replaced with copper, and new ball valves be installed. There appears to be Studer type vents on the plumbing inside the wall cavity that have had the tops removed. These need to be assessed more closely and possibly repaired. The electric panel on the inside of the storage room needs assessment by an electrician, however, it appears to be in working order. Some of it's wiring may need tidying up and a new face put on it that can be locked. There is a large feed to an external stage/entertainment area by the baseball diamond, per the DPW.

Interior lights (3) in the bathrooms and storage should be replaced with LED fixtures. All lights should be put on countdown timers. The interior masonry walls are in good condition, but need to be repainted and coated with a graffiti resistant material. The concrete floor slab in both of the bathrooms and storage room is in good condition but should be sealed with a floor paint. The plywood ceilings in the bathrooms need to be repainted. The floor drains, the toilet, urinal, and sink should be augered and televised to insure they are open and functional. Televising could verify if the sanitary outside the building is in good conditon. YCUA should be coordinated with to establish if the sewer lead in the ROW is in usable condition.

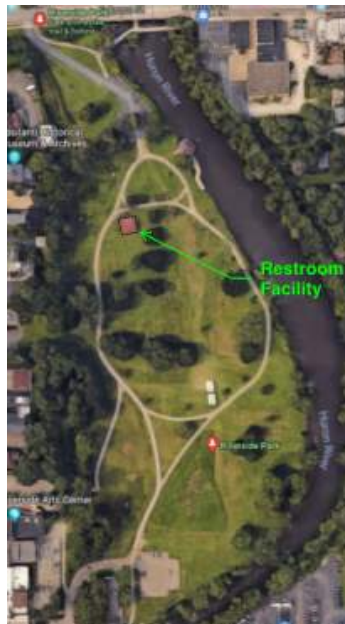
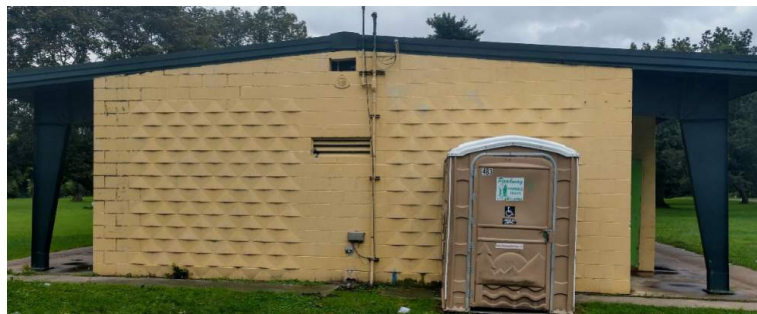
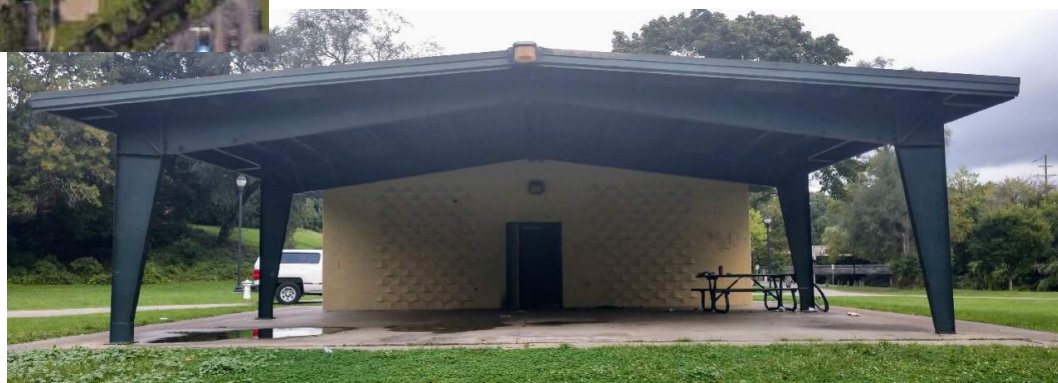
The Riverside Park restroom building is constructed of single-wythe masonry walls, concrete floor slab, and metal roof. The roof extends from the building to cover a concrete slab on grade picnic area adjacent to the building. The building itself consists of two toilet rooms on the north side of a storage area. Each restroom has a louvered opening to allow natural ventilation. Restroom fixtures were likely ceramic.

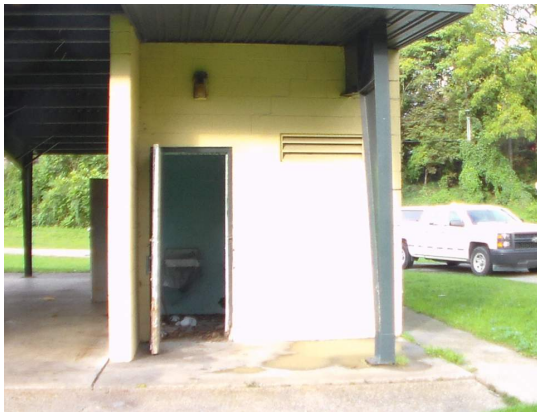
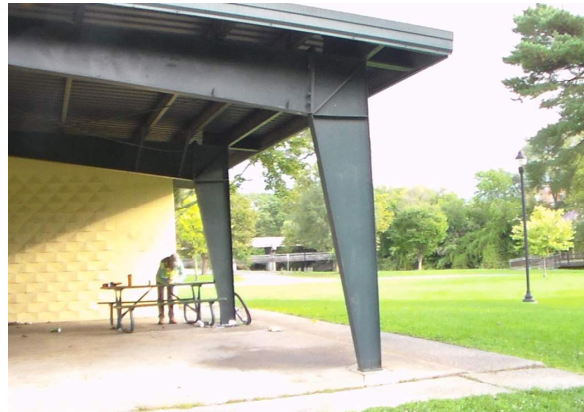
All the hollow metal doors, hinges, and frames are in poor condition and need to be replaced. The bathroom doors are not 3' wide and need to be opened up for ADA access. The ventilation louvers are either damaged or missing, and need to be replaced. The insect screening in many places is damaged and needs to be replaced in the following places – the louvered ventilation, steel beams for access to ventilation above the bathroom ceilings, inside the storage room to the outside, and to the ventilation cavity above the bathroom ceilings. Glass block windows for natural light would be a valuable addition to the bathrooms.

All restroom fixtures are damaged and need to be replaced. ADA accessible fixtures and toilet rooms will provide only one accessible fixture per existing room. The plumbing and electrical infrastructure appears to be in good condition. Interior lighting should be replaced with LED fixtures. The interior masonry walls are in good condition, but need to be repainted and coated with a graffiti resistant material. The concrete floor in both of the bathrooms and storage room is in good condition, but should be sealed. The ceiling in the bathrooms needs to be repainted.

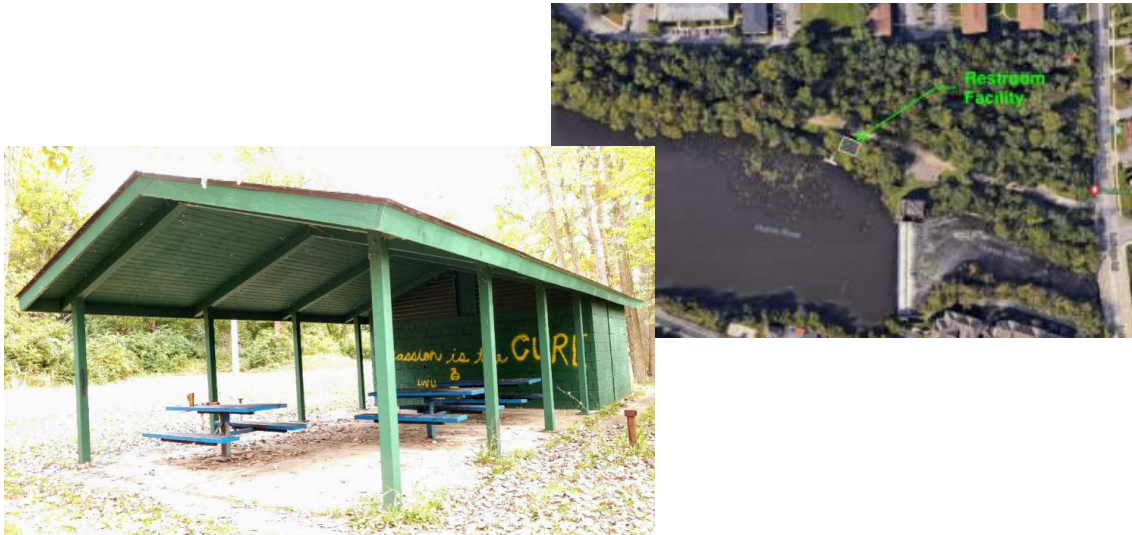
The Peninsular Park restroom building is constructed of single-wythe masonry walls, concrete floor slab, steel frame supports and steel beams, and a tongue and groove roof with asphalt shingles. The roof extends from the building to cover a concrete slab on grade picnic area adjacent to the building. The roof appears to have been redone in the last couple of years and a patch completed in the tongue and groove sheathing. The building itself consists of two single occupant toilet rooms. Each restroom has a louvered opening on two sides to allow natural ventilation. Restroom fixtures are ceramic. The fixtures have been carefully winterized with the traps blown out and the Sloan valves disassembled.

The masonry walls are structurally in good condition but need to be repainted with a graffiti resistant material. The underside of the roof in the pavillion needs to be repainted. The paint on the steel frame supports is deteriorating in a few areas, causing the supports to rust. The spot rust needs to be removed from the steel and repainted with a graffiti resistant paint. The concrete pad at the picnic area is in acceptable shape. The joints should be sealed with a polyurethane sealer. Exterior lighting should be replaced with LED fixtures. The plastic coated steel picnic tables are in decent condition, however, rust removal and painting is required. The interior floor in both bathrooms needs to be sealed.
