**CITY OF YPSILANTI  
CITY COUNCIL SPECIAL MEETING  
APRIL 12, 2022 @ 7:00 PM  
COUNCIL CHAMBERS - CITY HALL  
One South Huron, Ypsilanti, MI 48197  
[VIRTUAL ACCESS](#)**

## **Parks Bathrooms Discussion:**

The purpose of this report is evaluate the existing conditions at several park facilities, provide recommendations to make operational again, and provide an opinion of probable cost of the work required to correct the condition for the City's use in future planning efforts.

At the invitation of the City, representatives from OHM Advisors visited the City Park's restroom facilities, on various dates in August and September 2018, to observe the existing conditions; no architectural or structural drawings were available for these structures.

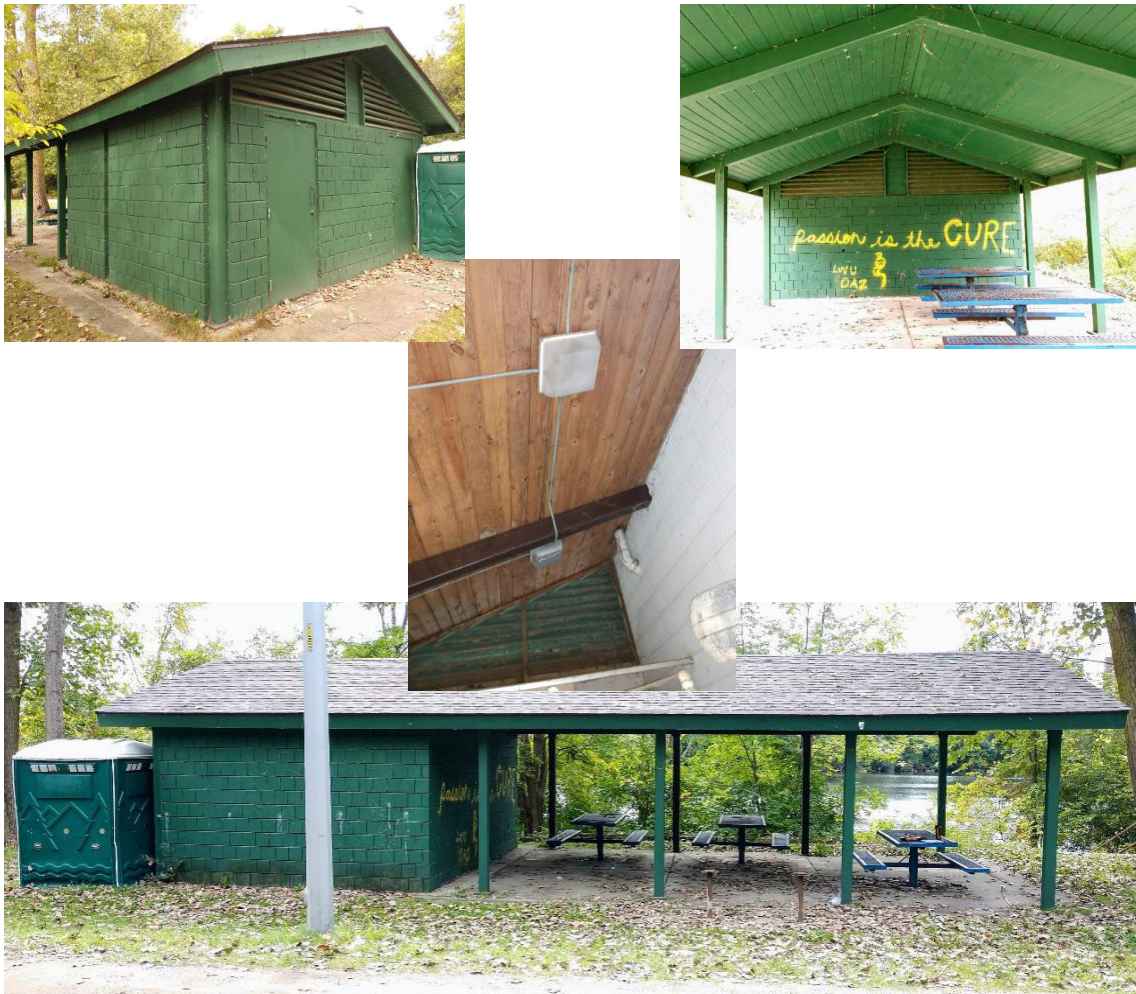
All restroom fixtures are antiquated, however, the plumbing and electrical infrastructure appears to be in good condition. The sloan valves, water supply lines, and fixtures should be replaced. It's possible that the ceramic fixtures could be reused and replumbed. The interior masonry walls are in good condition, but need to be repainted and coated with a graffiti resistant material. The concrete floor slab in both of the bathrooms and storage room is in good condition but should be sealed. The original wood tongue and groove ceiling in the bathrooms needs to be painted.

Interior lighting should be replaced with LED fixtures. The electrical wiring needs to be assessed by an electrician, and the switches updated. The electrical panels need to be locking boxes.

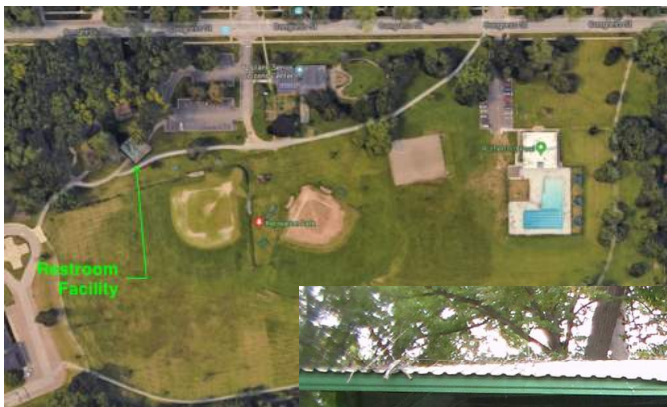
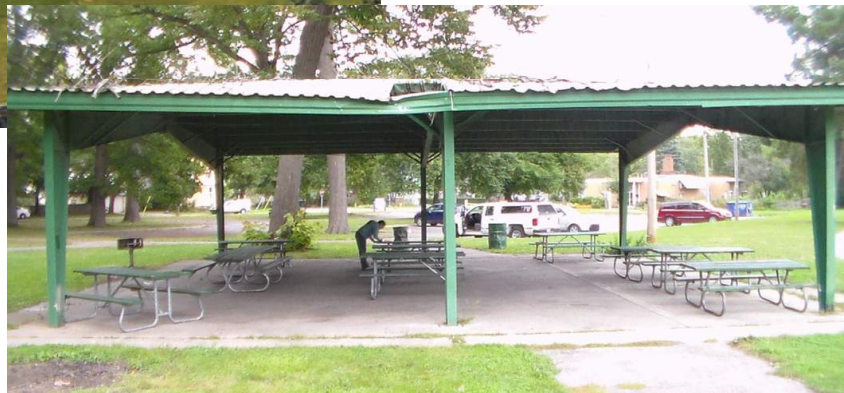
Recreation Park does not currently have a restroom building. The existing covered picnic area is constructed of a concrete floor slab, metal columns and beams, and a metal roof. The roof has been damaged, likely by a tree. The roof covers a concrete slab on grade with picnic tables. It appears there used to be a building, based on evidence on the concrete slab. There are signs of walls that were removed, and utilities coming up through the floor. It looks as if there were two single occupant toilet rooms on either side of a storage or utility area. At this time all that remains are the floor drains (3), the toilet drops (4), the sink drops inside walls (2), and what is likely a sanitary clean out headed for Congress Street.

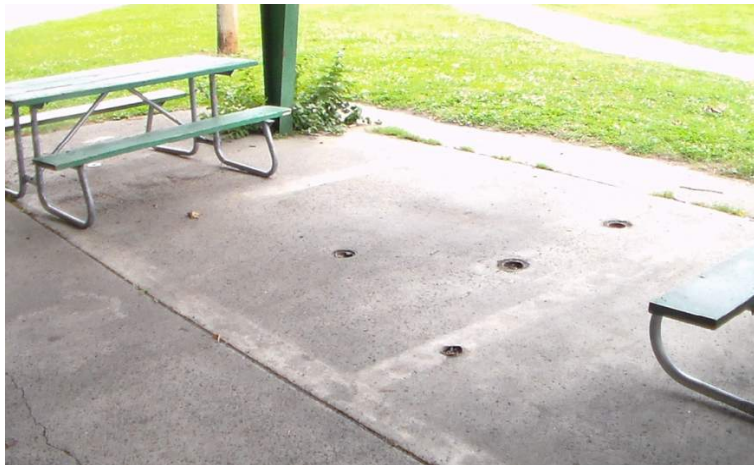
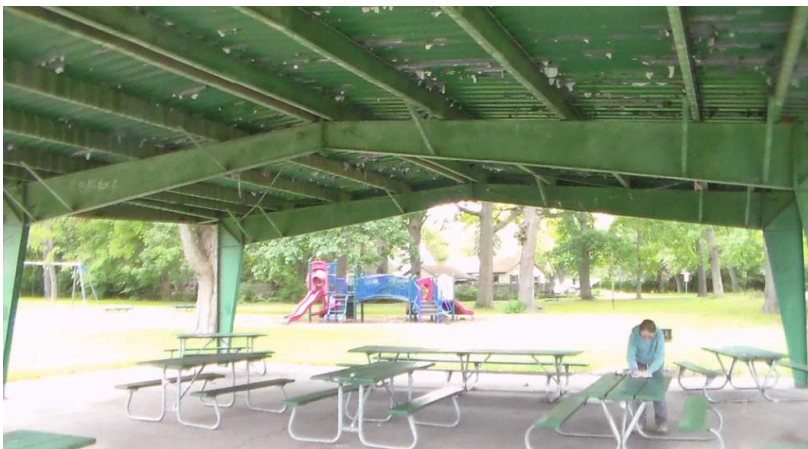
The paint on the roof (top and bottom), columns, and beams is flaking and rust is beginning to damage the steel. There are holes caused by rust at the base of the columns. The roof appears to have been damaged by a tree. Two roof support beams, four roof panels, and one angle support have been damaged. The rust needs to be removed from the steel, the holes will have to be soldered with plates, and the structure needs

It is recommended that this site have a prefabricated bathroom unit installed. It will need the sanitary line cleaned and televised, and the sanitary relocated to the new buidling pad. The water service will need to be located and installed into the building pad, and ADA access provided. The prefabricated building could be located next to the existing structure, as it likely could not be installed within the structure. The drains in the current structure should be abandoned, or removed if a new slab is poured in those areas.
