# AGENDA

## Historic District Commission Meeting

7:00 PM - Tuesday, August 22, 2023

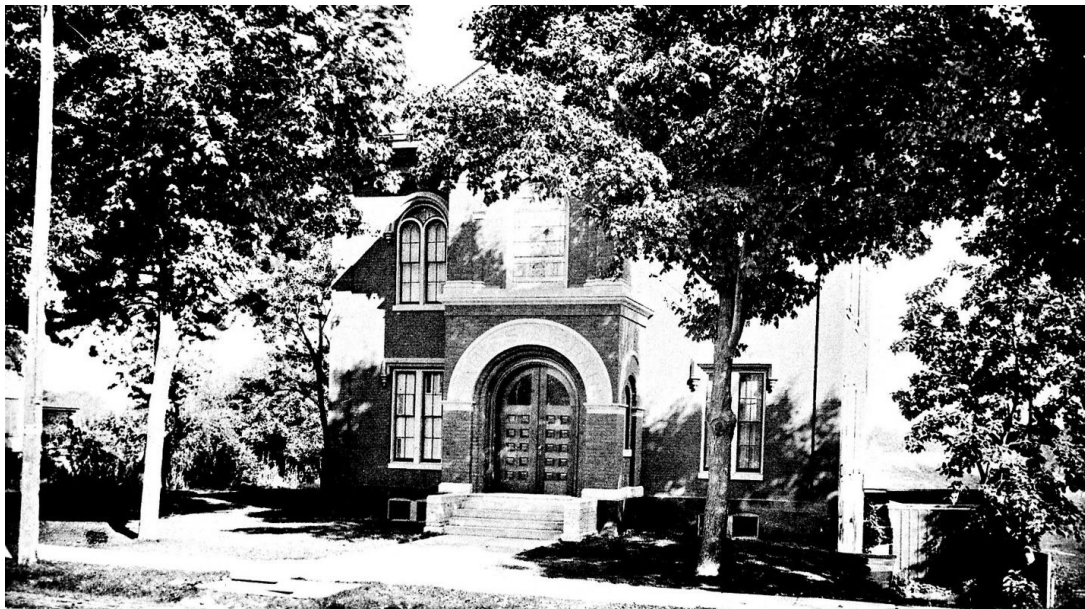
Undated image from a negative in the Ypsilanti Historical Society's photo archives. Shrubs are visible to the north and a carriage barn or garage appears to be visible to the south.

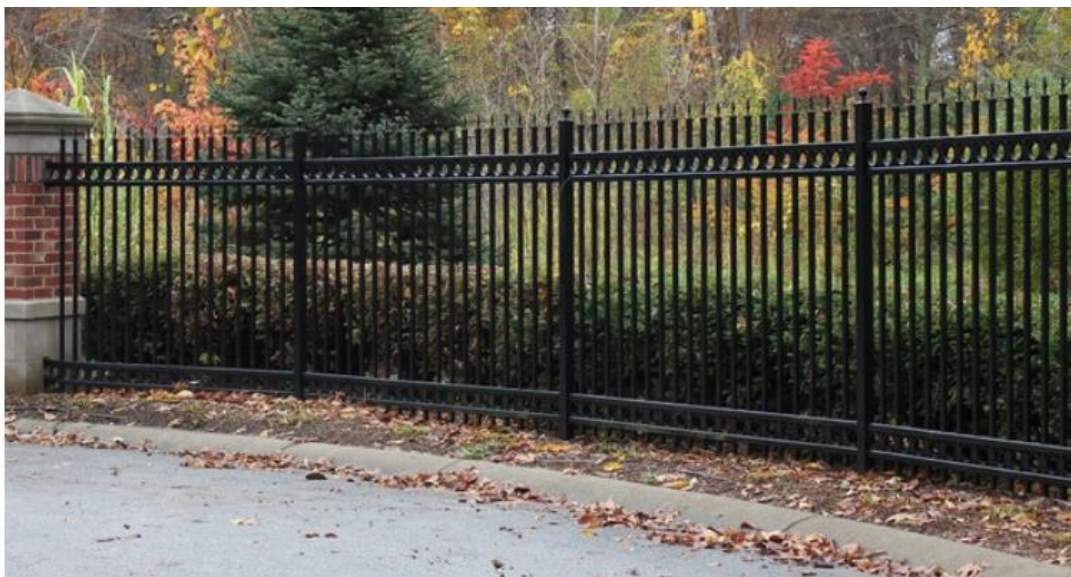
Similar fence shown on Alumi-Guard's website.

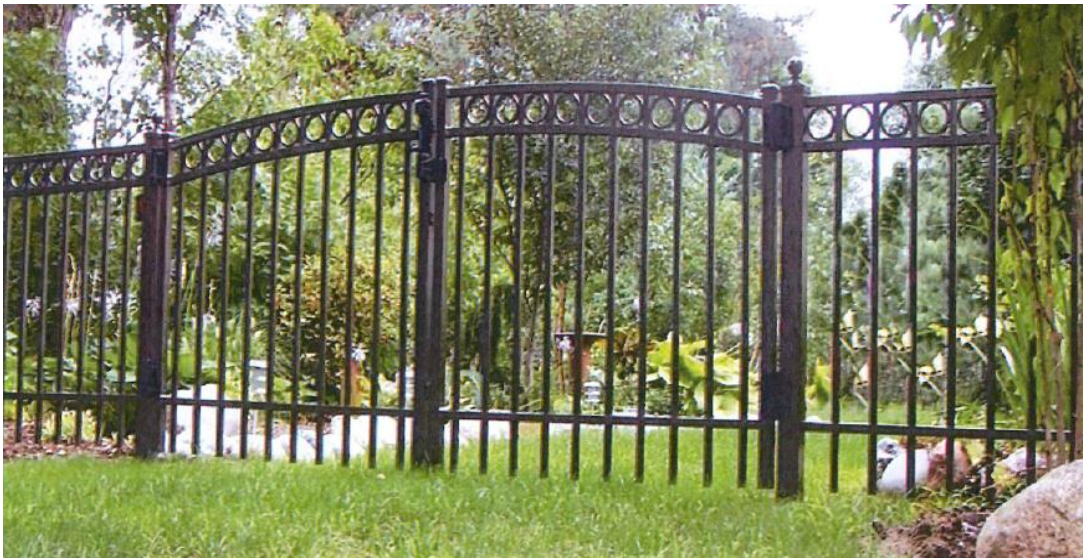
Sample gate #1 included in the applicant's zoning review permit application.

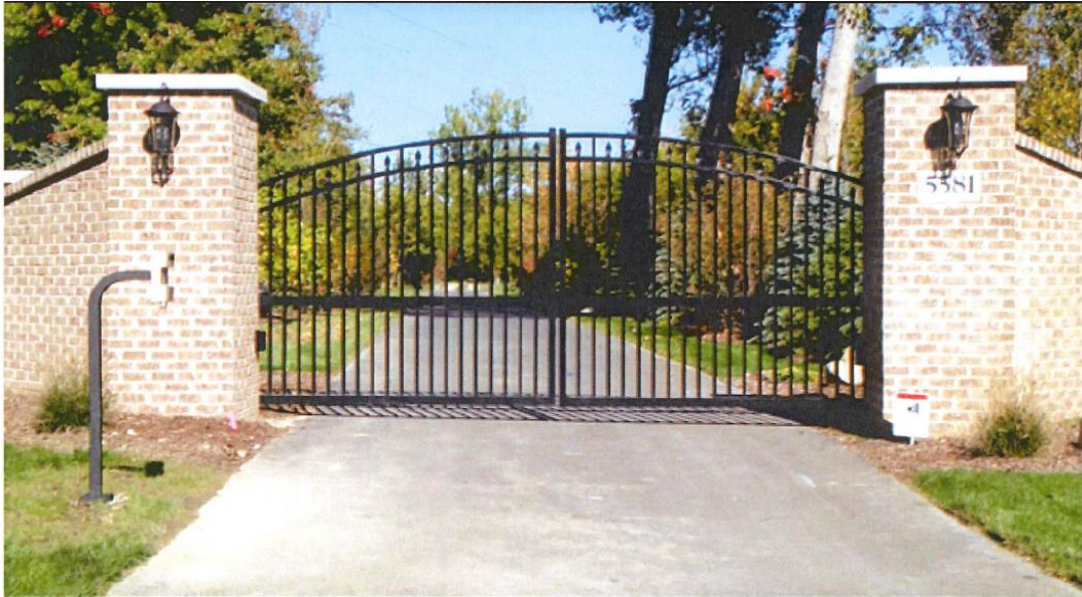
Sample gate #2 included in the applicant's zoning review permit application. Bricks were not mentioned on either the HDC or zoning review applications.

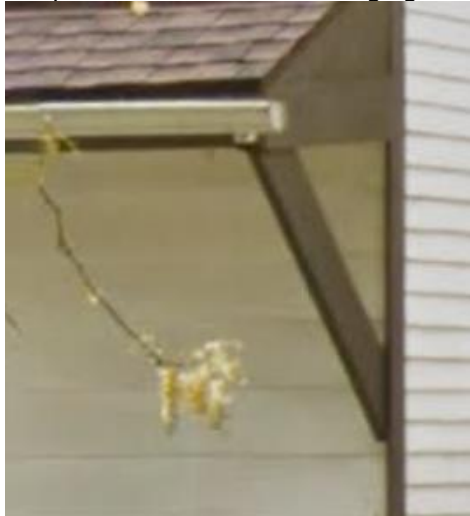
3. Repairing the downspout at the northeast corner: currently, the stubby beginning of a downspout is in place near the northeast corner of the house, close to the angled wood brace that helps to support the porch roof. The proposal is to add to that downspout to make it functional and carry water away from the house. However, having a downspout come straight down in front of the angled brace, a couple feet in front of the northeast corner of the house likely does not comply with the Fact Sheet's directive to have them as inconspicuous as possible and at the corner of the structure. Comparing Google streetviews over time tells the story of the porch roof and this northeast corner of the house.

In August 2011 and October 2014, the house's porch roof had neither a wood brace for support, nor a gutter or downspout. By August 2016, the angled wood brace was added but no gutter or downspout. By July 2019, the K-style gutter was added but there is no downspout installed, and the stub as the beginning of the downspout is barely visible in front of the wood brace (picture below). In 2020 and 2021, the stub of a downspout remains in place, and is there today. Staff needs to determine if this gutter and downspout work was done properly with permits. Staff maintains that having the downspout come down a couple feet in front of the actual house and without attaching the downspout to the house for stability seems like it would not work well or be compliant with the district's design guidelines as explained in the Fact Sheets.

307 N Hamilton, east (front) elevation where downspout near the northeast corner will be extended and it would be best if downspout gutter could be secured against the house instead of loosely hanging straight down from the gutter. The north chimney is barely visible just behind the north side bay window, and that chimney is proposed to be taken down to the roofline and covered over with roofing shingles.

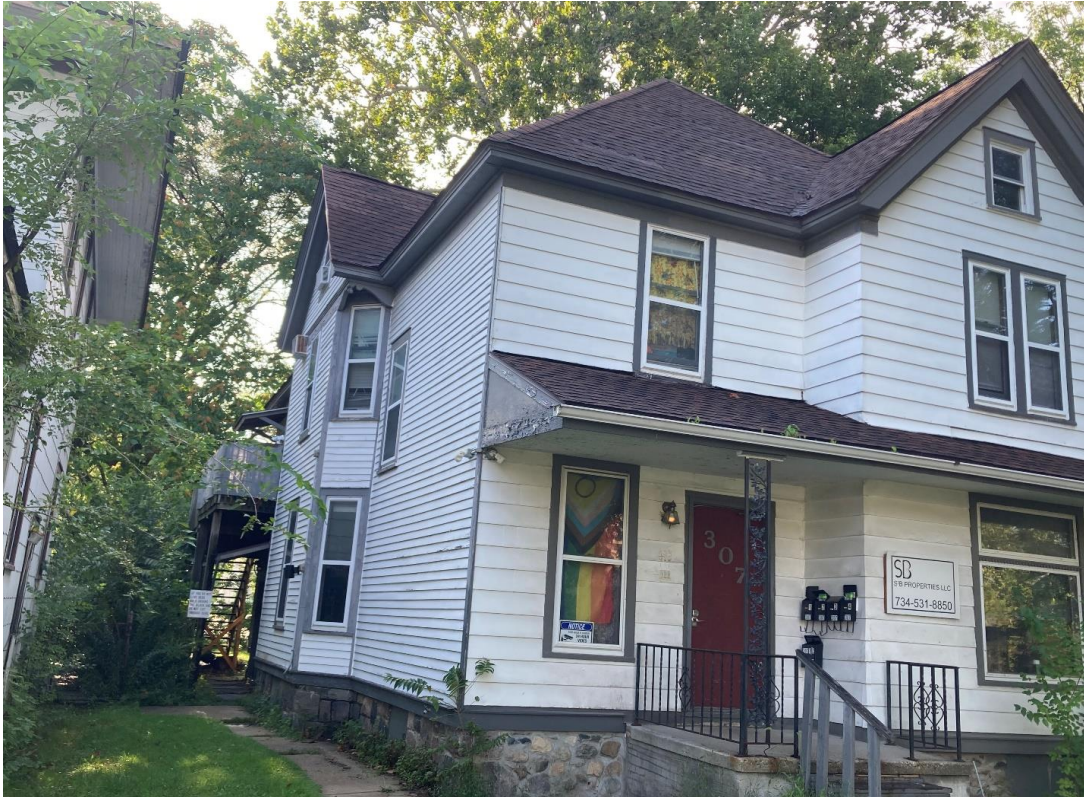
307 N Hamilton, August 2023, south side where gutter and downspout will be added.

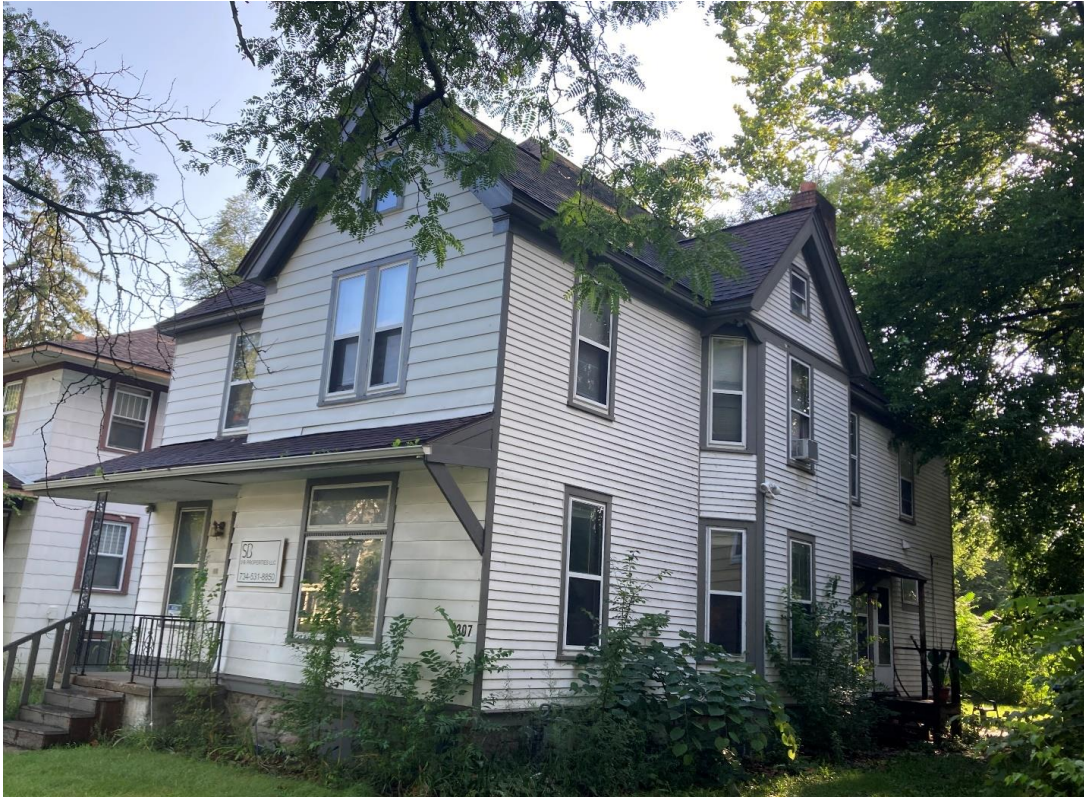
307 N Hamilton, August 2023, north side showing north chimney and the spot where the downspout near the northeast corner will be extended.

4. Chimney: removing the north chimney above the roofline. Staff finds that the north chimney is not very visible from the sidewalk and is not a character-defining feature. Staff finds that removing it above the roofline and capping off the opening that remains with asphalt roof shingles meets the Secretary of the Interior's Standard for Rehabilitation #9 because the exterior alteration will not destroy historic materials or features that characterize the property.

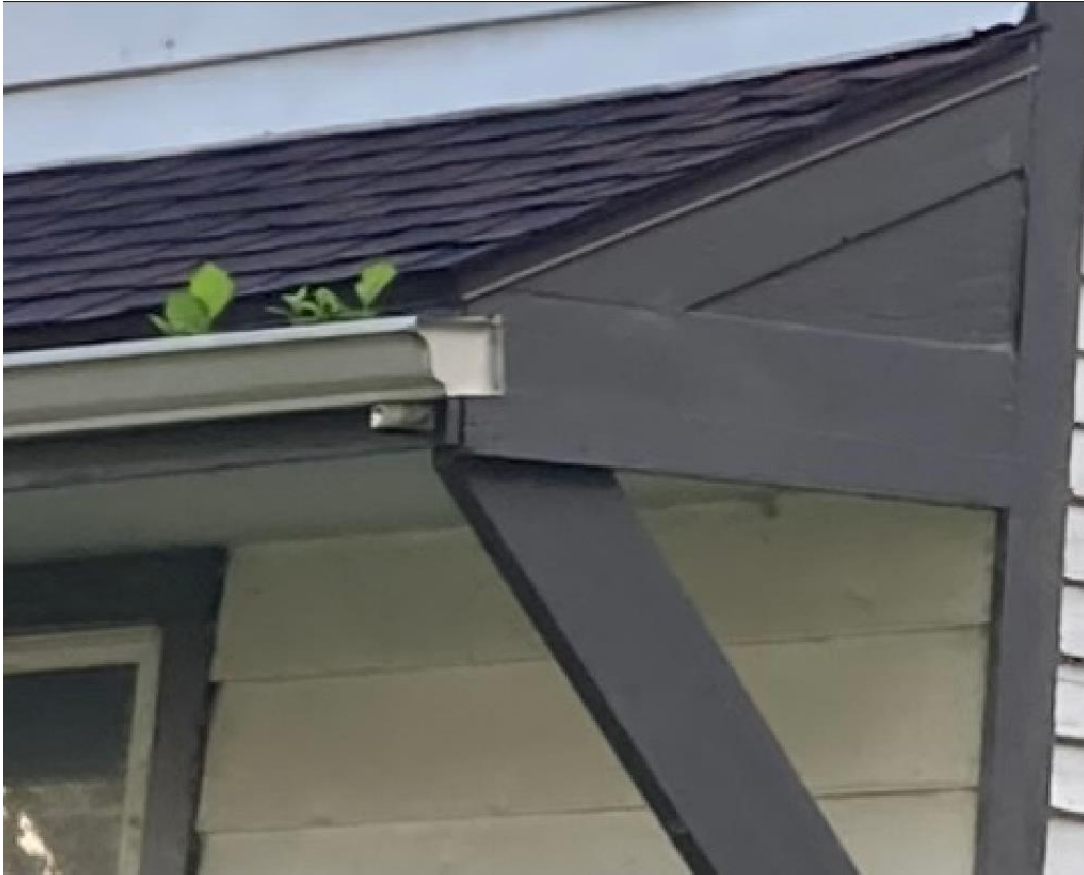
August 2023 staff detail photo of gutter, downspout stub, and wood porch roof support at 307 N Hamilton. Having the downspout hang straight down without attaching it to the house for support seems to staff like that will likely not function well or be in compliance with the design guidelines.

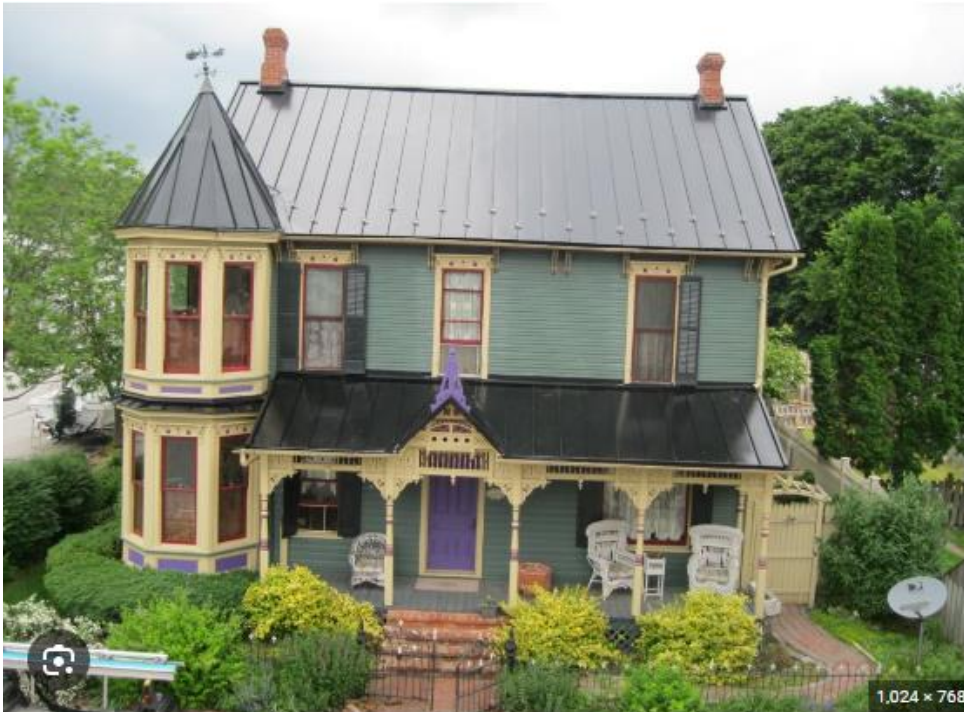
Figure 6. Photo came up with Google image search on "Queen Anne with standing seam metal roof." Staff thinks this looks like a more rural example of a Queen Anne.

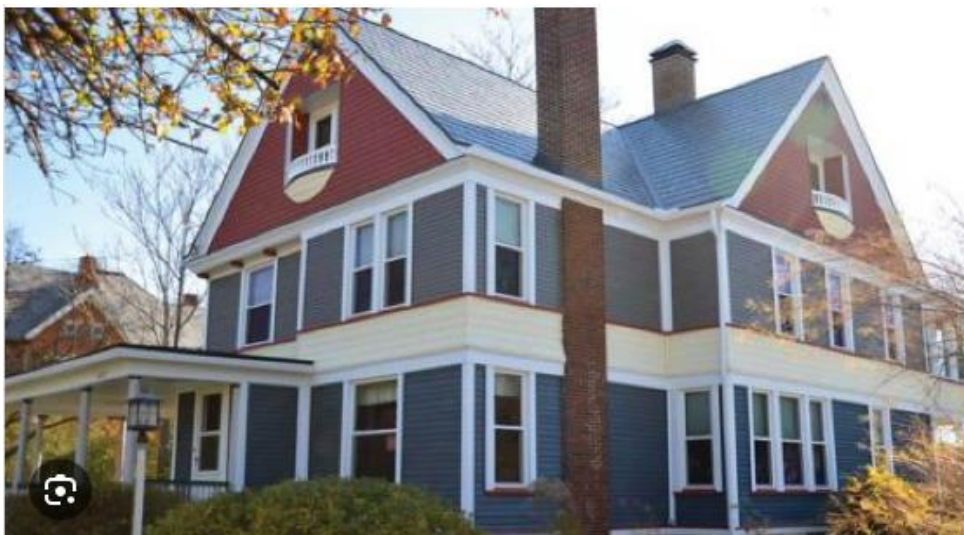
Figure 7. Photo came up with Google image search as above. This metal roof appears to be made up of shingles so it still lends this house some texture but it also is made of metal.

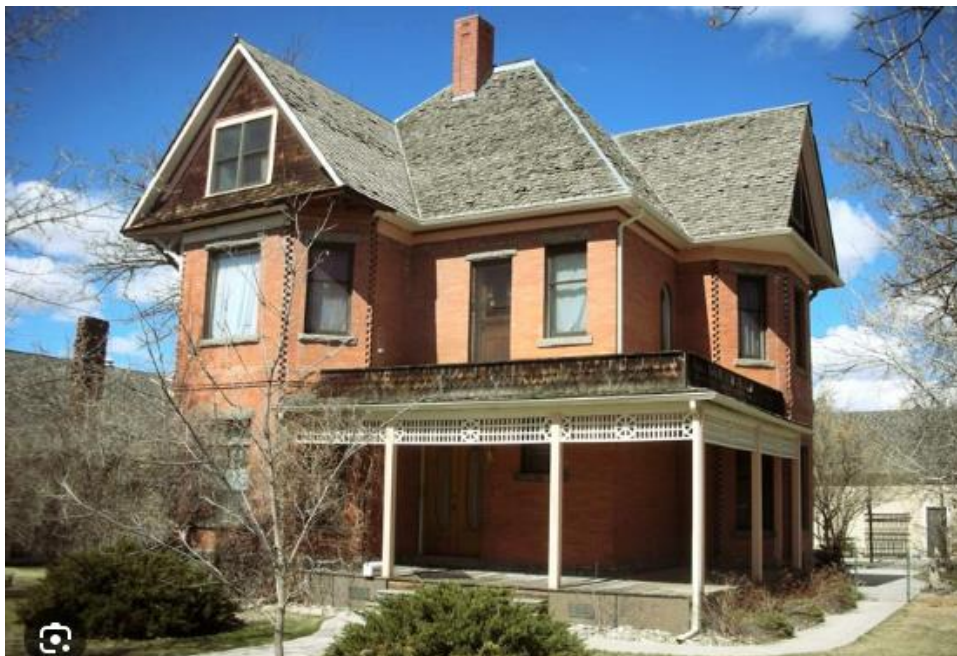
Figure 9. Photo from the image search as above. Queen Anne with an old shingle roof. Roof is in poor condition but the texture shingles provide complements the house's Queen Anne details.

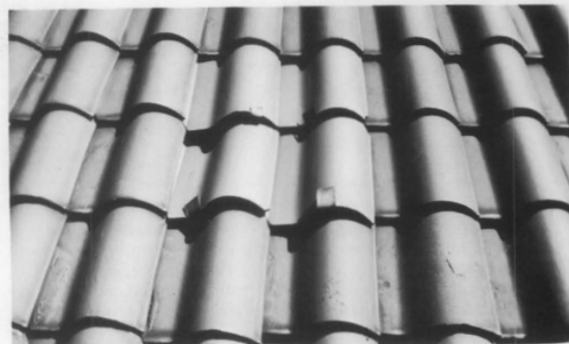
*Repairs on this pantile roof were made with new tiles held in place with metal hangers. (Main Building, Ellis Island, New York)*

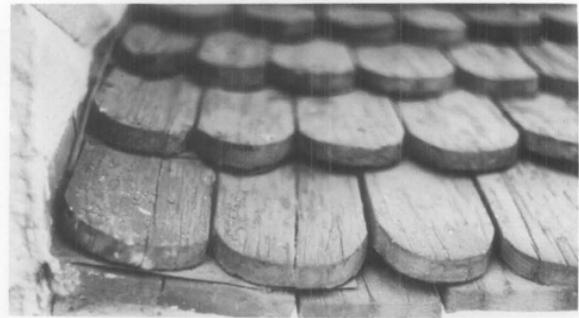
*Replacement of particular historic details is important to the individual historic character of a roof, such as the treatment at the eaves of this rounded butt wood shingle roof. Also note that the surface of the roof was carefully sloped to drain water away from the side of the dormer. In the restoration, this function was augmented with the addition of carefully concealed modern metal flashing. (Mount Vernon, Virginia)*

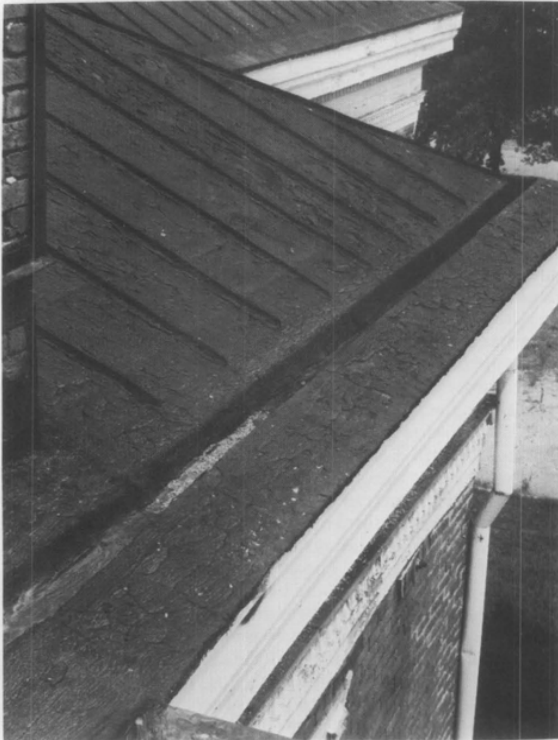
Repeated repair with asphalt, which cracks as it hardens, has created a blistered surface on this sheet-metal roof and built-in gutter, which will retain water. Repairs could be made by carefully heating and scraping the surface clean, repairing the holes in the metal with a flexible mastic compound or a metal patch, and coating the surface with a fibre paint. (Roane County Courthouse, Kingston, Tennessee, photo courtesy of Building Conservation Technology, Inc.)

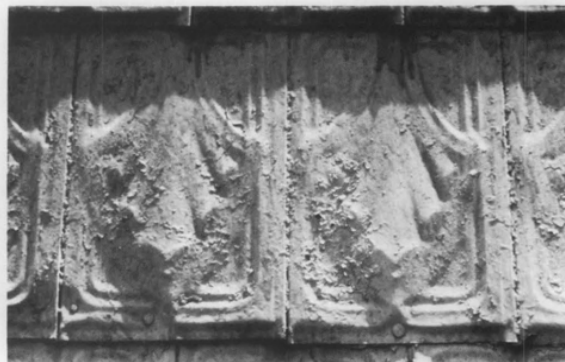
Tin shingles, commonly embossed to imitate wood or tile, or with a decorative design, were popular as an inexpensive, textured roofing material. These shingles  $8\frac{3}{8}$  inch by  $12\frac{1}{2}$  inch on the exposed surface were designed with interlocking edges, but they have been repaired by surface nailing, which may cause future leakage. (Ballard House, Yorktown, Virginia, photo by Gordie Whittington, National Park Service)

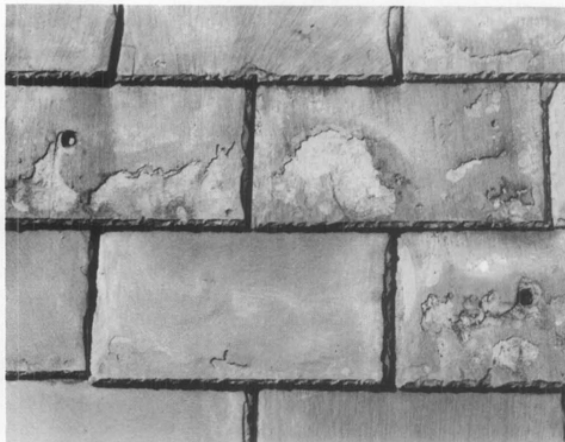
*This detail shows slate delamination caused by a combination of weathering and pollution. In addition, the slates have eroded around the repair nails, incorrectly placed in the exposed surface of the slates. (Lower Pontalba Building, New Orleans, photo courtesy of Building Conservation Technology, Inc.)*

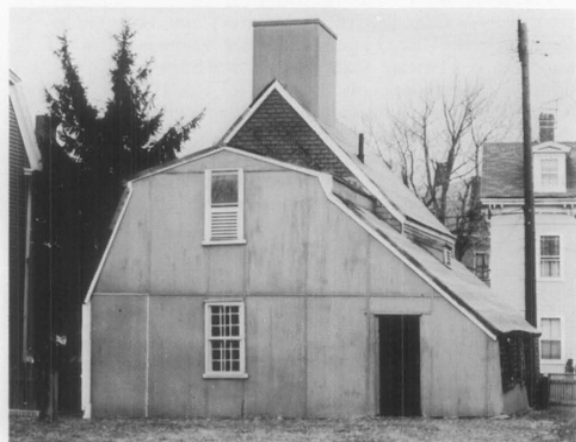
*Temporary stabilization or "mothballing" with materials such as plywood and building paper can protect the roof of a project until it can be properly repaired or replaced. (Narbonne House, Salem, Massachusetts)*

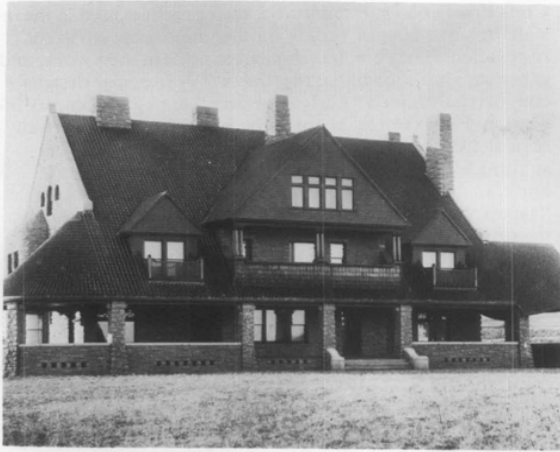
*These two views of the same house demonstrate how the use of a substitute material can drastically affect the overall character of a structure. The textural interest of the original tile roof was lost with the use of asphalt shingles. Recent preservation efforts are replacing the tile roof. (Frank House, Kearney, Nebraska, photo courtesy of the Nebraska State Historical Society, Lincoln, Nebraska)*

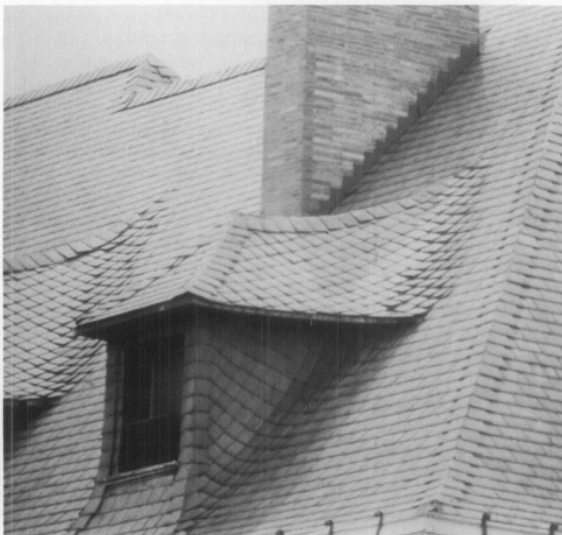
*Because of the roof's visibility, the slate detailing around the dormers is important to the character of this structure. Note how the slates swirl from a horizontal pattern on the main roof to a diamond pattern on the dormer roofs and side walls. (18th and Que Streets, NW, Washington, D.C.)*

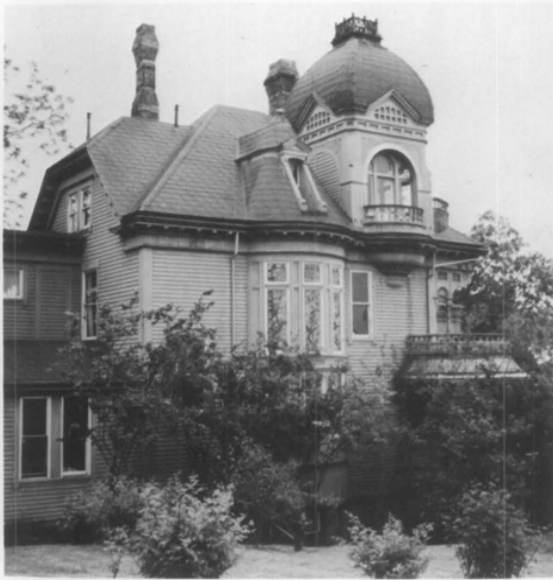
*Special problems inherent in the design of an elaborate historic roof can be controlled through the use of good materials and regular maintenance. The shape and detailing are essential elements of the building's historic character, and should not be modified, despite the use of alternative surface materials. (Gamwell House, Bellingham, Washington)*

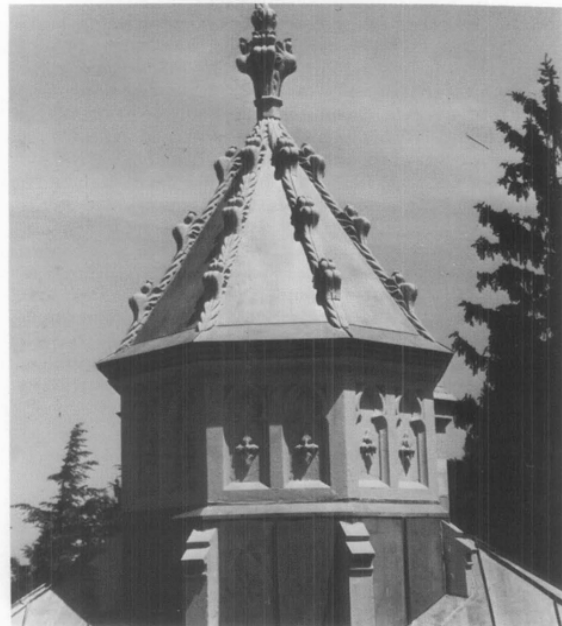
Decorative features such as cupolas require extra maintenance. The flashing is carefully detailed to promote run-off, and the wooden ribbing must be kept well-painted. This roof surface, which was originally tin plate, has been replaced with lead-coated copper for maintenance purposes. (Lyndhurst, Tarrytown, New York, photo courtesy of the National Trust for Historic Preservation)

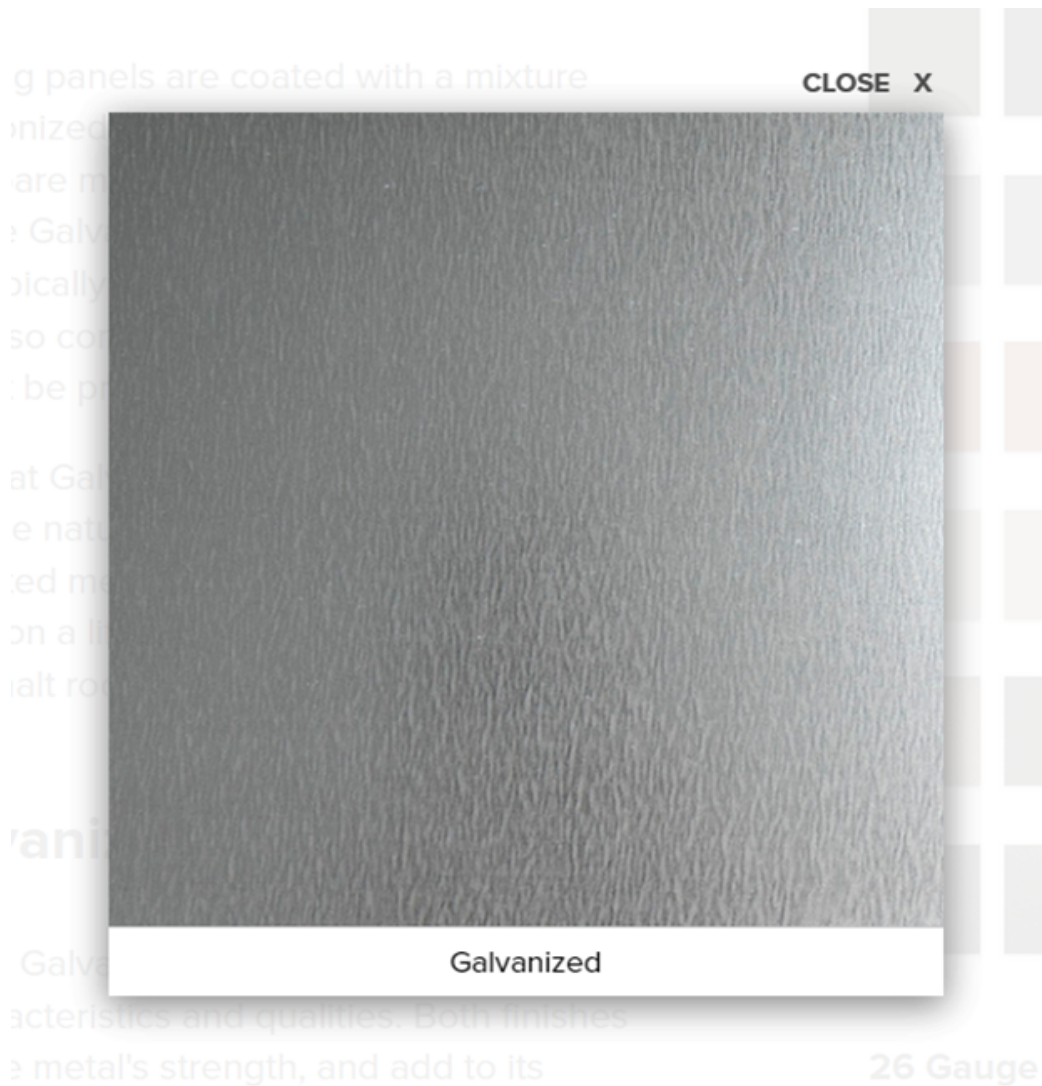
Bridger Steel (<https://www.bridgersteel.com/metal-colors/galvalume> ) Shows a Color called "Galvanized." It looks like this on their website:

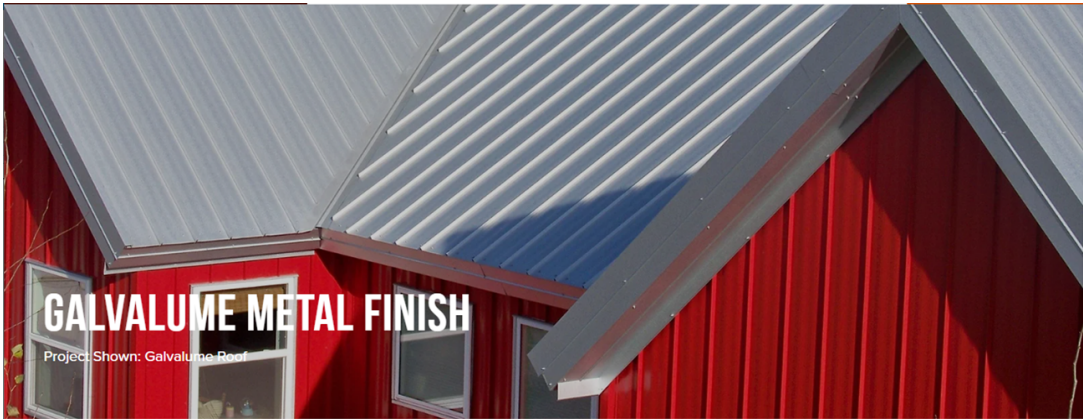
A sample standing seam roof they show is:

Galvalume is a coated metal product used for commercial, agricultural and residential applications to emulate galvanized steel. Galvalume metal has a matte finish that lends itself to industrial, modern, and rustic projects that require a little more subtlety than traditional, shiny, or spangled galvanized metal panels. Use Galvalume metal for sophisticated accents on office buildings, rustic and modern homes, or in industrial style restaurants.

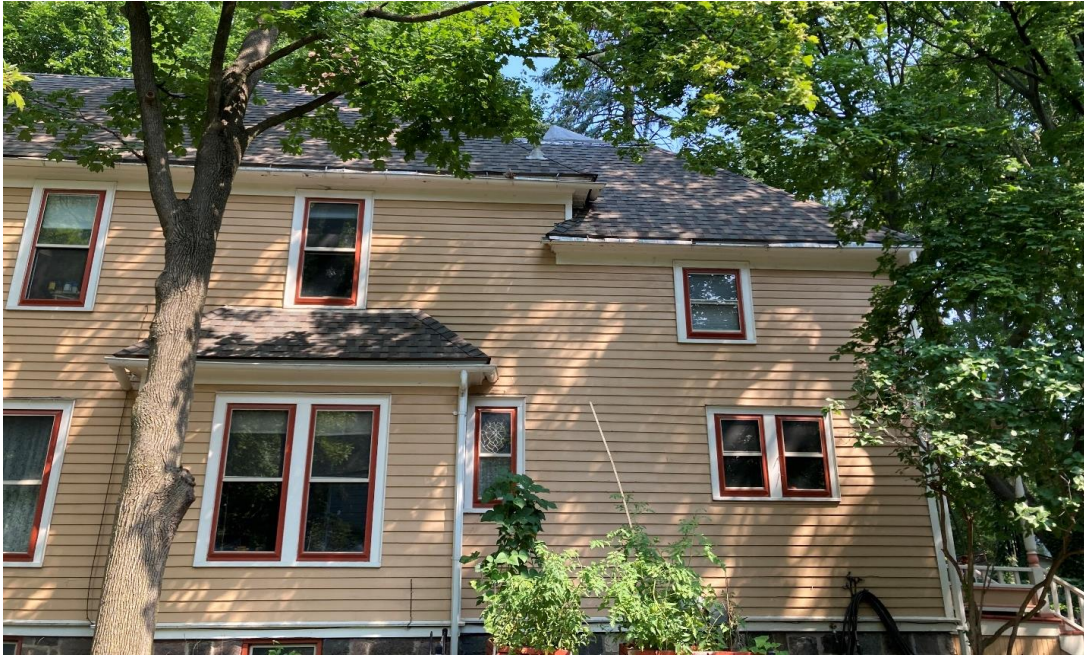
316 N Grove, August 2023, south side of house. Second-floor flat roof shown just to the right/east of the roofed first-floor windows, and the skylight installation is visible on the flat roof.

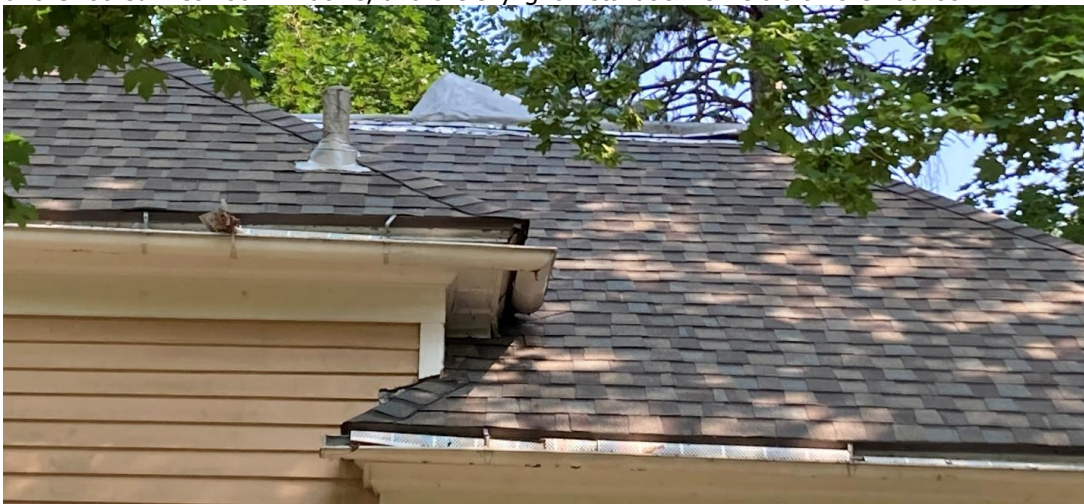
316 N Grove, August 2023, south side of house, detail of second-floor flat roof and the skylight installation.
