1. Planning Commission Regular Meeting Agenda

**Agenda  
Planning Commission  
Council Chambers  
Wednesday, 15 March 2017 – 7:00 P.M.**

- 539 S Huron St.  
*Site Plan Review*

AKT Peerless prepared this Baseline Environmental Assessment (BEA) for the property located at 539 S. Huron Street, Ypsilanti, Washtenaw County, Michigan (the subject property). AKT Peerless' scope of work was based on (1) Section 20126(1)(c) of Part 201 of the Natural Resources and Environmental Protection Act (NREPA), Michigan Public Act 451, 1994, as amended, and (2) AKT Peerless' proposal PF-20085, dated November 17, 2016, and the terms and conditions of that agreement.

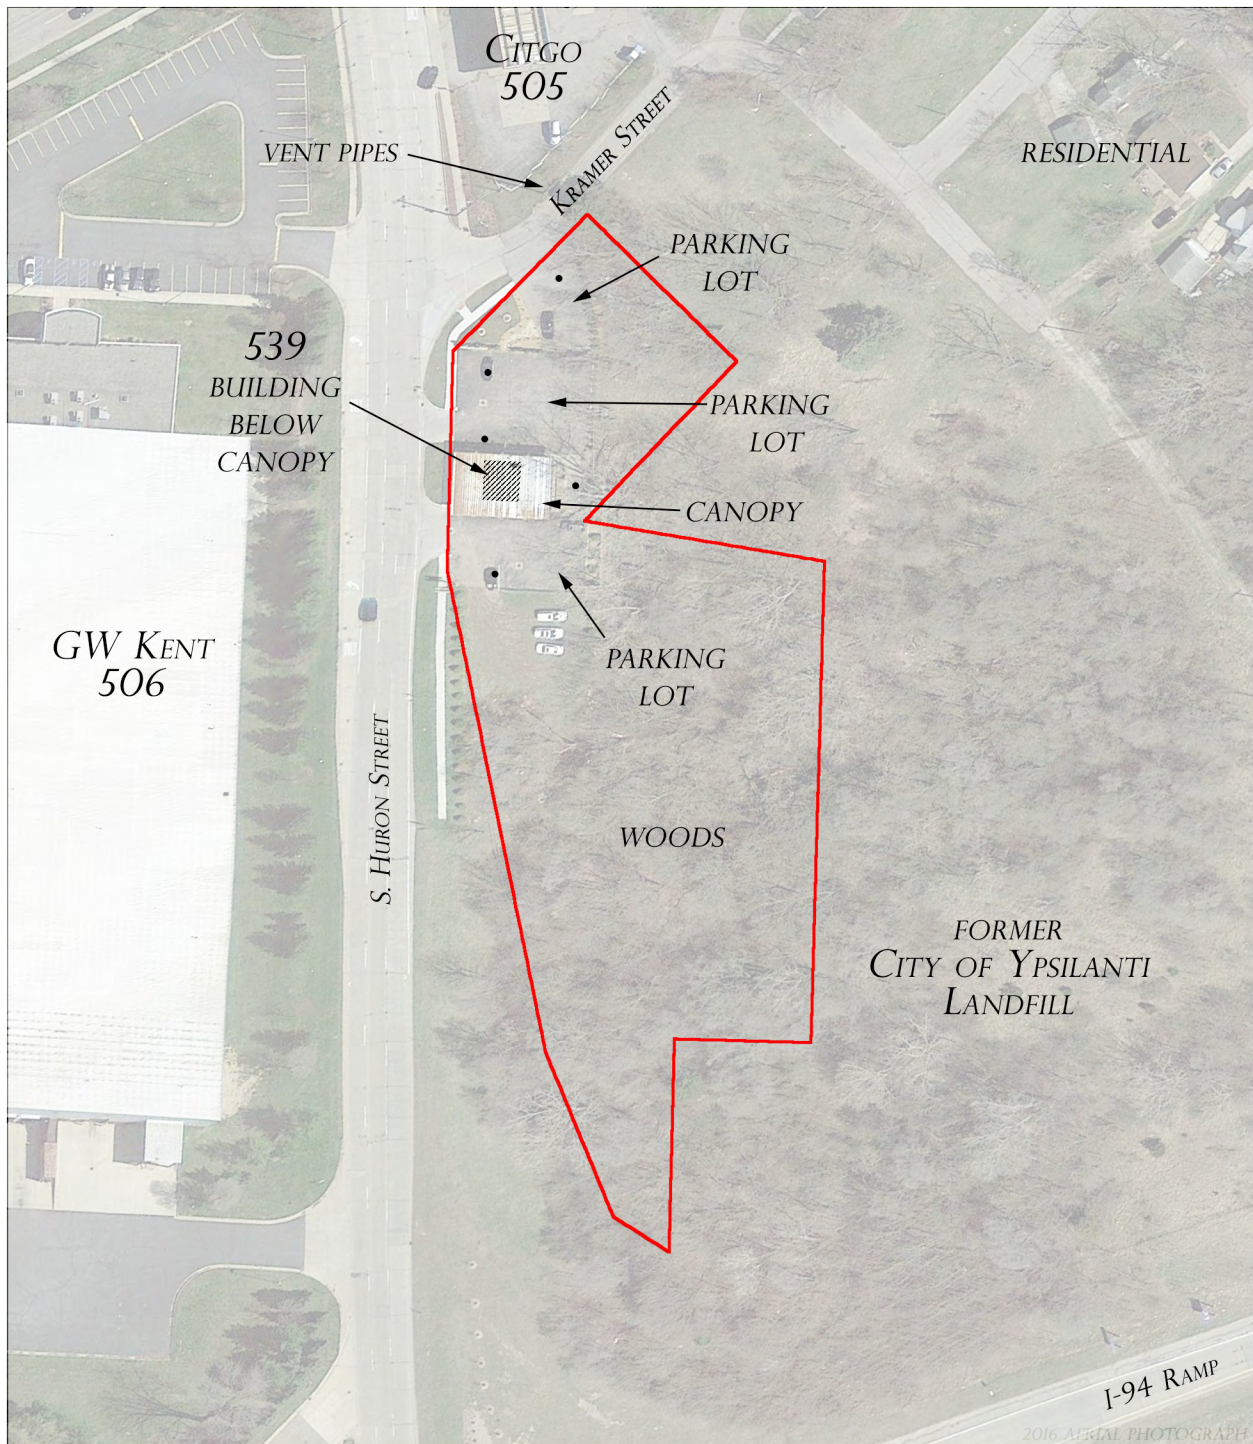
### **Site Sketch**

- APPROXIMATE PROPERTY BOUNDARY
- "AMOCO TEST WELL" MONITORING WELL

- REC 1** - Based on historic sources reviewed, the northern portion of the property was previously used as a gasoline station. The 1950 and 1964 fire insurance maps depict three underground storage tanks (USTs) along S. Huron Street. No records were found regarding the removal of these USTs. Building department records indicate a new gasoline station was constructed in 1972 with five USTs north of the building, near Kramer Street. Five USTs were reportedly removed in 1986. No prior sampling and analyses-related documentation has been provided to McDowell & Associates, nor was it available in local building, assessing, and fire department records or the MDEQ. Five monitoring well covers labeled "Amoco Test Well" were observed in the parking lots during the site reconnaissance.

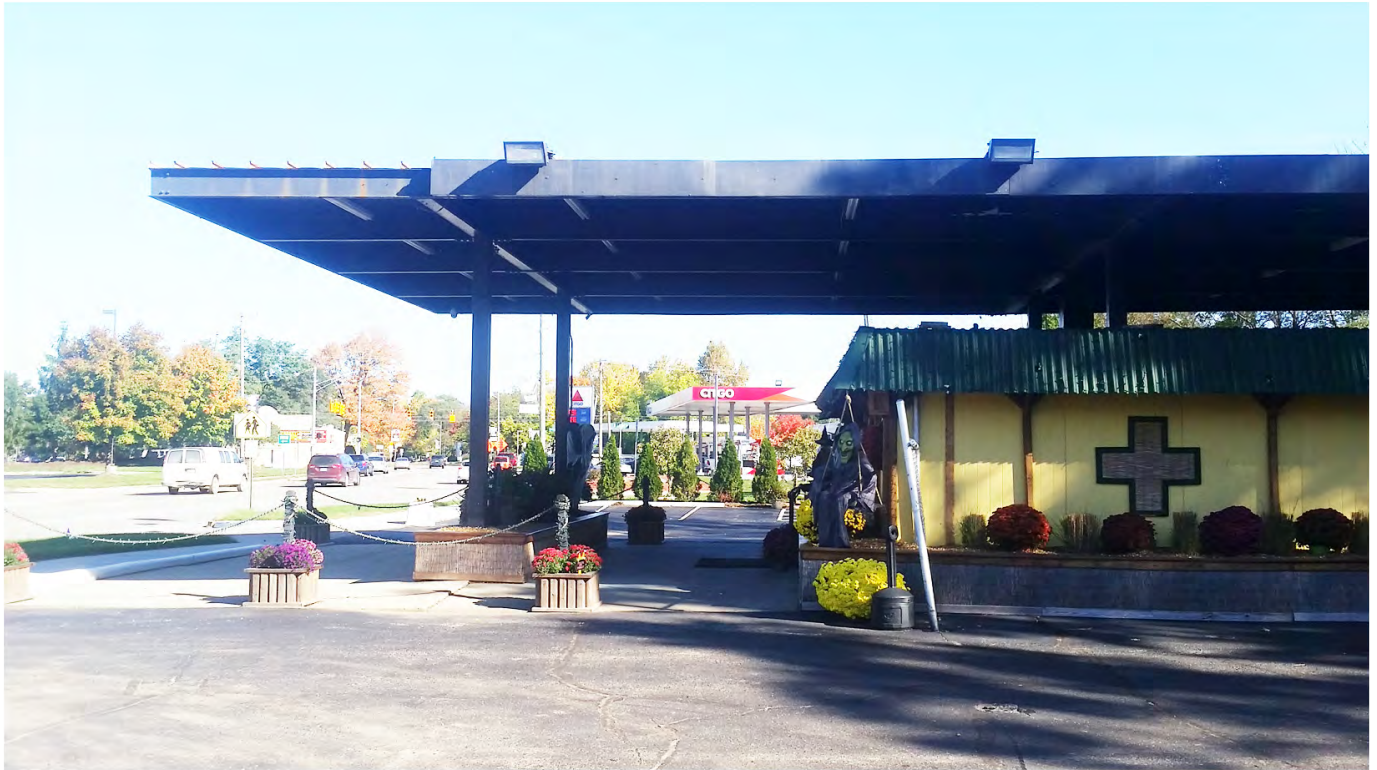
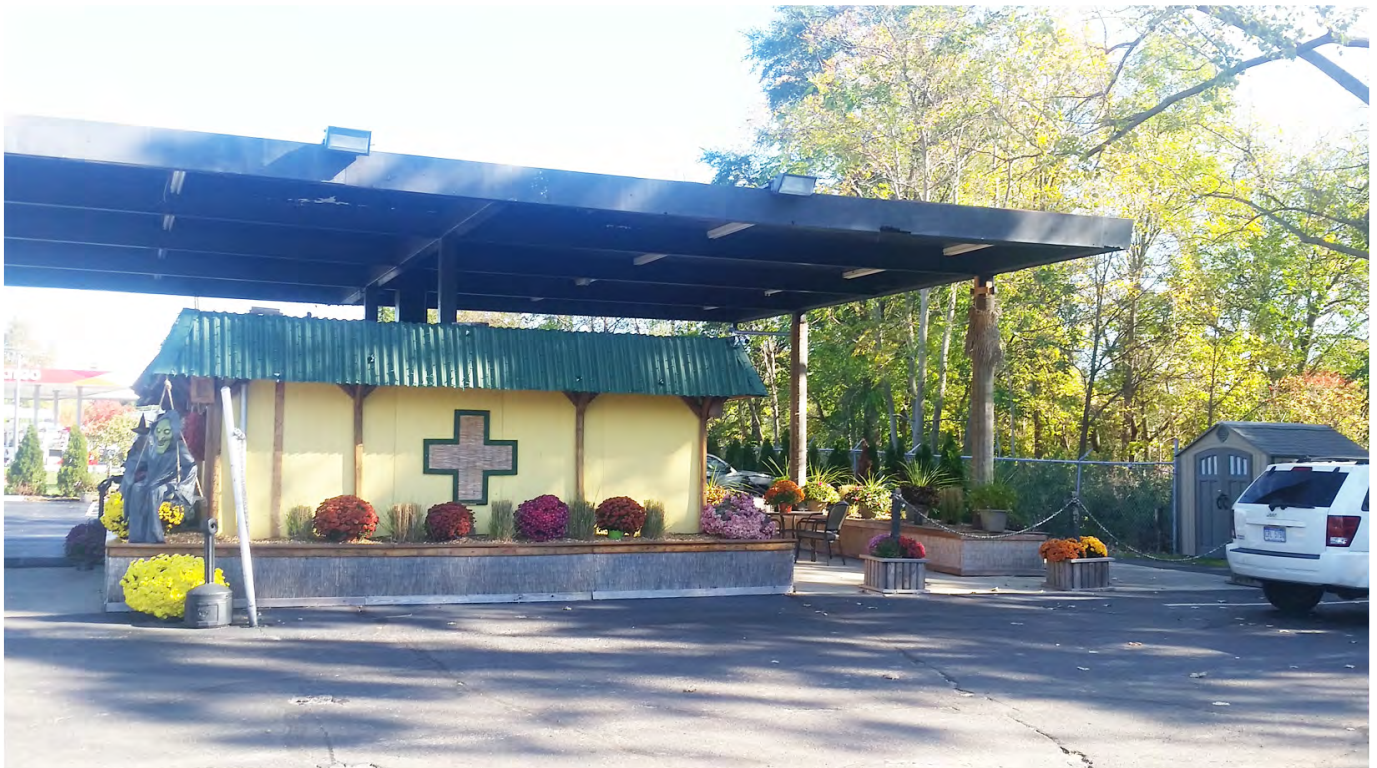
*9.-10. SOUTH SIDE OF BUILDING.*

- The existing building is planned for demolition. Prior to demolition, an Asbestos Survey should be conducted. If regulated asbestos-containing materials are identified, the materials should be removed by a licensed asbestos contractor prior to demolition.
- The northern adjoining property is an existing gasoline station with four currently-in-use USTs. While this site is listed as a “closed” leaking underground storage tank (LUST) site, an adjoining gasoline station located up gradient from the subject property is considered a potential environmental concern to the subject property.

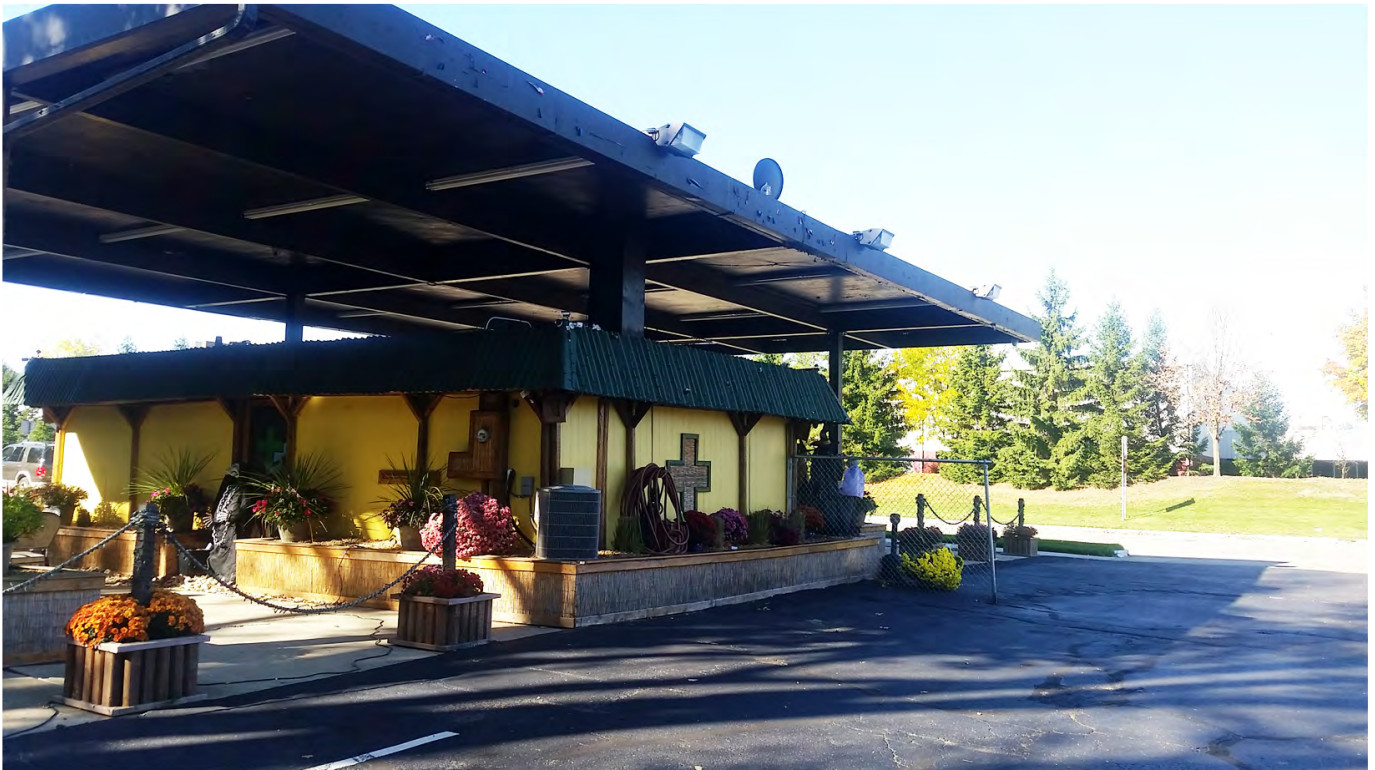
*11. NORTH AND EAST SIDES OF BUILDING.*

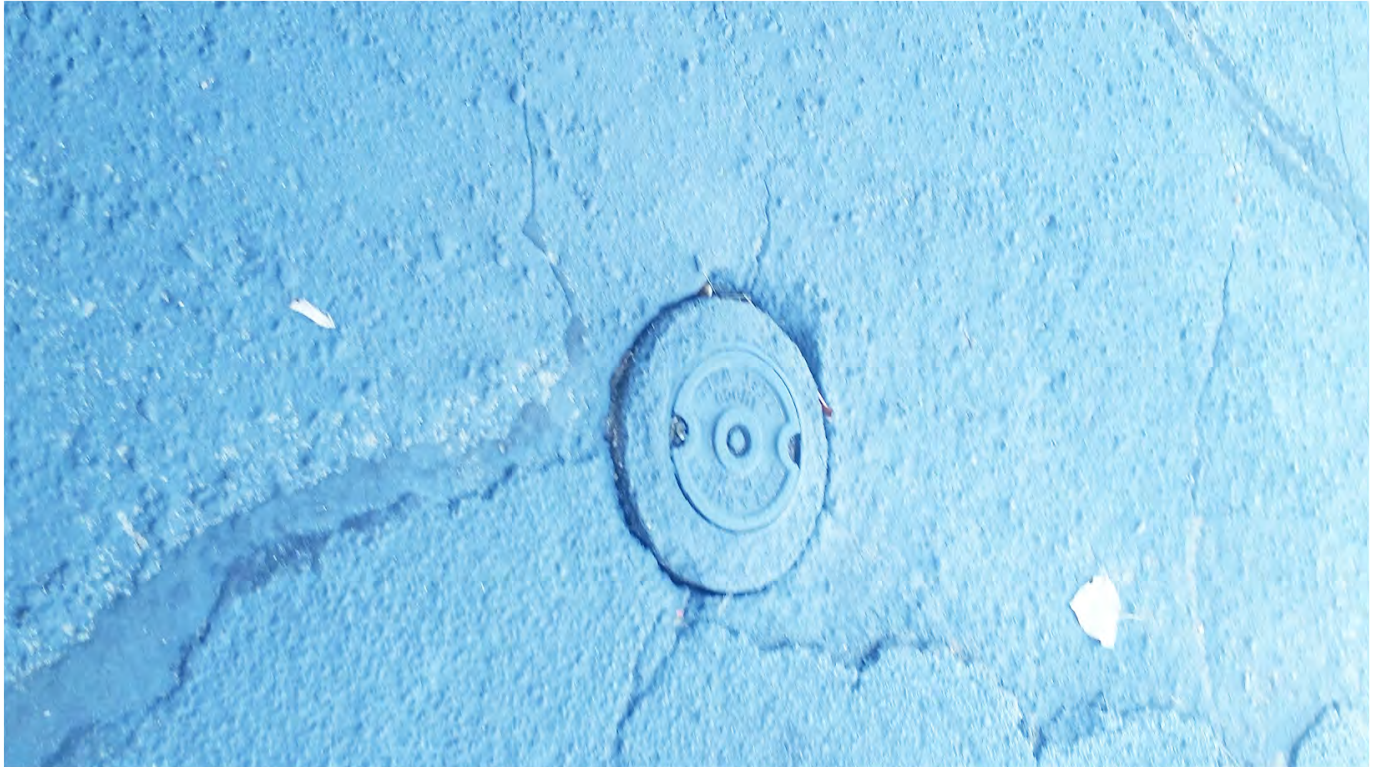
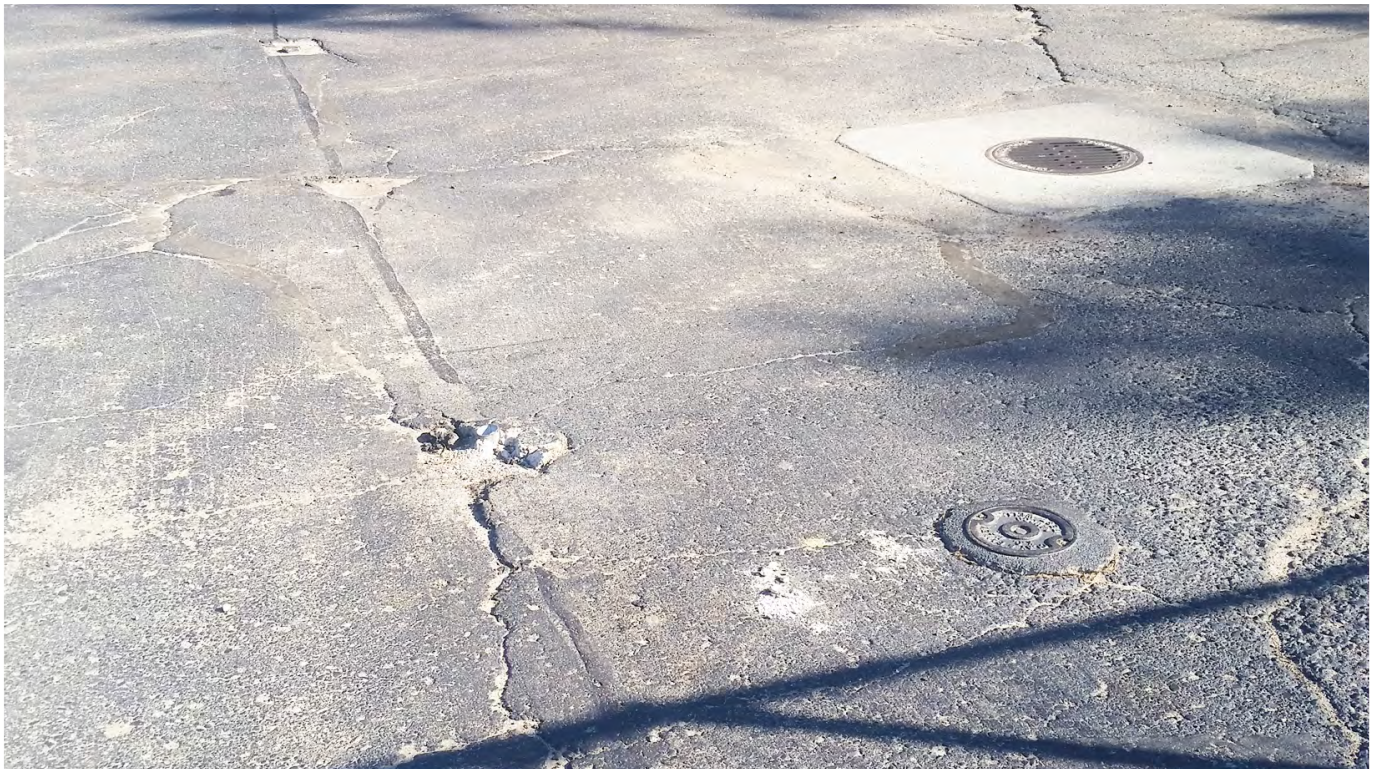
*13.-14. TYPICAL "AMOCO TEST WELL" COVERS.*

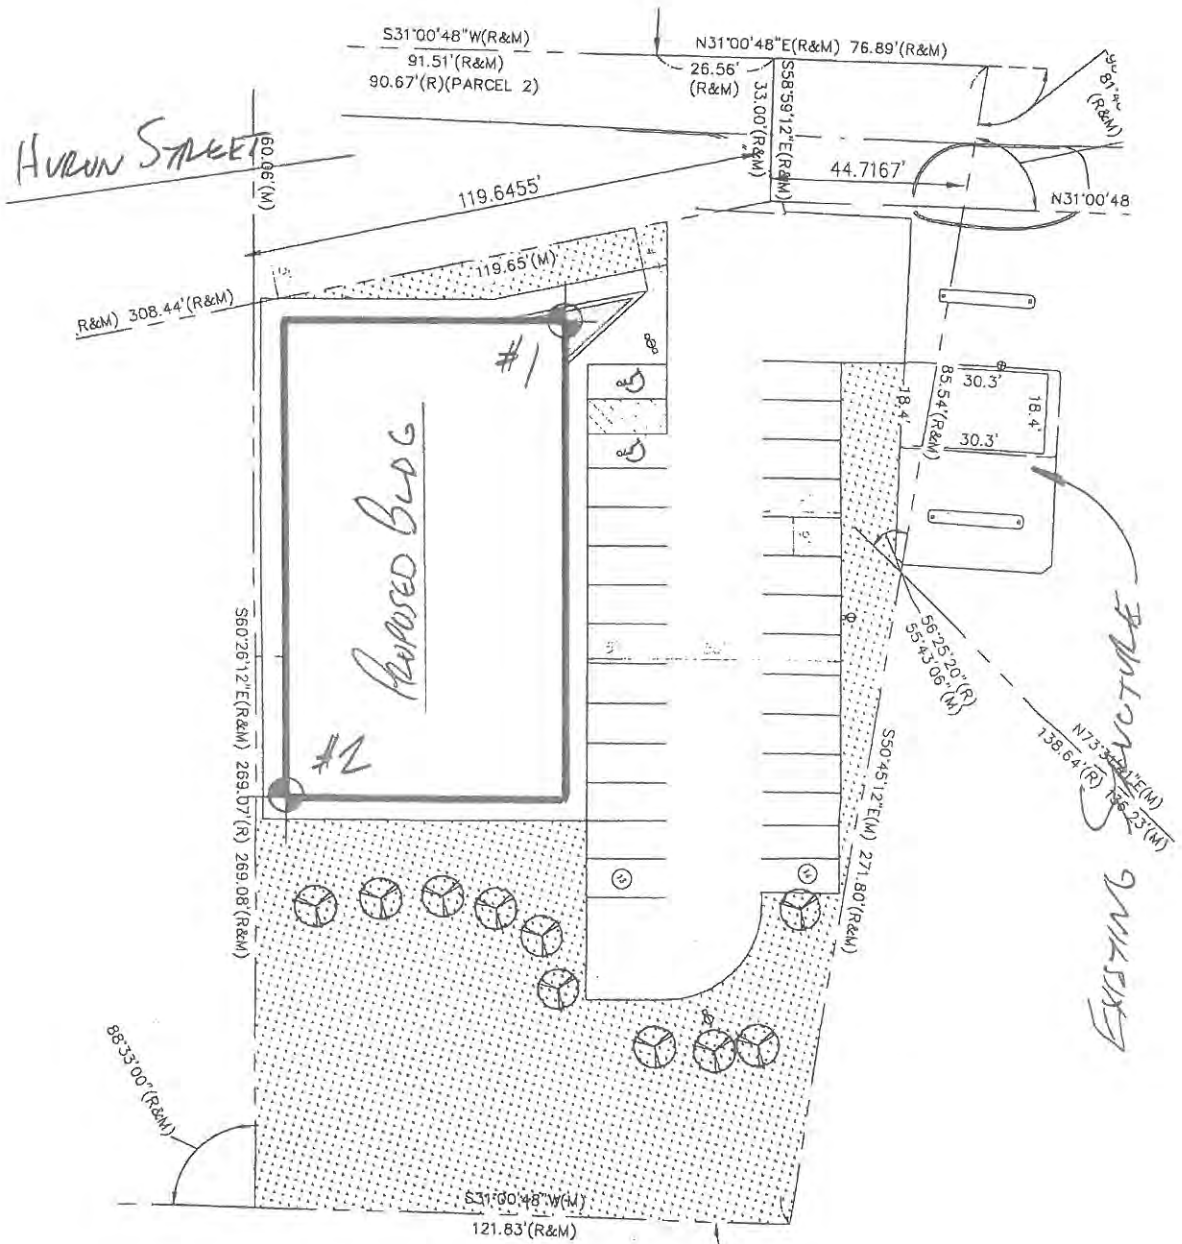
Soil Boring Location Plan

G.W. ENCOUNTERED AT 9 FT. 6 INS.  
G.W. ENCOUNTERED AT FT. INS.  
G.W. AFTER COMPLETION 10 FT. 0 INS.  
G.W. AFTER HRS. FT. INS.  
G.W. VOLUMES heavy
