# AGENDA

## Historic District Commission Meeting

7:00 PM - Tuesday, June 14, 2022

## HDC Work Permit Staff Review

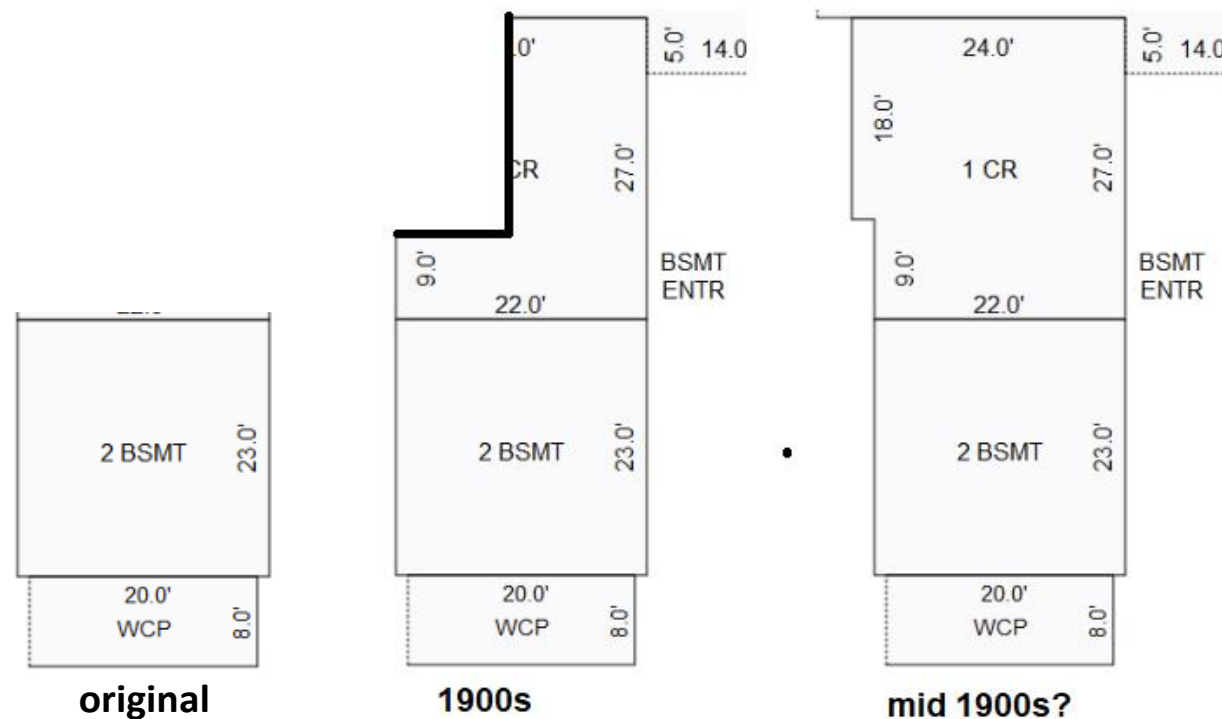
Guessing the time frame between home additions based on material used found foundation and siding “lines”  
The 1900s (1<sup>st</sup> addition) they matched the foundation block to original however the 2<sup>nd</sup> addition used cinder block  
Siding is not original to house as this siding didn’t start until early 1900s (I found 1907)

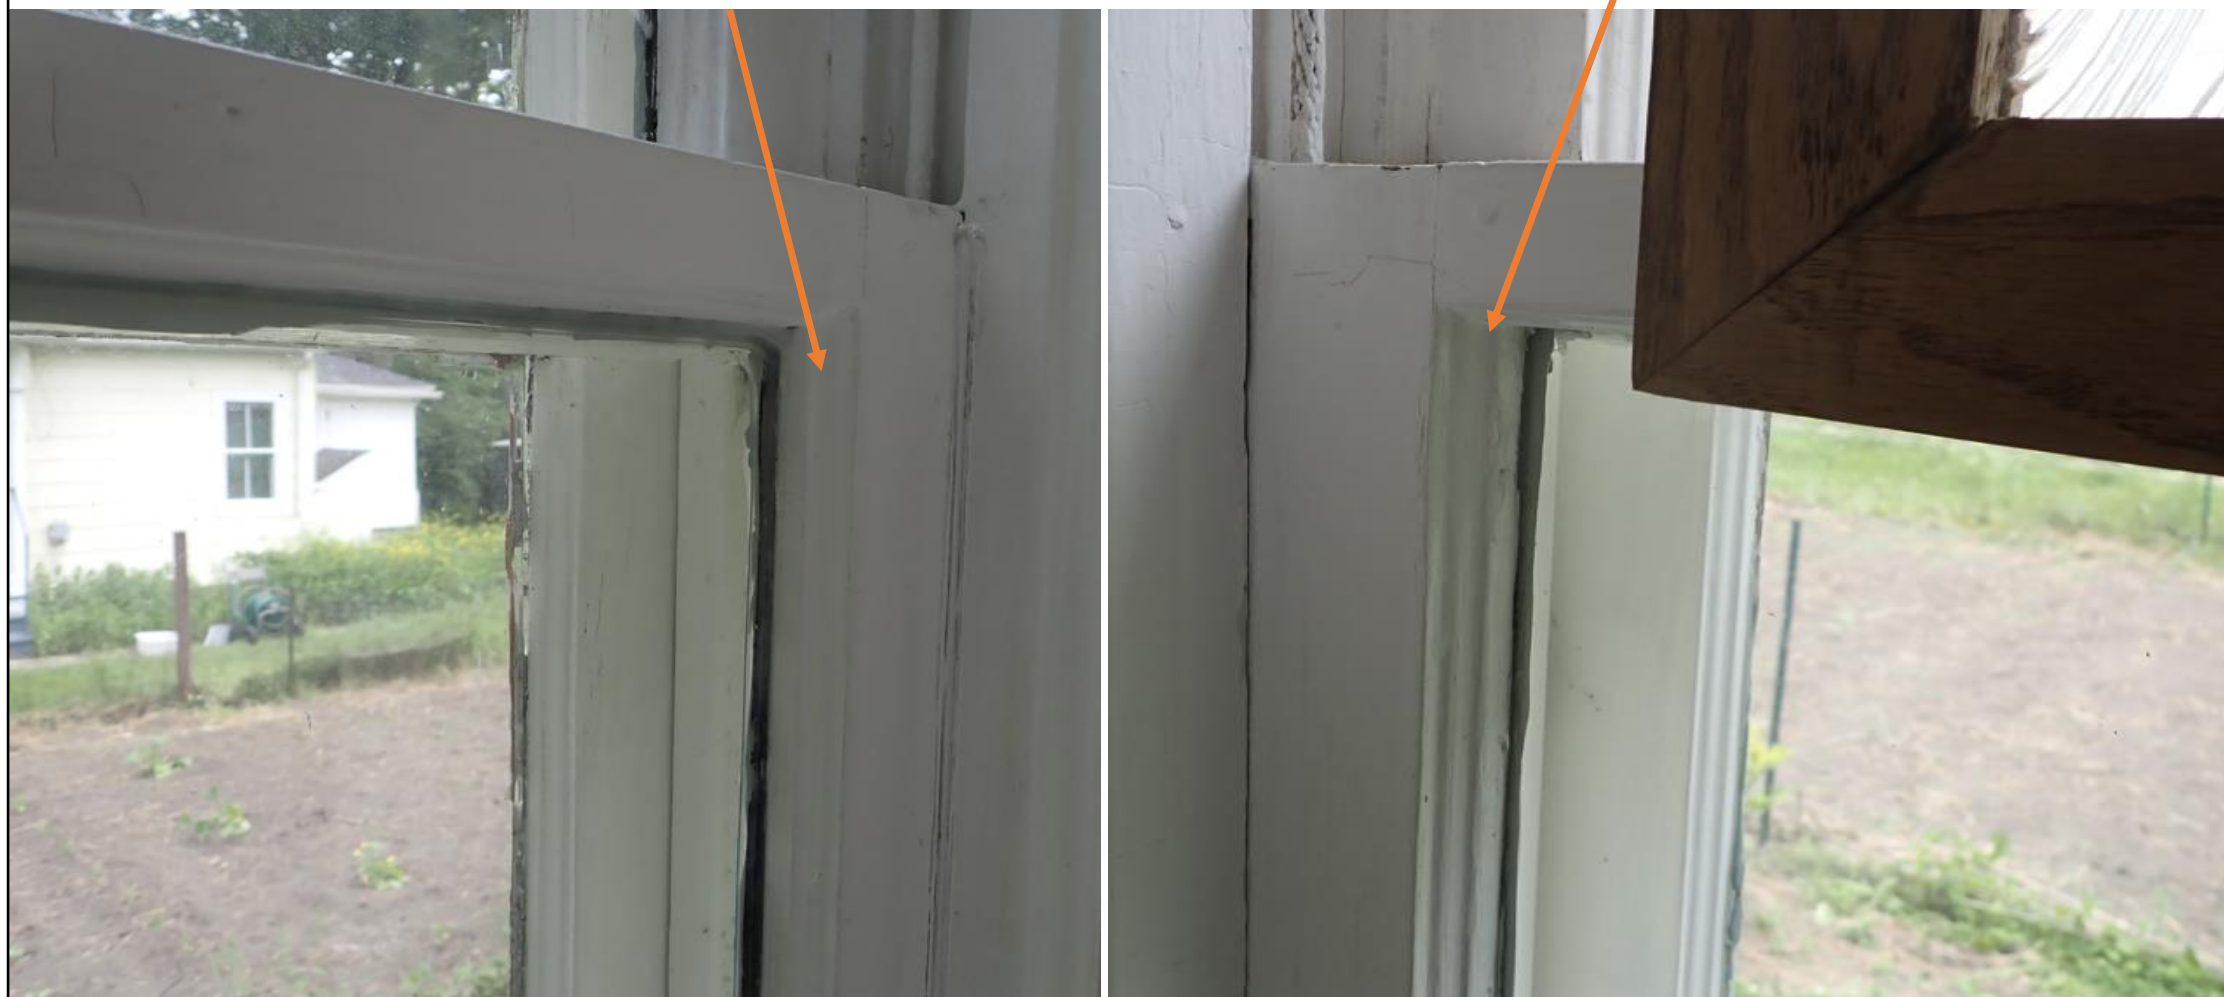
The stop molding holding the glass is more “cove” on the original and an “OG Step” pattern on the two in the addition

The original window is a 1:3 style double hung (taller) - the addition windows are 1:1 (shorter)

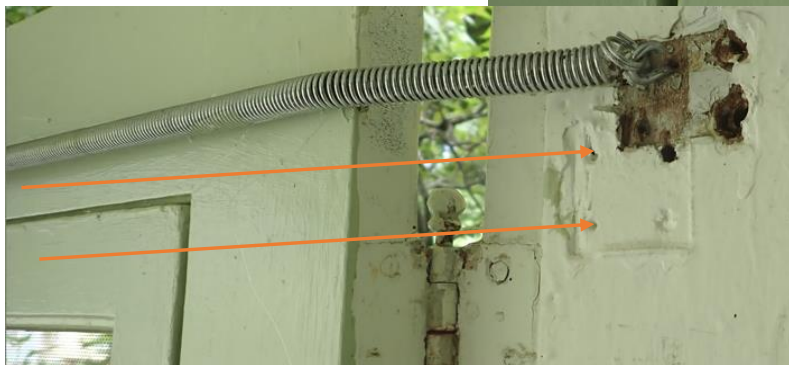
This door closure marking that has been painted over several times does not line up with the current storm door

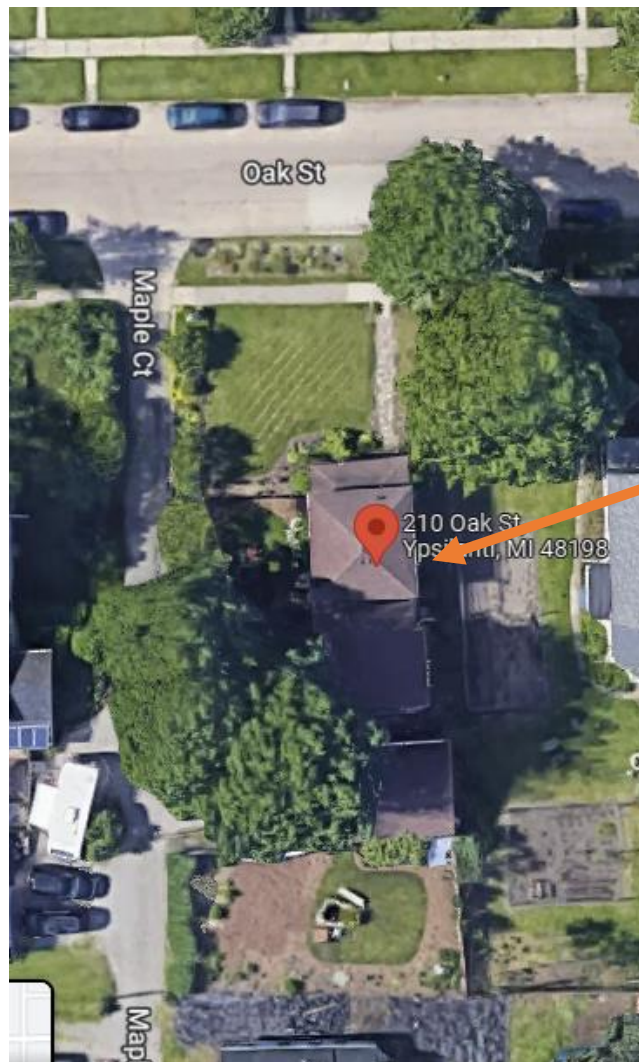
Double hung in dining room can not be easily seen from street.

Propose to replace this window with a 1:3 style to match the existing double hung  
This would match the other two windows on the same wall in the same room (if they are approved)

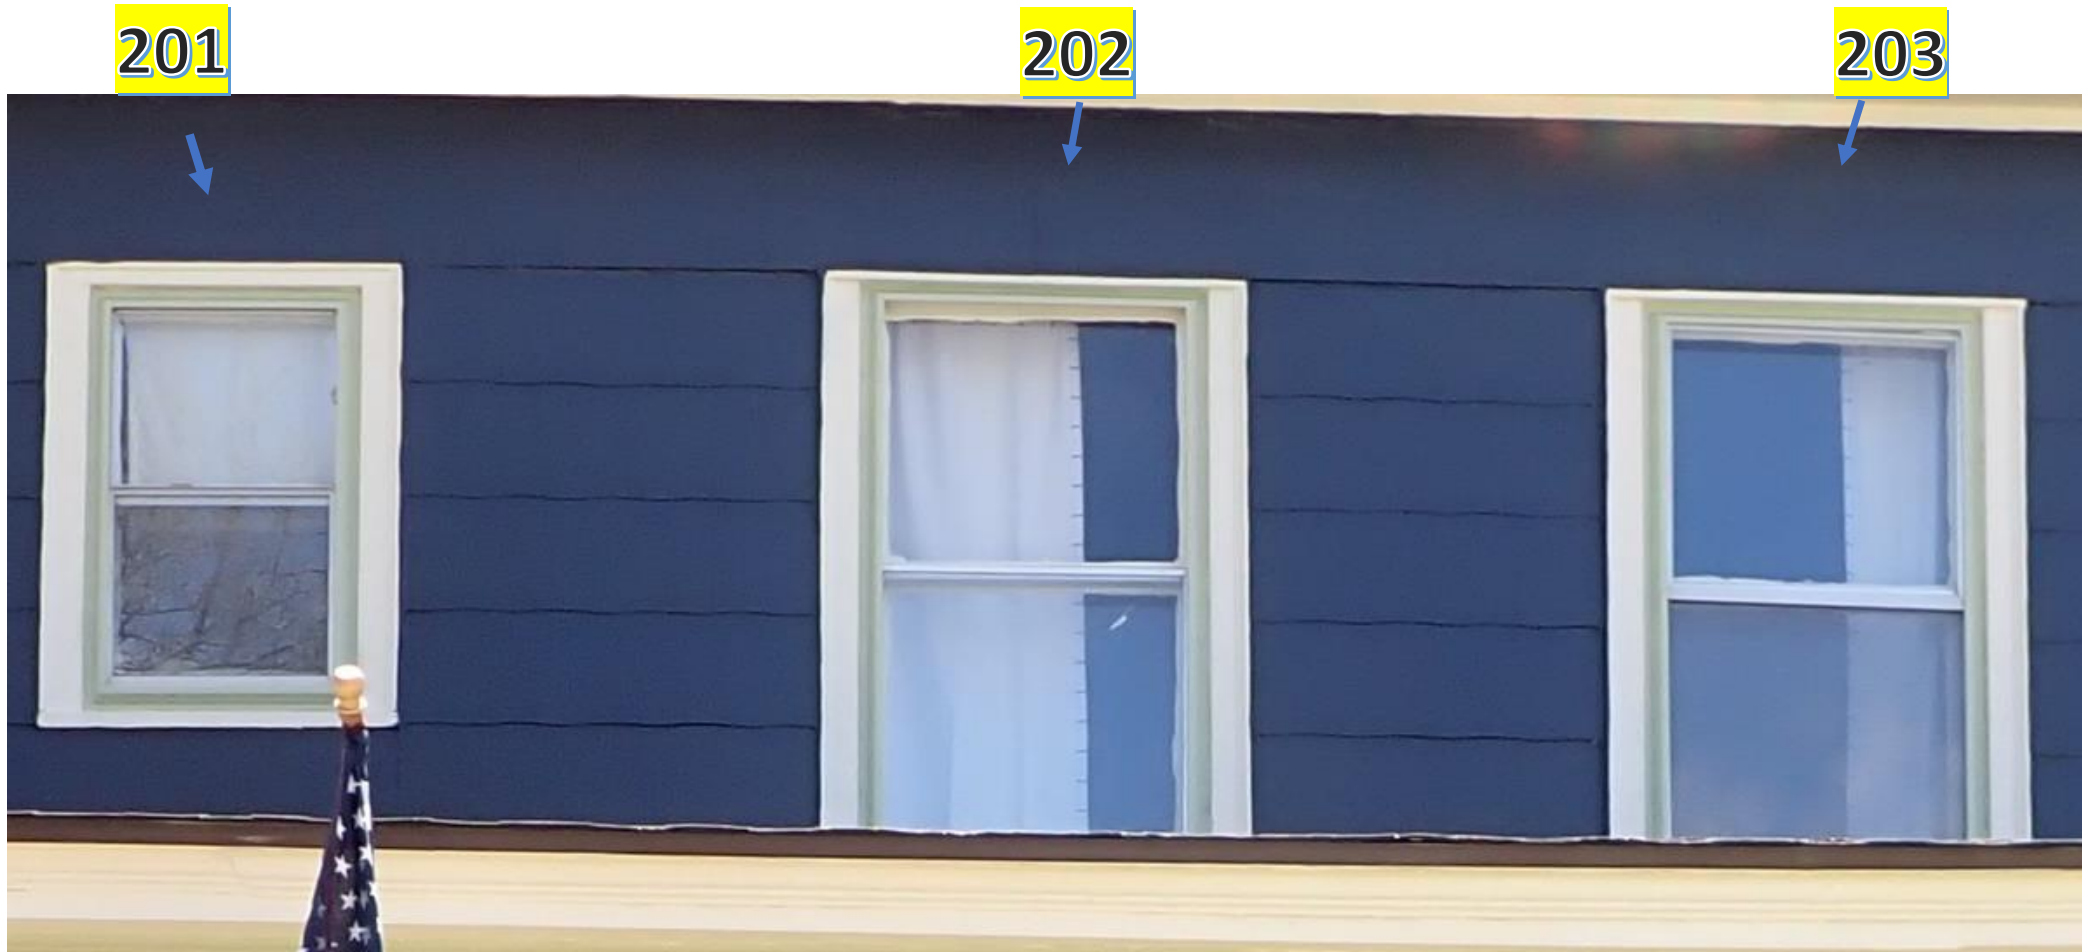
**Front of house - 201 is framed differently on top compared to 202 and 203**

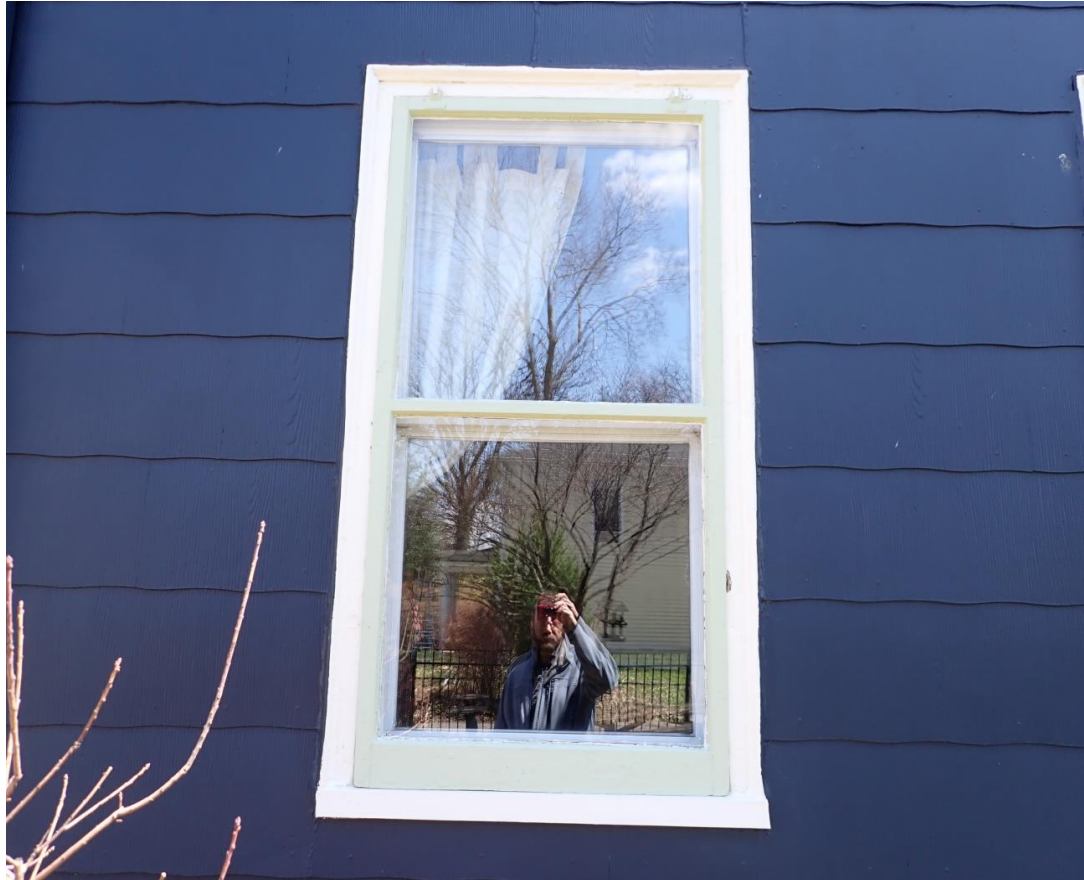
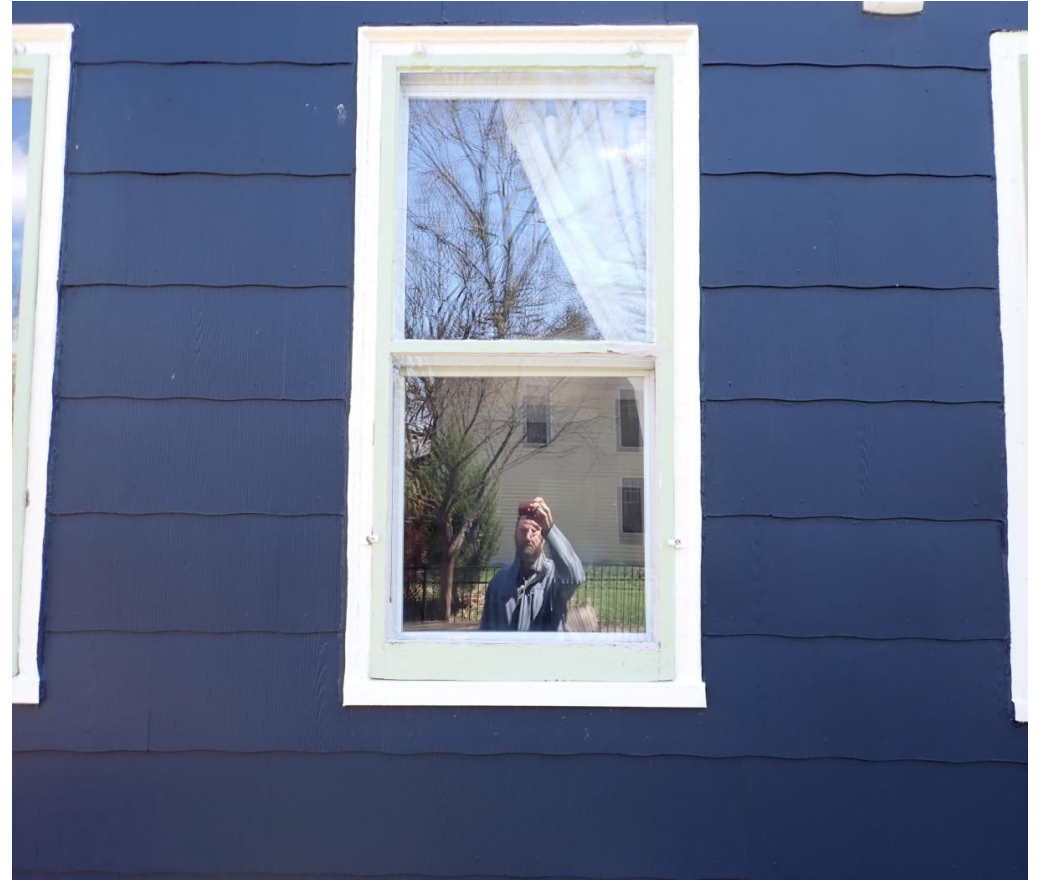
101 (Living Room) – 1:3 Double Hung – lower window pane is cracked and interior string missing

Wood Window – String tyle

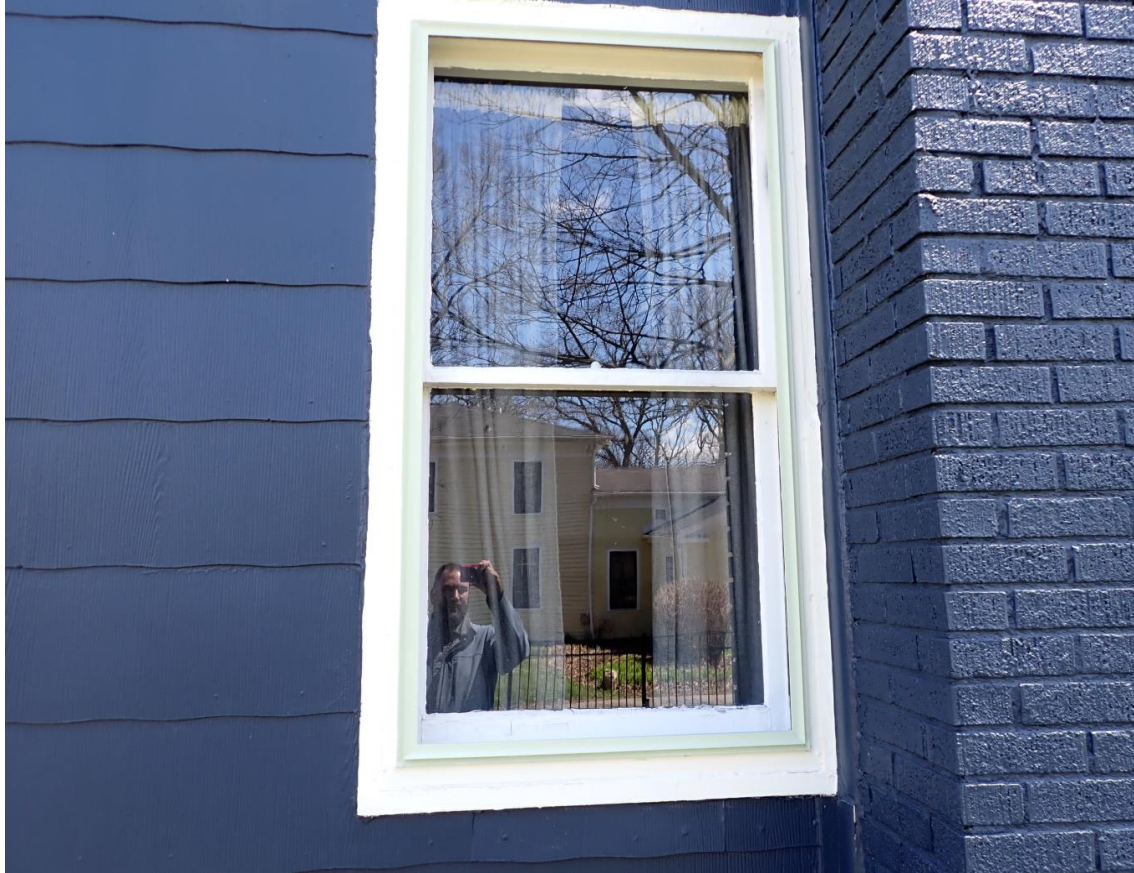
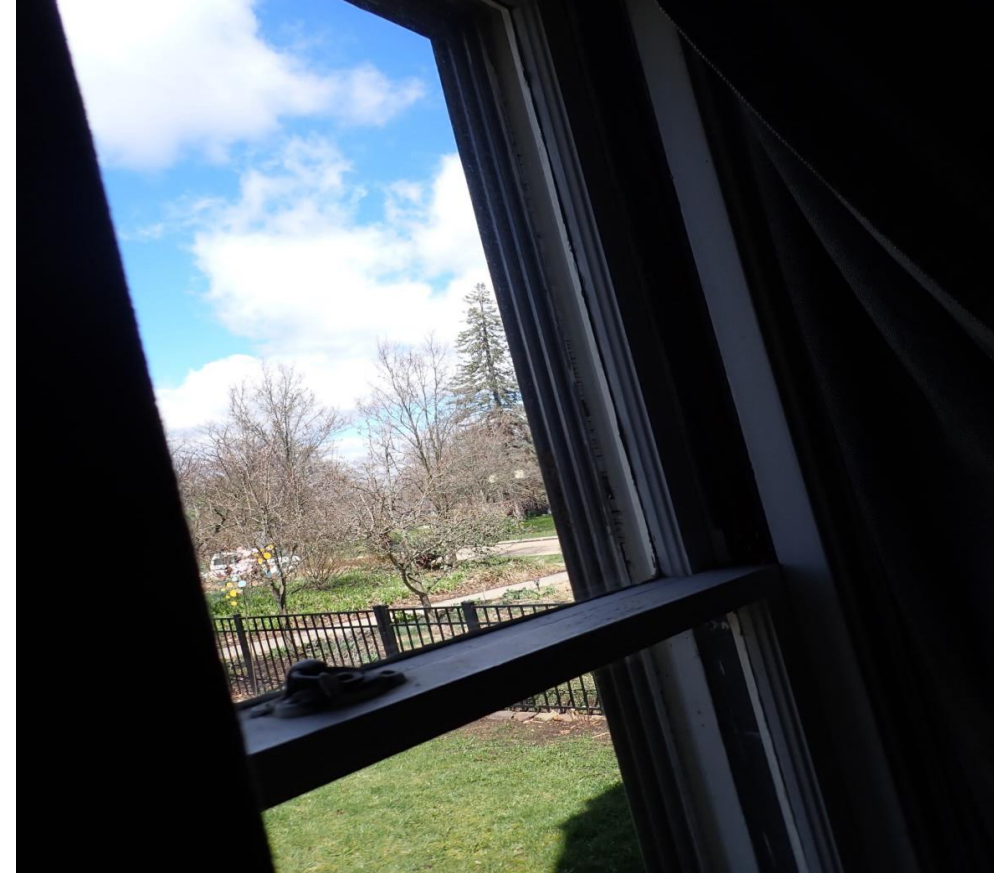
210 Oak Street  
104 (Laundry Room) – Double Hung

Vinyl Window

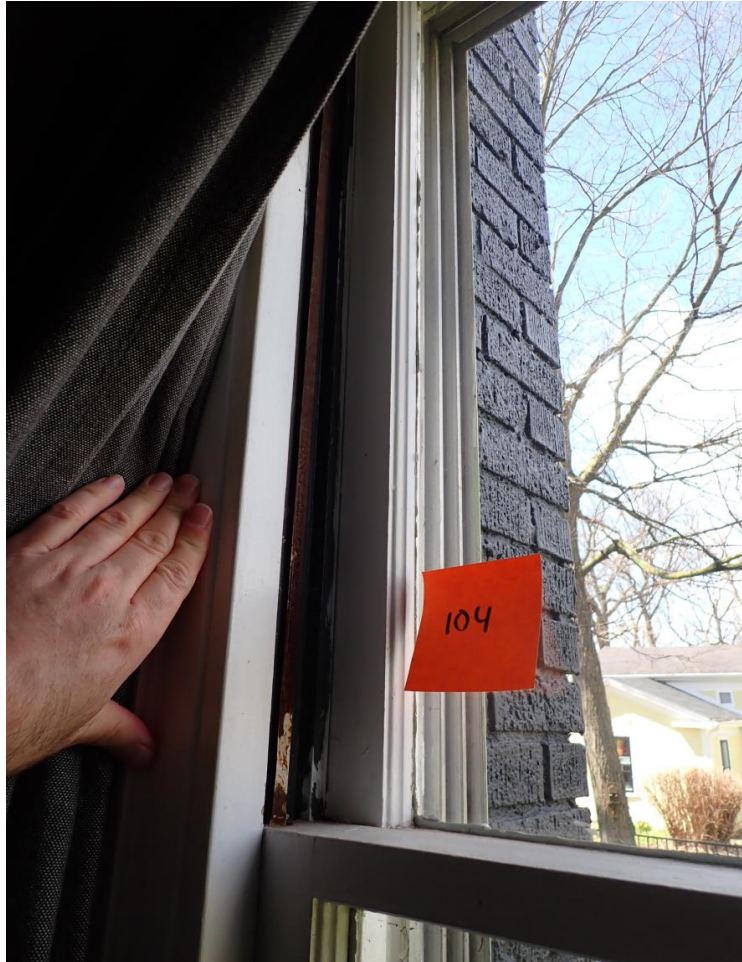
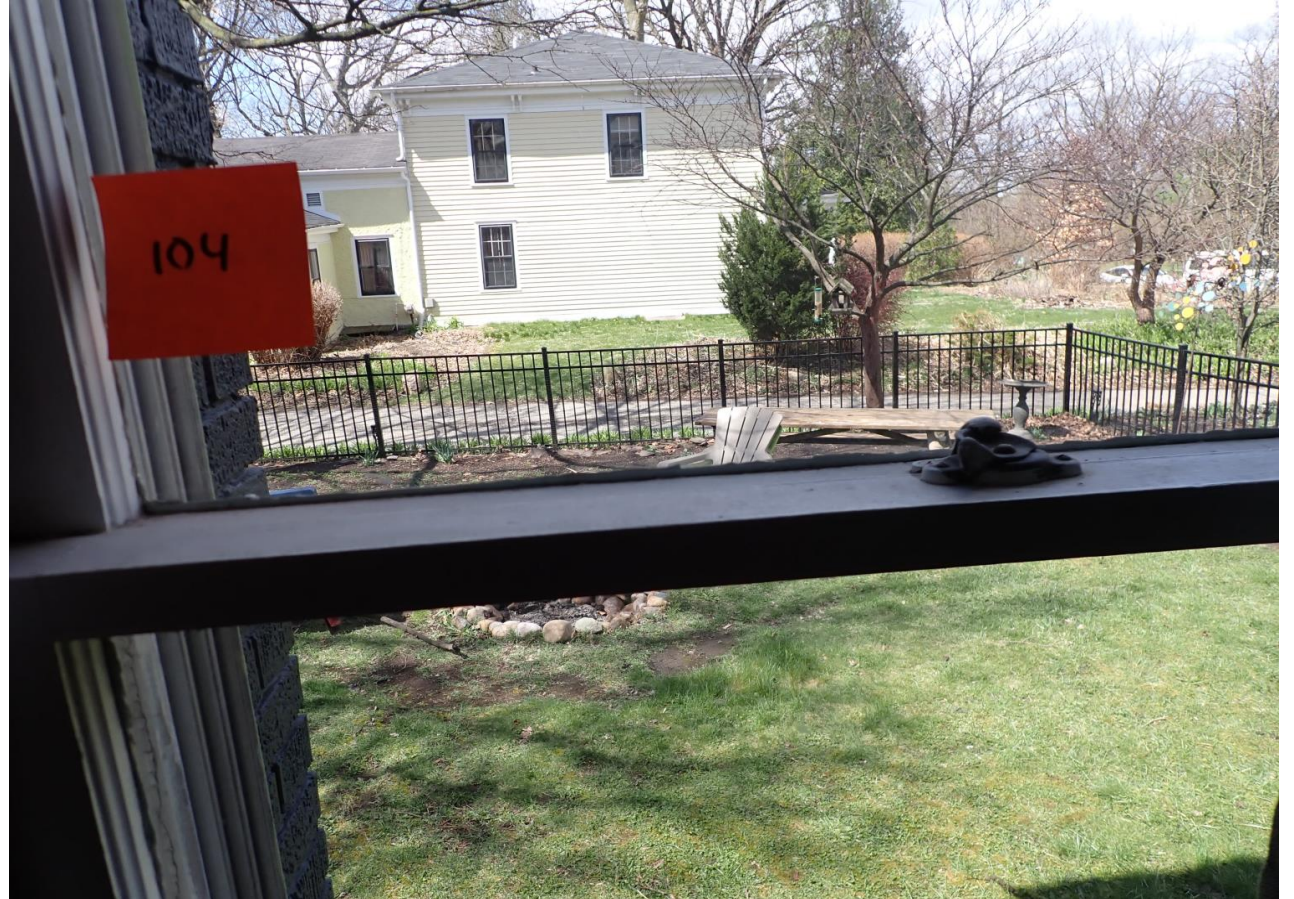
210 Oak Street  
104 (Laundry Room) – Double Hung

Wood Window – Zinc track  
Aluminum storm – missing glass

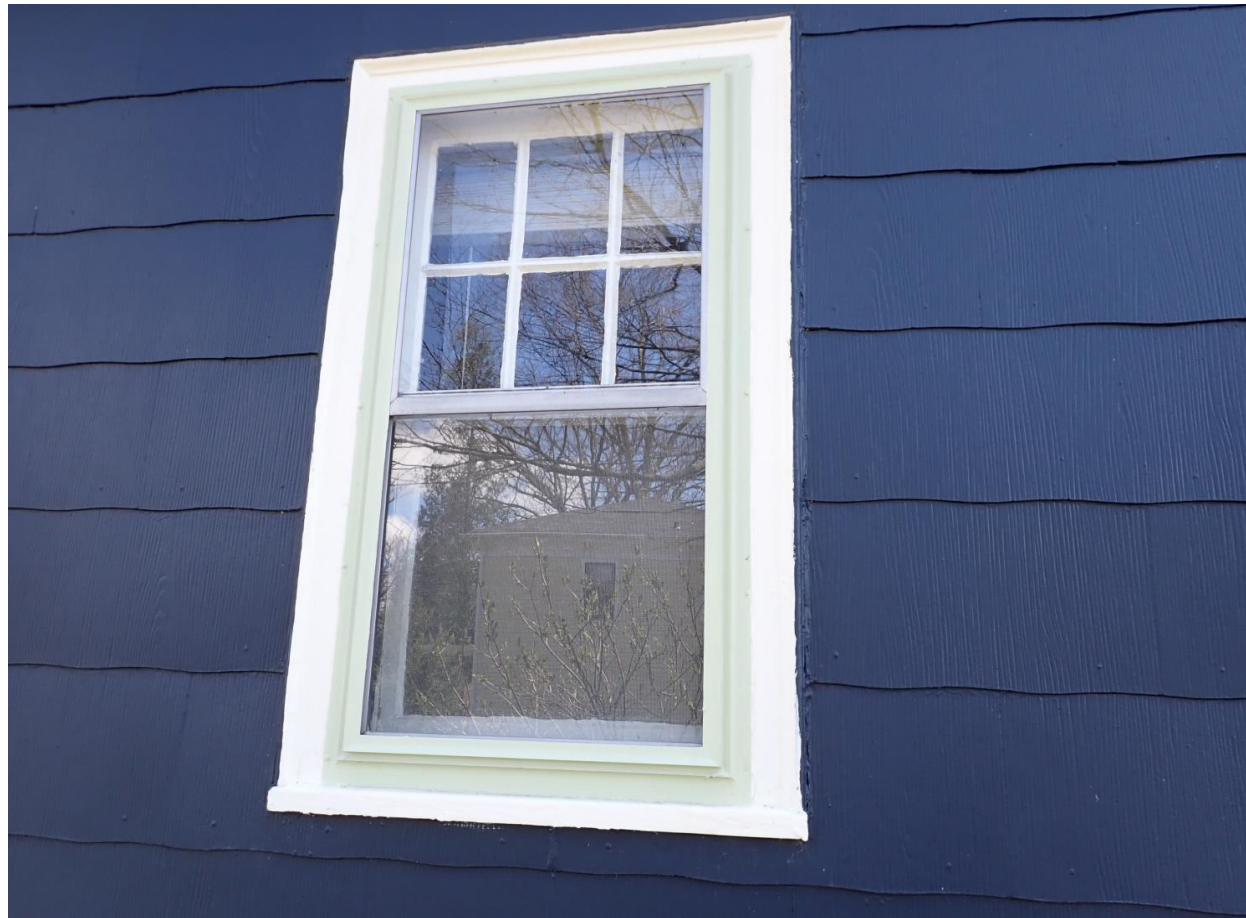
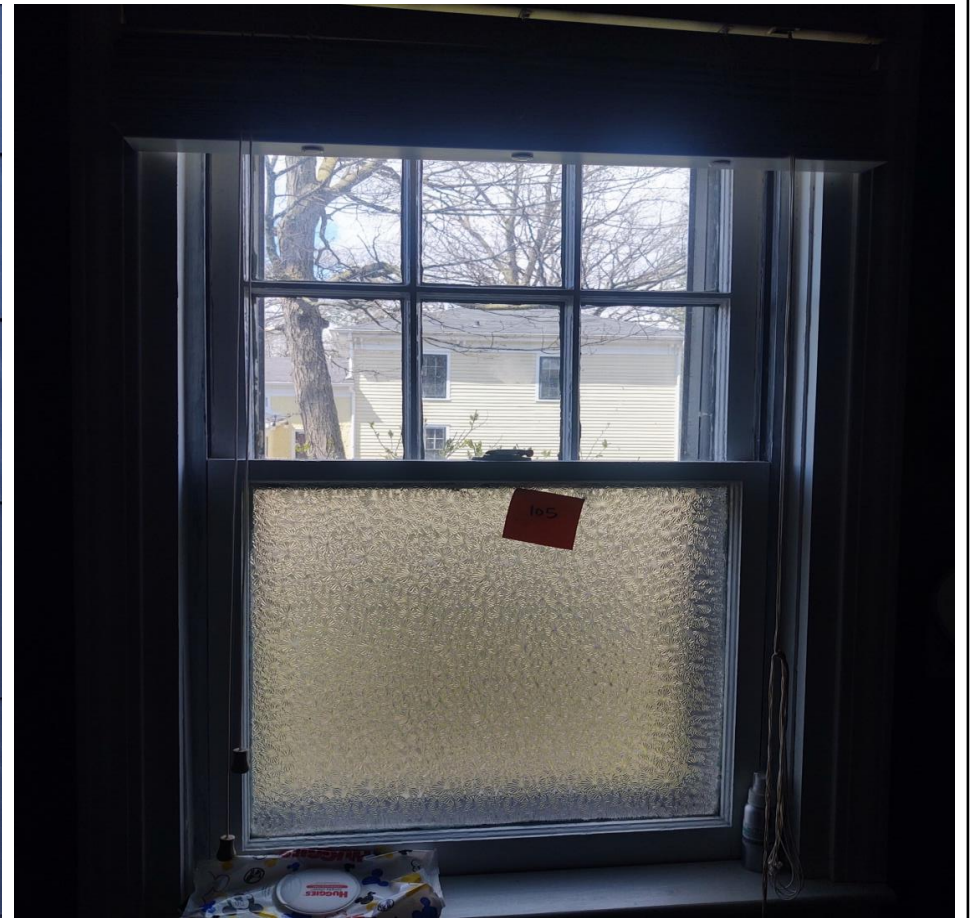
210 Oak Street  
105 (Bathroom) – Double Hung – 3w x 2h – upper sash

Wood Window – Zinc track

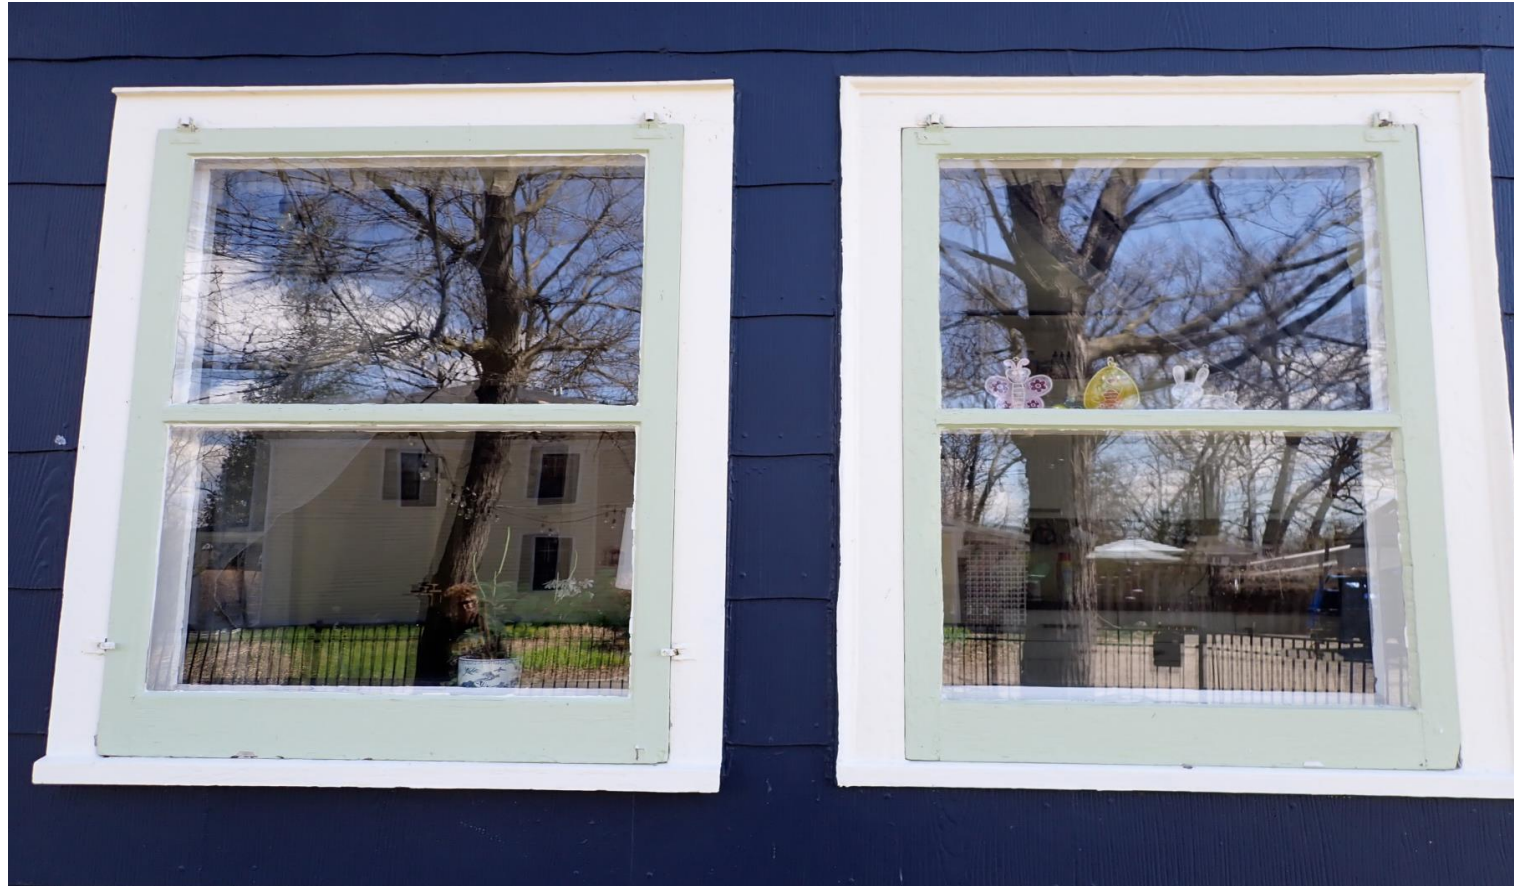
210 Oak Street  
106 and 107 (Kitchen) – Double Hung

Wood Window – Zinc track

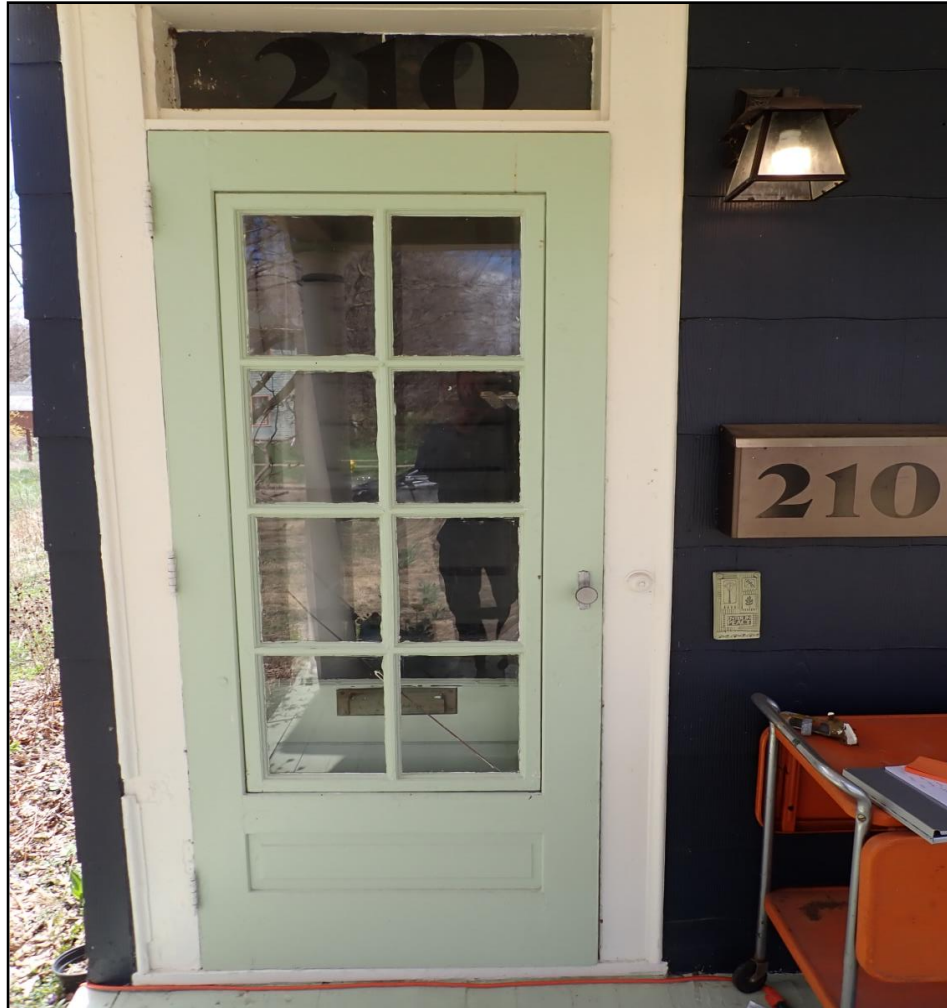
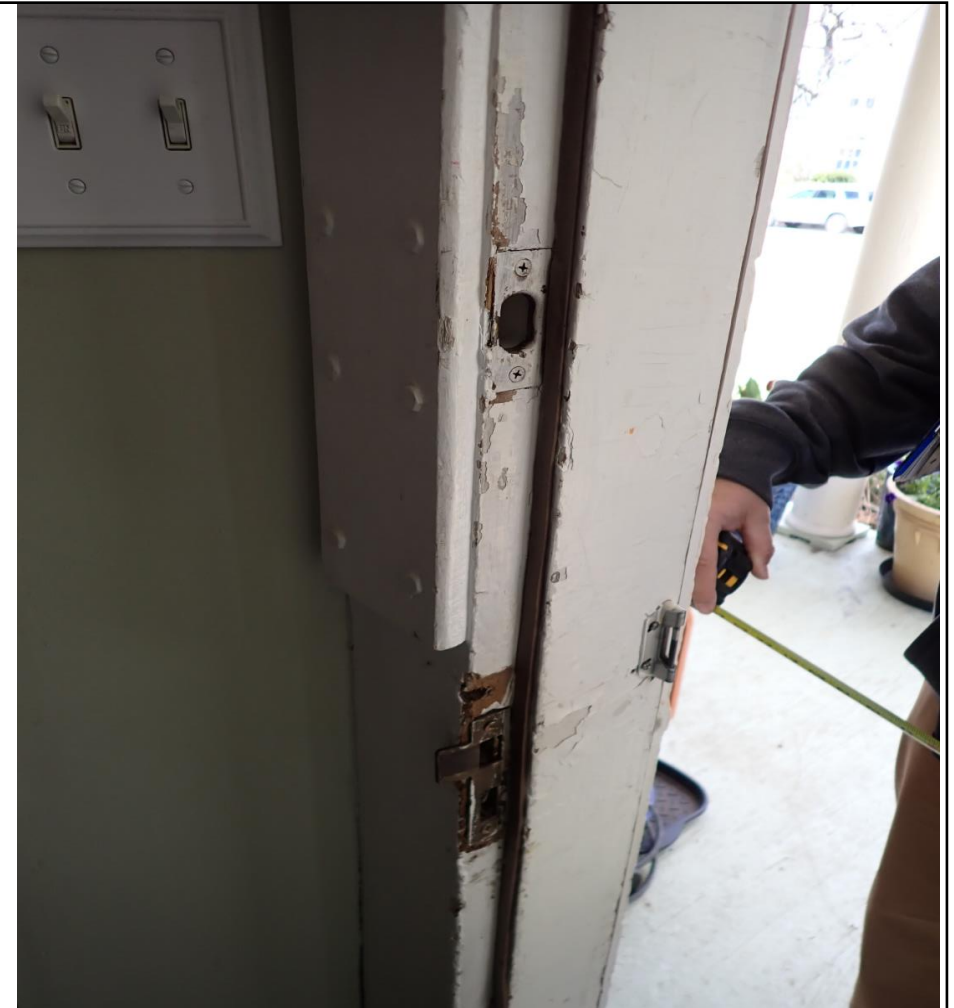
114 (Front Entrance) – Entry Door

Deadbolt was added on from original – door locks into 1x4 casing – reinforcement board was bolted over deadbolt locking area

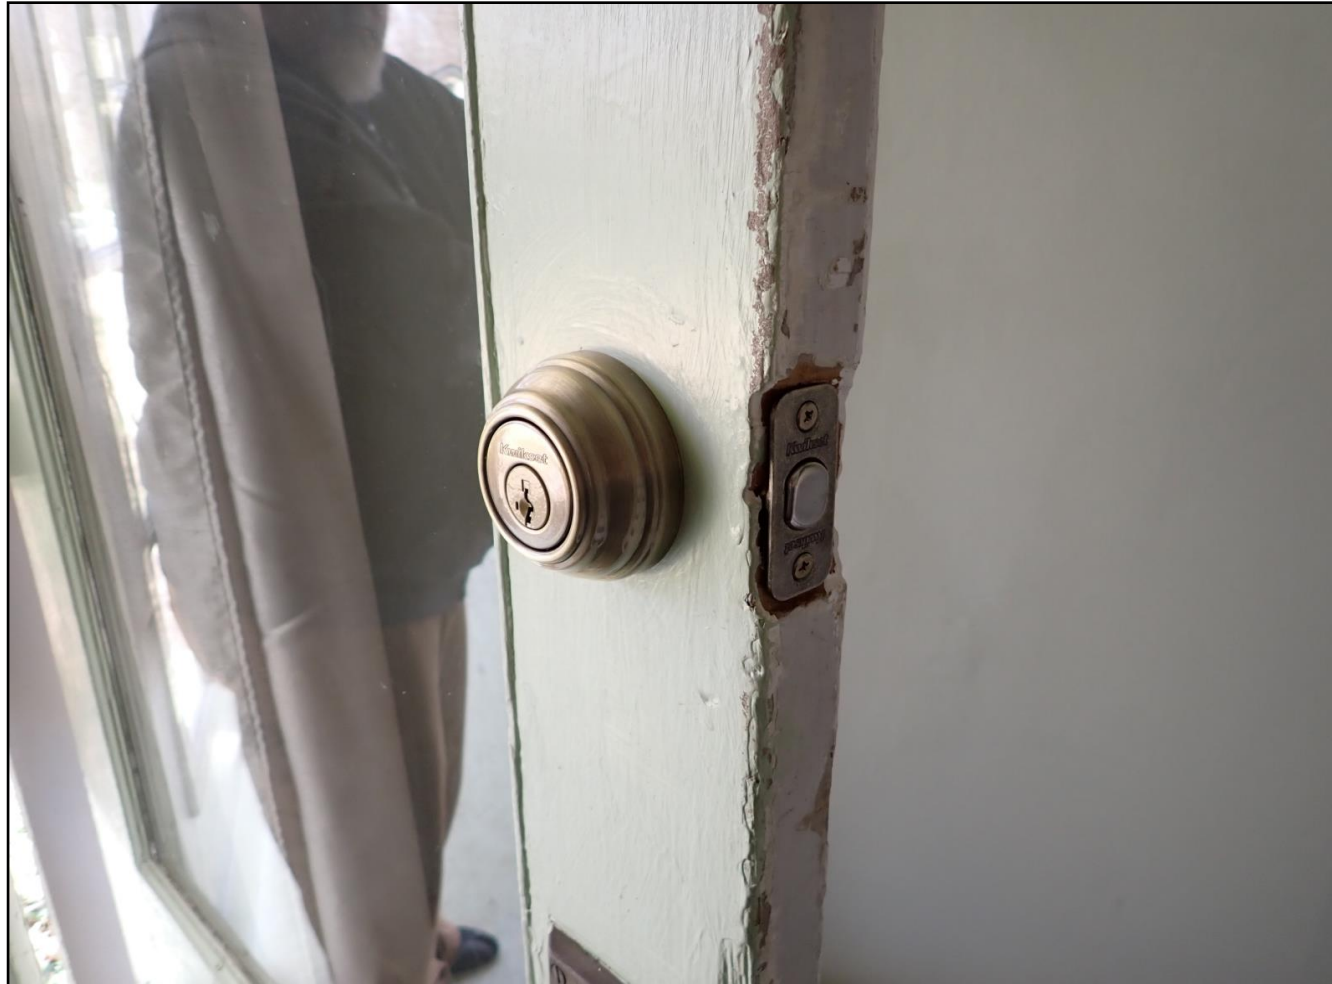
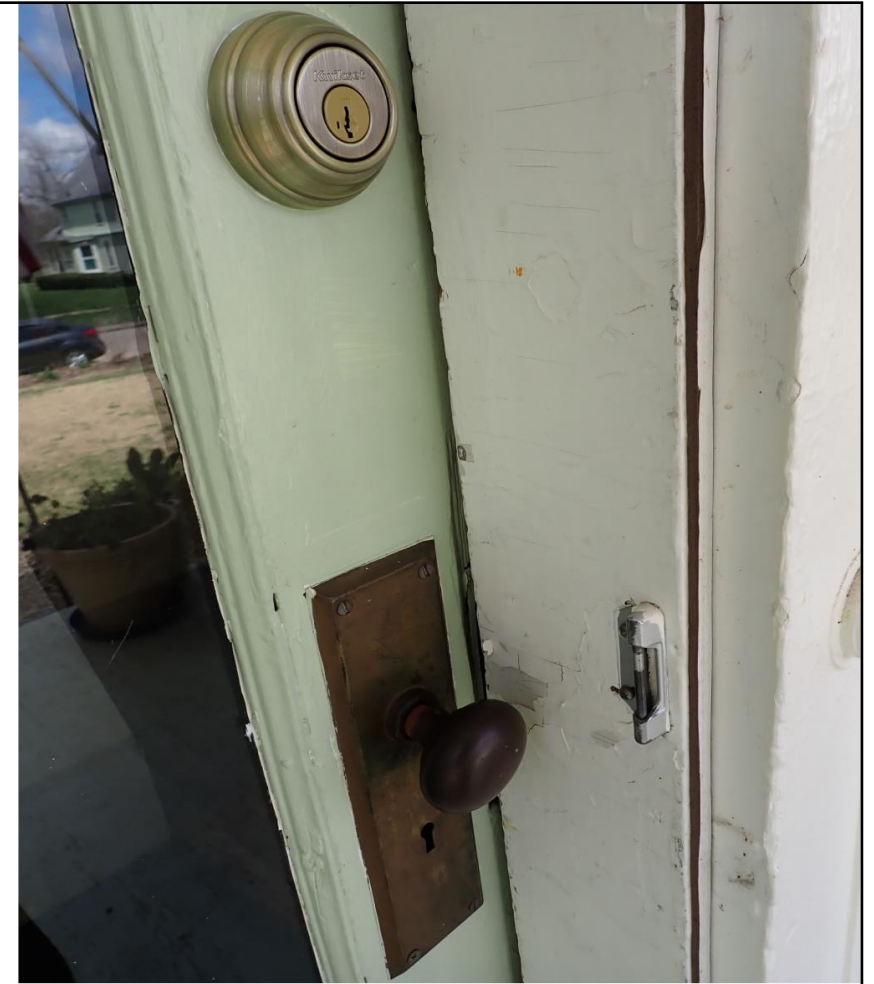
210 Oak Street

Deadbolt was added on from original

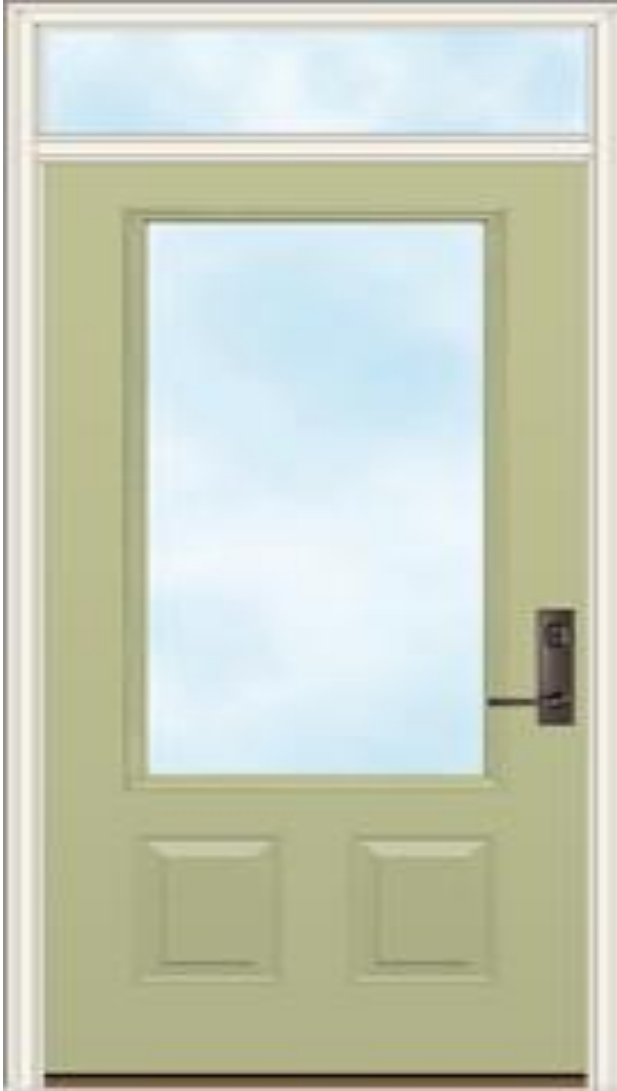
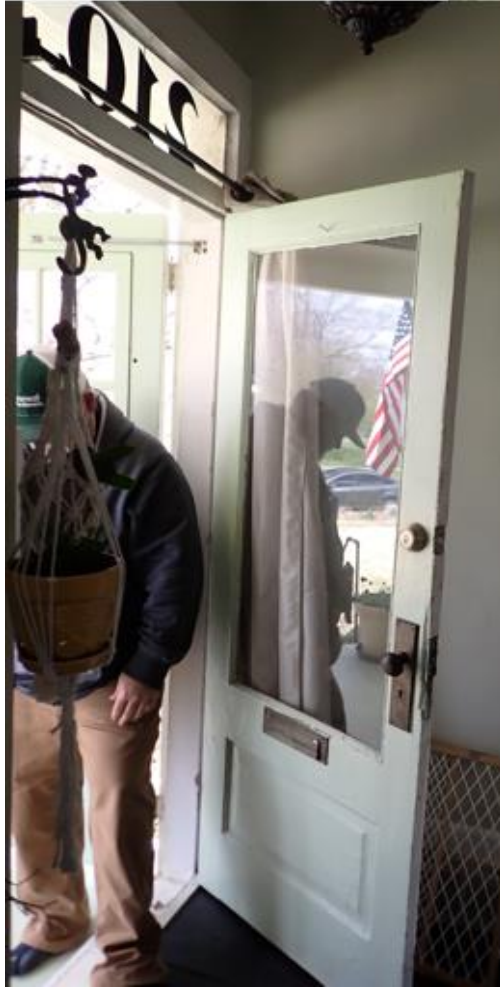
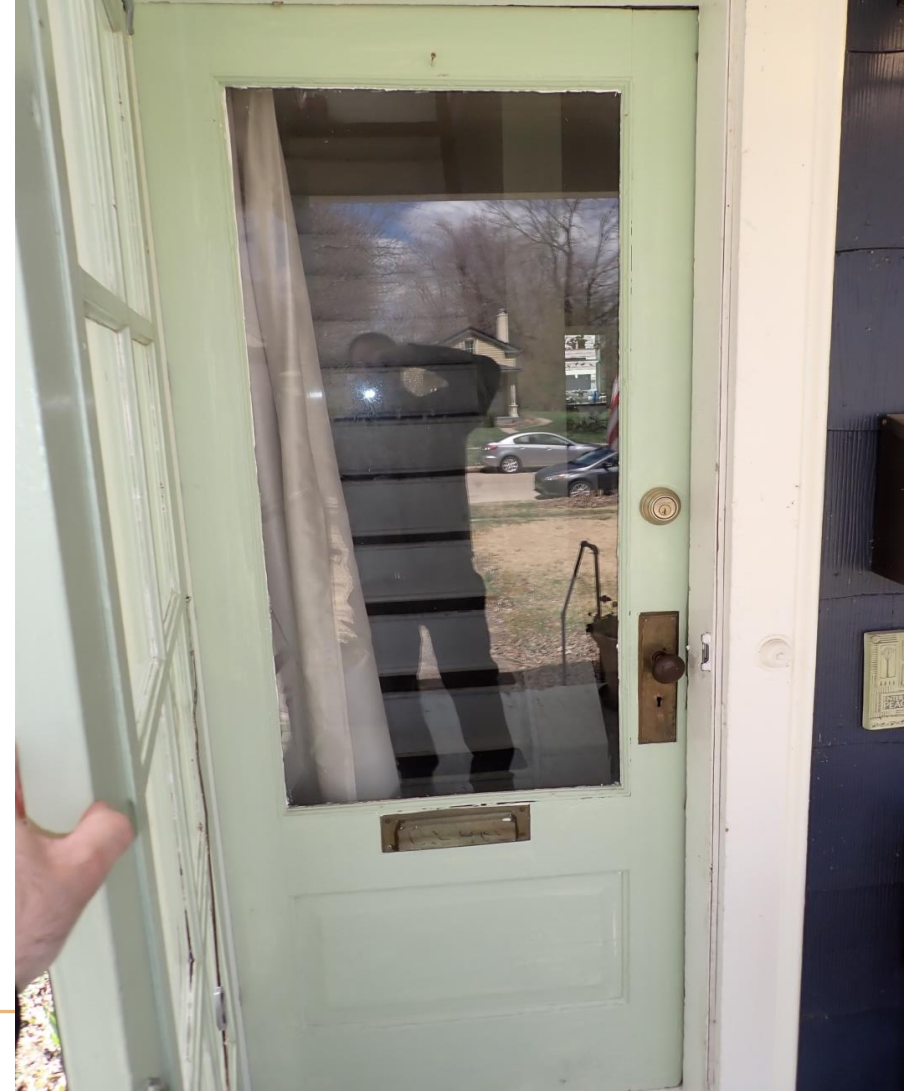
210 Oak Street

114 (Front Entrance) – Entry Door – No storm on new door
