# AGENDA

## Historic District Commission Meeting

7:00 PM - Tuesday, July 11, 2023

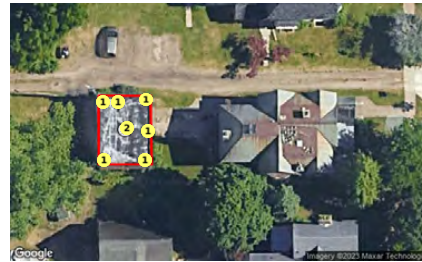
Deficiency: The flashing is showing signs of failure.

Deficiency: The protective layer of aluminum coating is starting to erode. This allows the UV rays to deteriorate the membrane .

Corrective Action: Clean the area of repair to a suitable surface. Apply a layer of flashing cement to the prepared area. Embed fabric into the flashing cement. Apply a second layer of flashing cement over the embedded fabric.

Corrective Action: Clean the repair area to a suitable surface. Apply a new layer of protective coating over the prepared area.

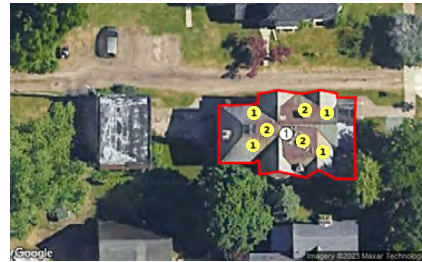
Deficiency: Damaged or missing slate

Deficiency: On upper flat lock steel roof the protective coating has broken down and the metal is exposed to the elements, oxidation or rust will take over and reduce the materials integrity. It has all ready started to get small holes in it from the rust

Corrective Action: Replace damaged slate (there is enough new tiles in attic)  
A 60' articulating lift will be required and ground protection mats will be needed.

Corrective Action: Clean and apply a rust inhabiting coating ( in a Galvanized or rust color) flashing grade on curbs, chimneys, pipes and holes and a top coat over entire area.

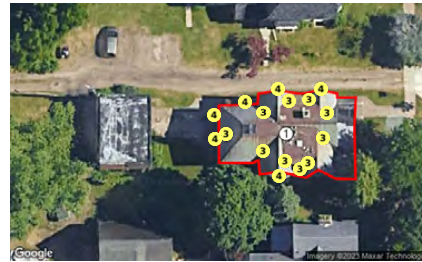
Deficiency: In the steel valleys and the pans around chimneys protective coating has broken down and the metal is exposed to the elements, oxidation or rust will take over and reduce the materials integrity.

Corrective Action: Clean and apply a rust inhabiting coating ( in a Galvanized or rust color) flashing grade chimneys flashing and holes and a top coat over entire area.

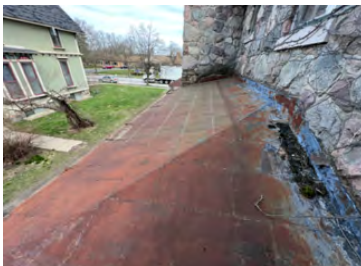
Deficiency: 3 porch and 3 bay window flat lock steel roofs have rusted and have started to become loose around the edges

Corrective Action: Secure metal as needed Clean and apply a rust inhabiting coating ( in a Galvanized or rust color) flashing grade on holes and a top coat over entire area.

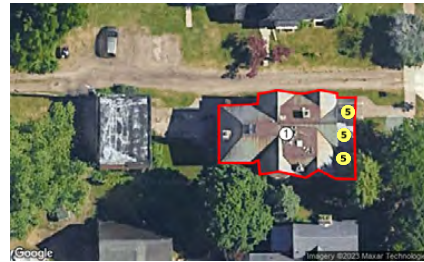
Deficiency: Slate and area of decking on front porch are damaged beyond repair.

Corrective Action: Remove existing slate, repair deck as needed (structural damage will need to be accessed once roof is removed and repaired on a time and material basis), cover entire area with a high temperature ice shield and install a galvanized standing seam roof system per industry standards

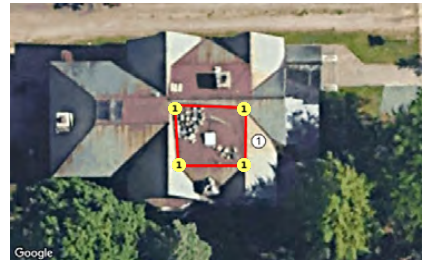
Deficiency: The flat roof is rusted and has deteriorated with age.

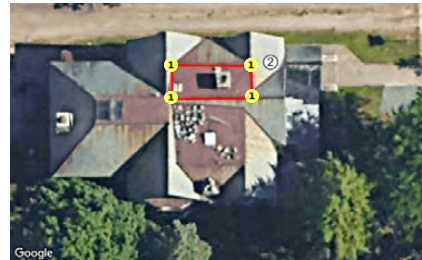
Deficiency: The flat roof is rusted and has deteriorated with age.

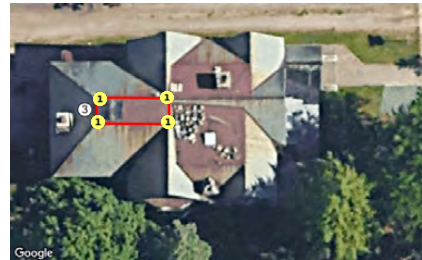
Deficiency: The flat roof is rusted and has deteriorated with age.
